Subject: **Roof Inspection and Draft Report**

Repair Building 1001 and interior improvements for DAPS  
Project No.: Qu1402M  
HJCG No: 2015-089  
Marine Corps Base, Quantico Virginia

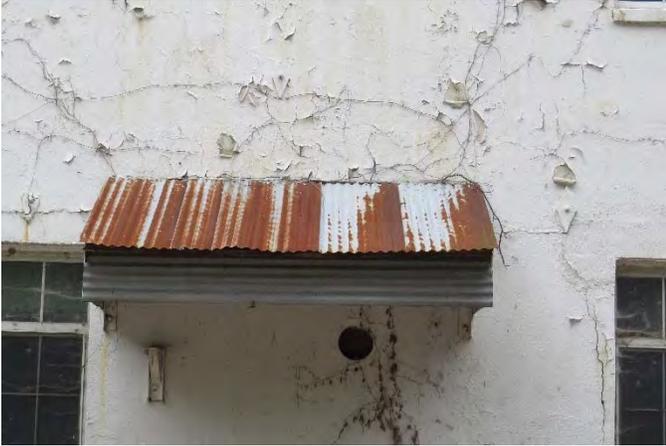
**Photo 15:** Overview of rear shed metal roof.

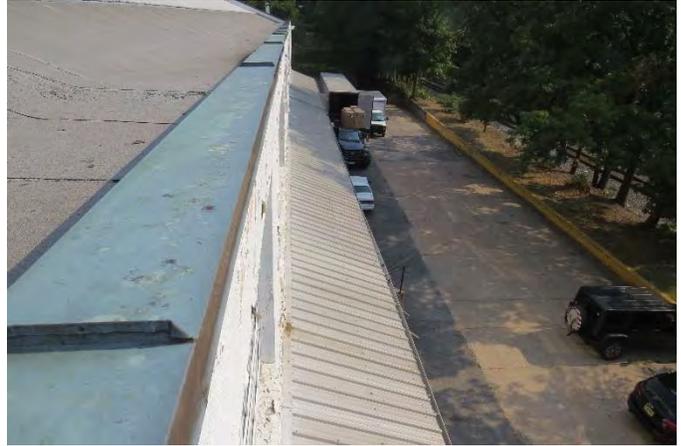
**Photo 16:** Overview of metal panels covering the loading dock.

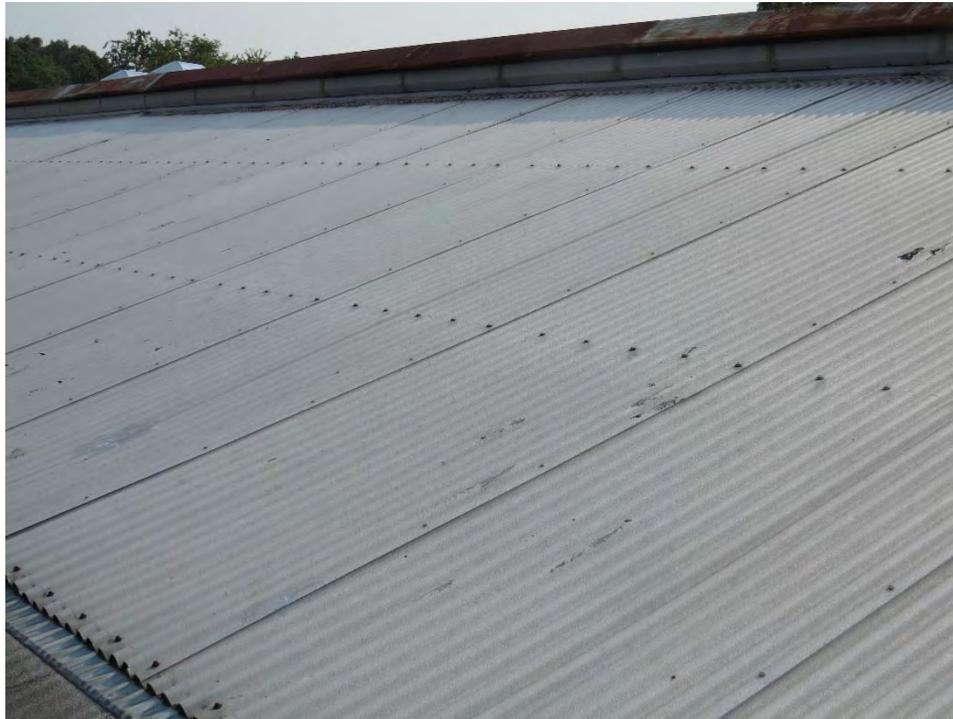
**Photo 19:** Overview of the metal panels

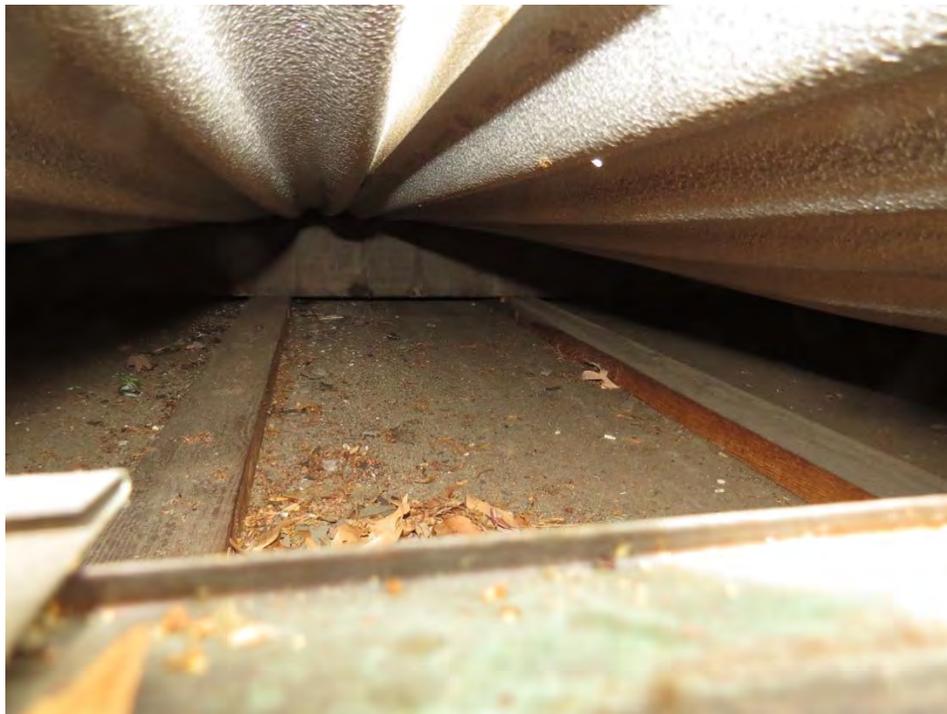
**Photo 20:** Overview of the wood sleepers below the corrugated metal panels.

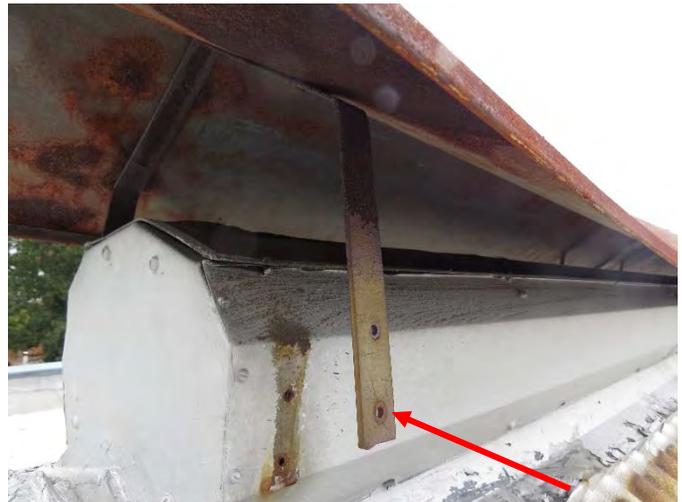
**Photo 30:** Detailed view of unsecured ridge cap support.

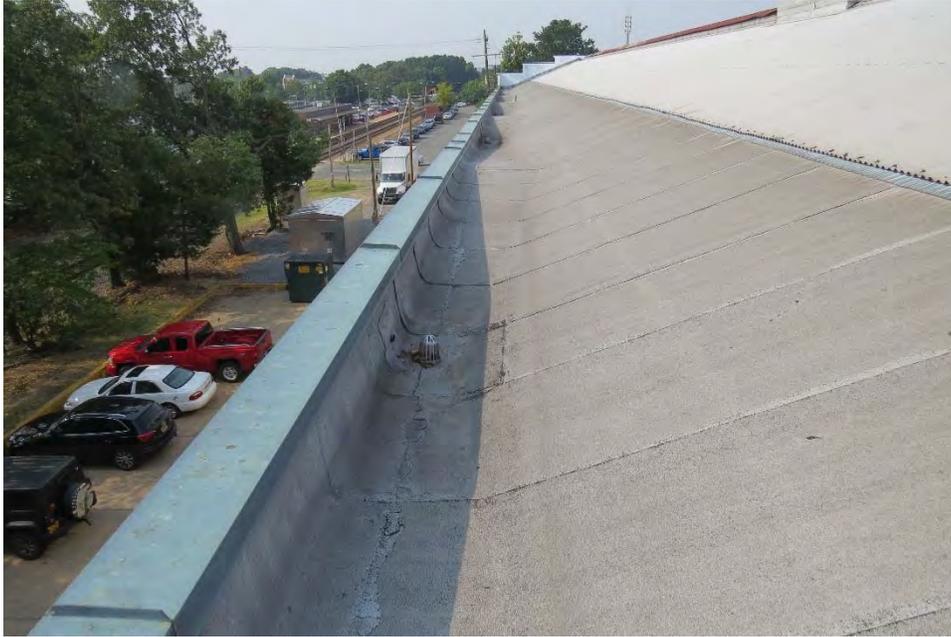
**Photo 35:** Overview of the granular surfaced membrane looking south from the north.

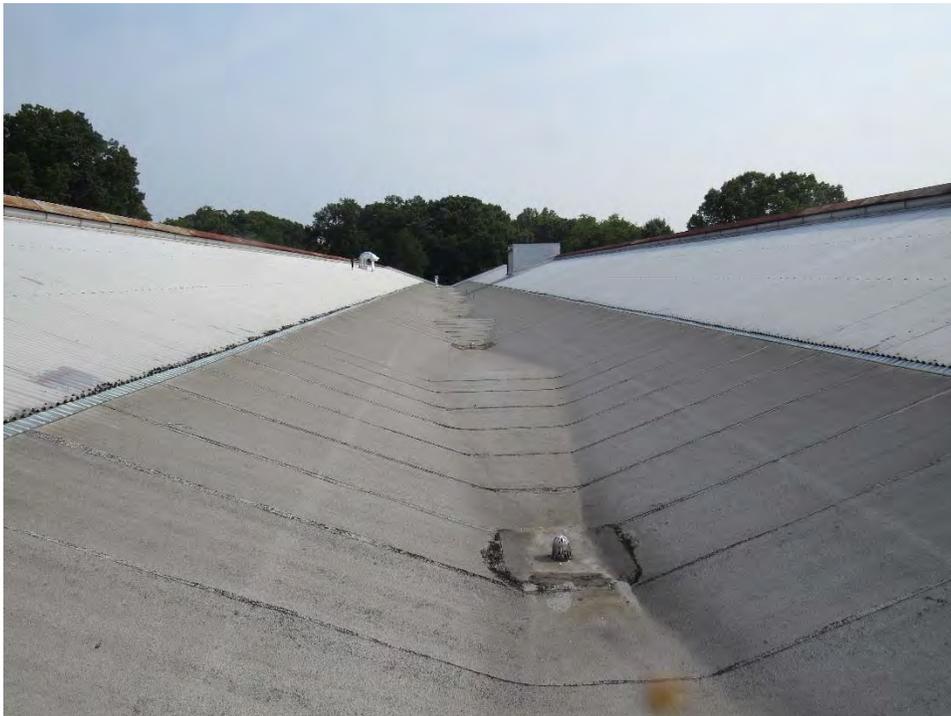
**Photo 36:** Overview of the granular surfaced membrane looking north from the south.

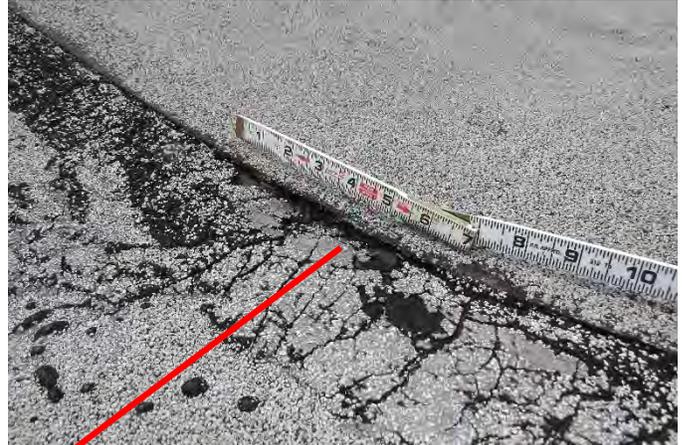
Numerous splits and cracks were noted throughout the roof. The splits and cracks are at various stages, with some cracks completely through the membrane, and other cracks through the top layer into the reinforcement. These cracks will continue to allow water to enter the building.

**Photo 38:** Detailed view of open membrane seam and split.

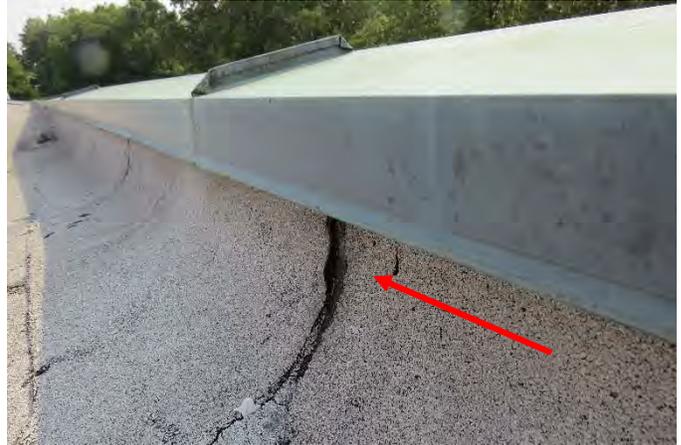
Numerous splits and cracks were noted throughout the roof. The splits and cracks are at various stages, with some cracks completely through the membrane, and other cracks through the top layer into the reinforcement. These cracks will allow water to enter the building.

**Photo 42:** Detailed view of membrane split.

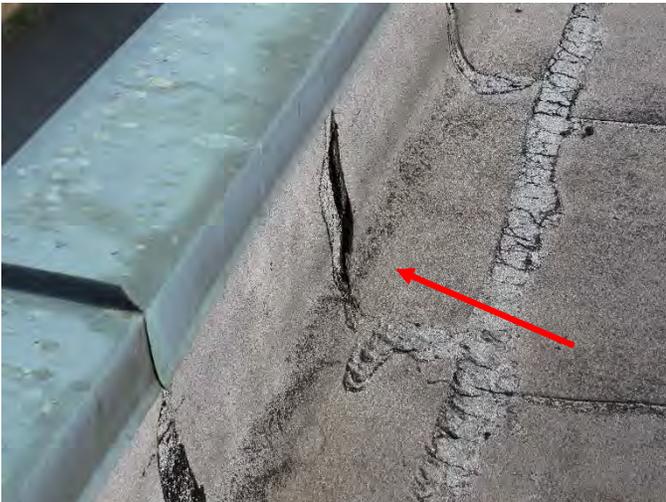
**Photo 43:** Additional view of membrane split.

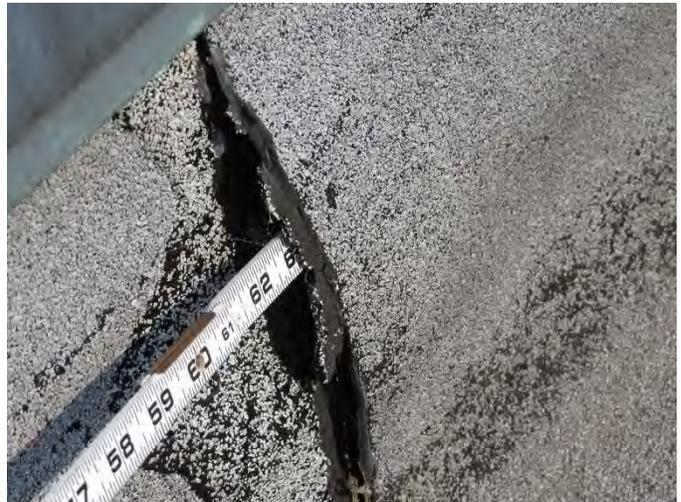
**Photo 44:** Detailed view of membrane split at a 90° angle.

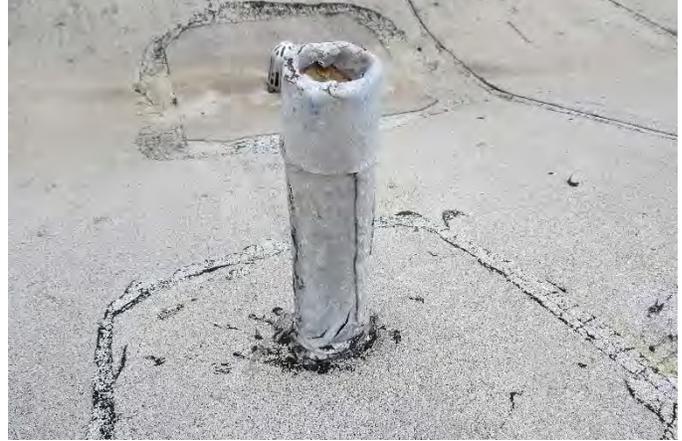
The lead flashings installed at the base of an existing plumbing vents were found to be weathered, split and open, providing a path for water to enter the building.

**Photo 46:** Detailed view of Lead flashing at plumbing vent.

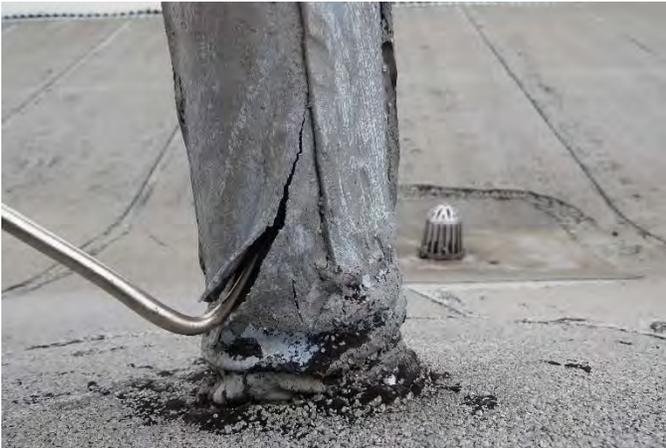
**Photo 47:** Additional view of membrane split.

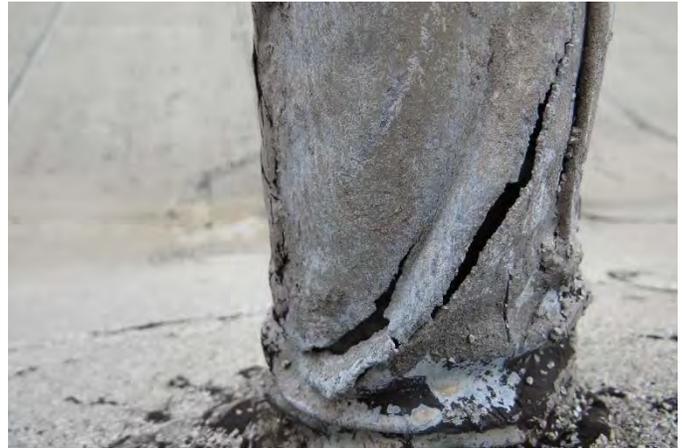
**Photo 48:** Detailed view of membrane split at a 90° angle.

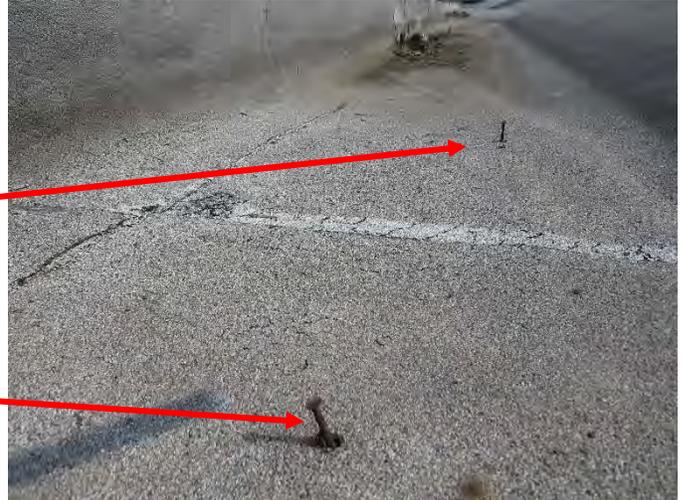
**Photo 50:** Detailed view of plywood deck fasteners backing out through the membrane

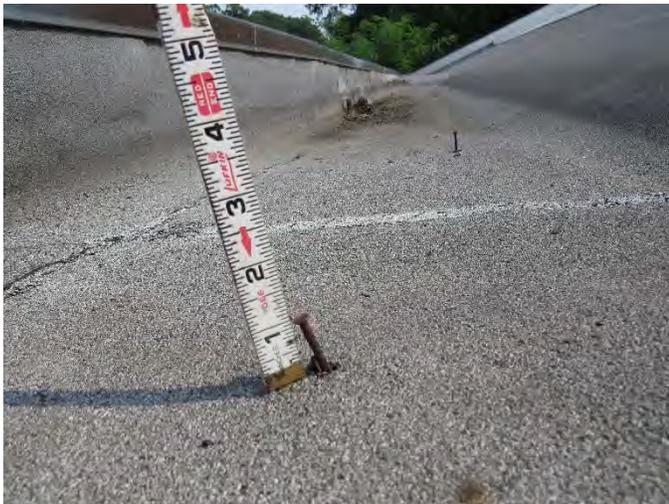
**Photo 51:** Detailed view of fasteners backing out through the membrane

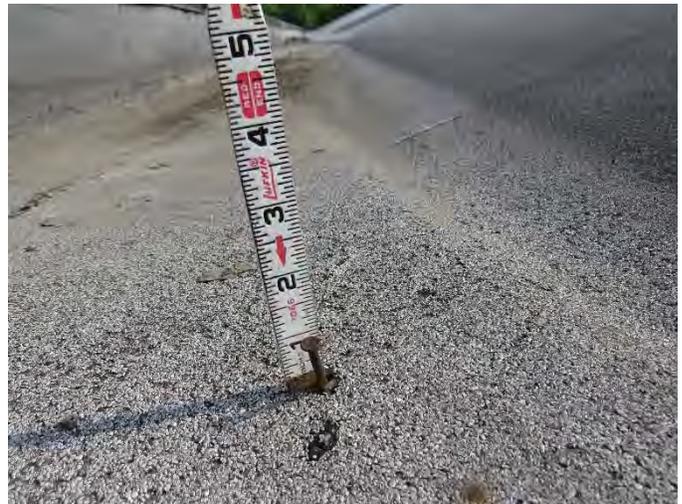
**Photo 52:** Detailed view of fasteners backing out through the membrane

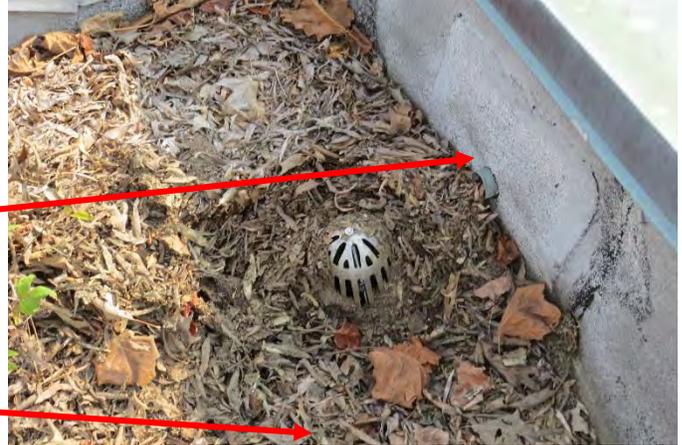
**Photo 54:** Detailed view of plywood deck fasteners backing out through the membrane.

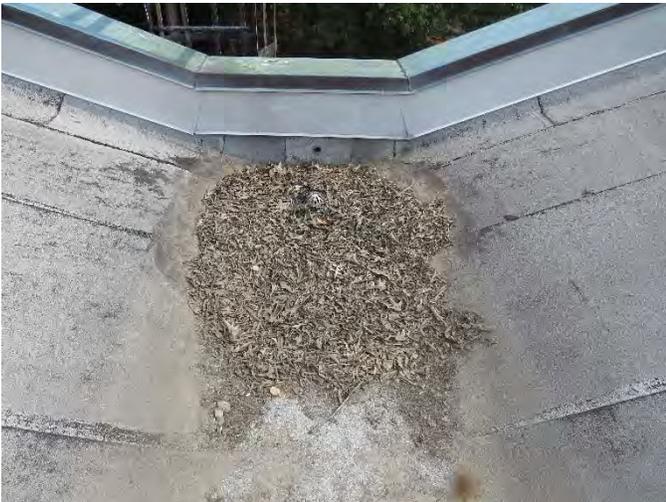
**Photo 55:** Detailed view of fasteners backing out through the membrane.

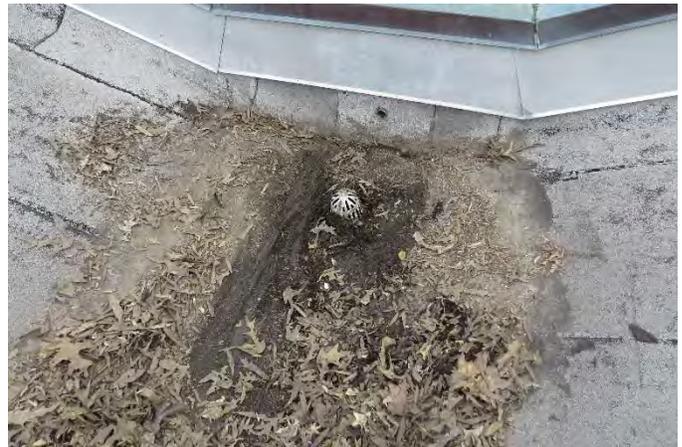
**Photo 56:** Detailed view of fasteners backing out through the membrane.

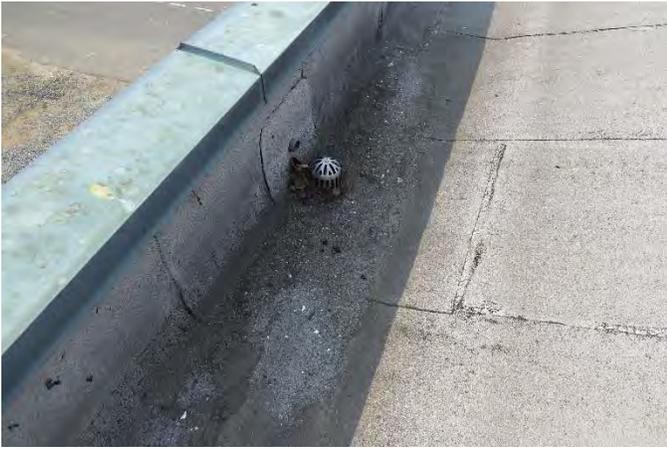
**Photo 57:** Detailed view of membrane split at a 90° angle.

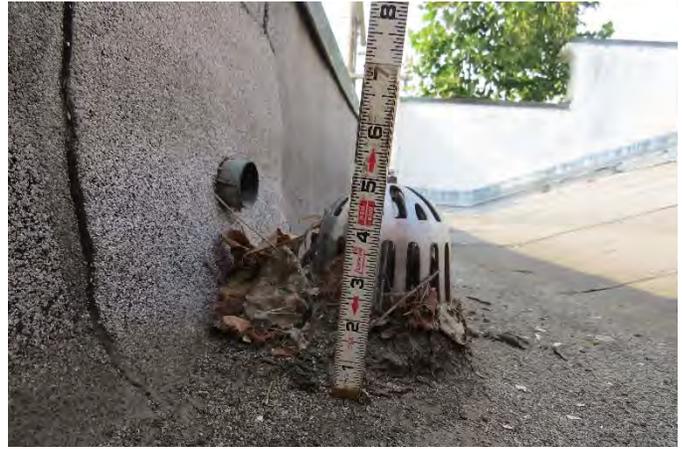
**Photo 58:** Additional view of membrane split at a 90° angle.

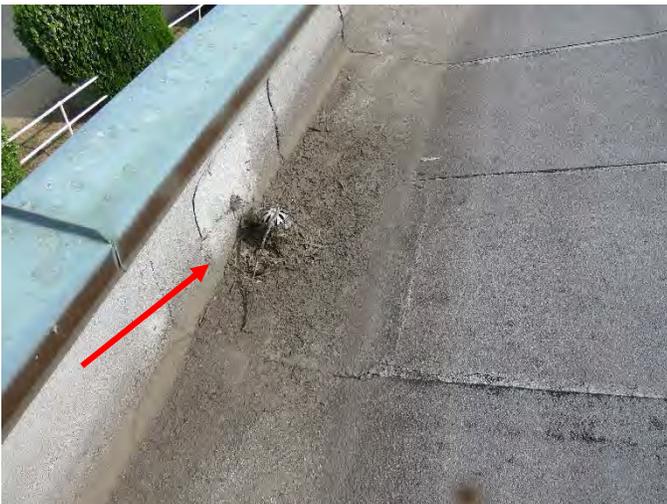
**Photo 59:** Additional view of membrane split at a 90° angle.

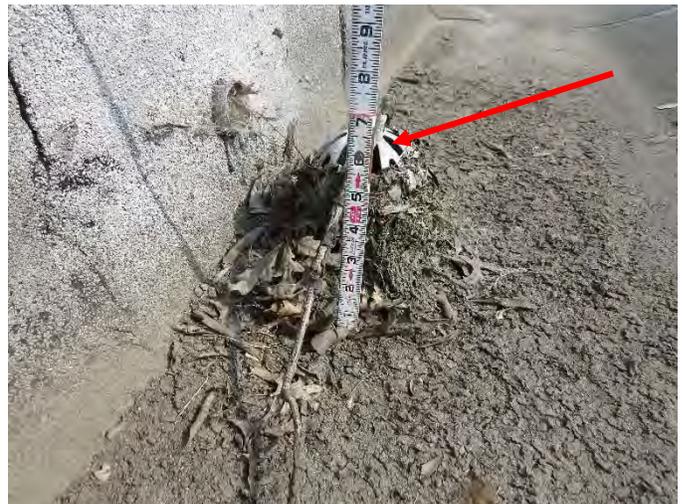
**Photo 60:** Additional view of membrane split at a 90° angle.

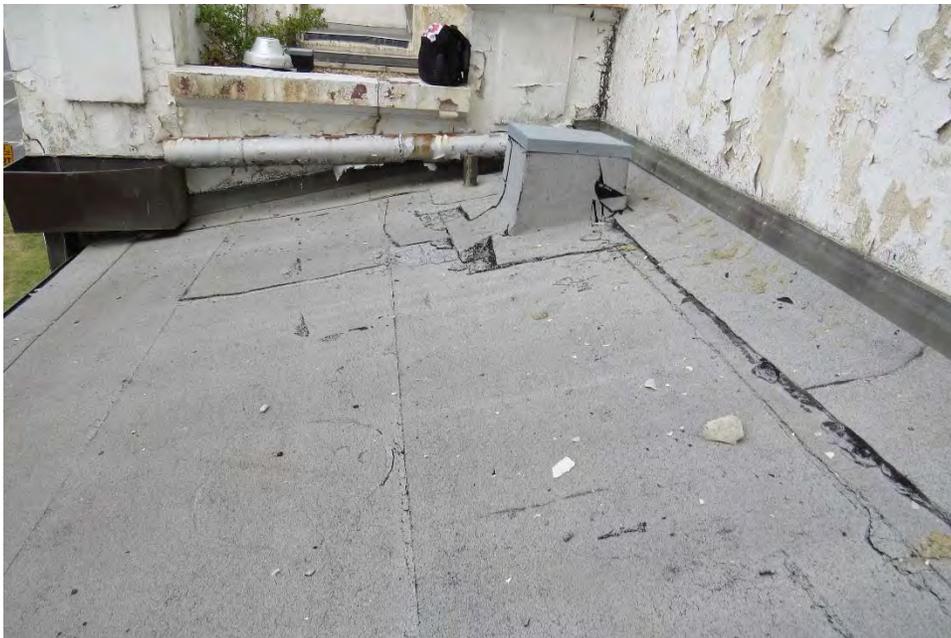
**Photo 64:** Overview of the granular surfaced membrane looking north from the south.

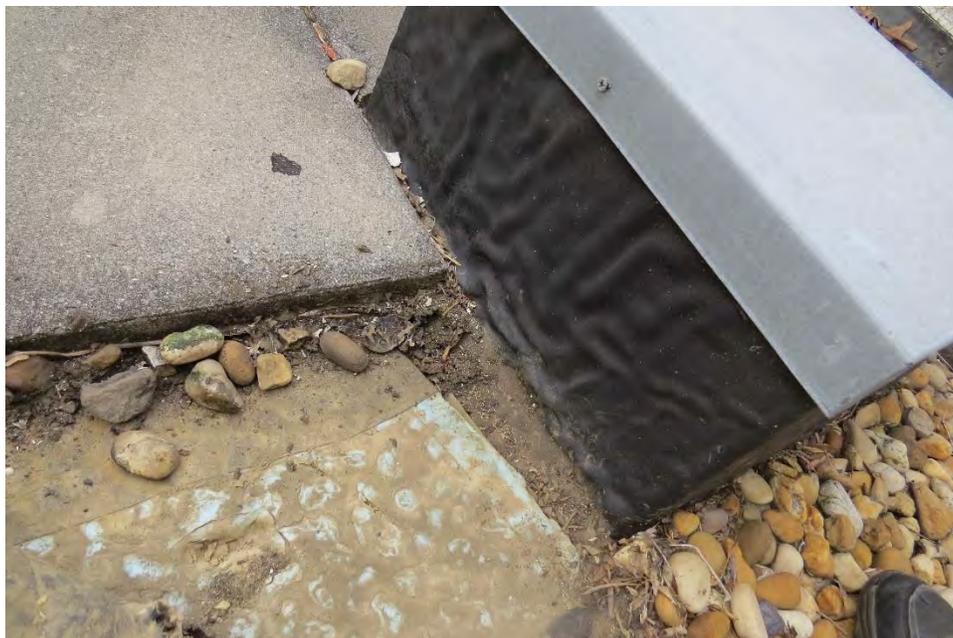
**Photo 70:** View of the exposed waterproofing flashing, insulation below the filter fabric and pea gravel protection

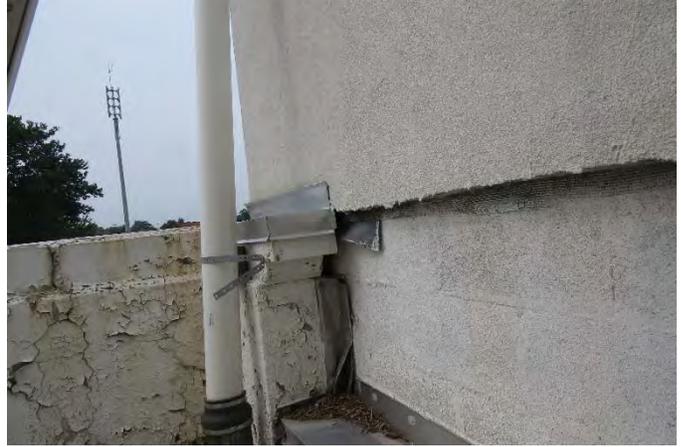
Several masonry transitional points were found to be open and unprotected. The inside corner of the roof area and rising wall conditions are open allowing wind driven rain to enter the building.

**Photo 72:** View of metal used to seal transition at rising wall.

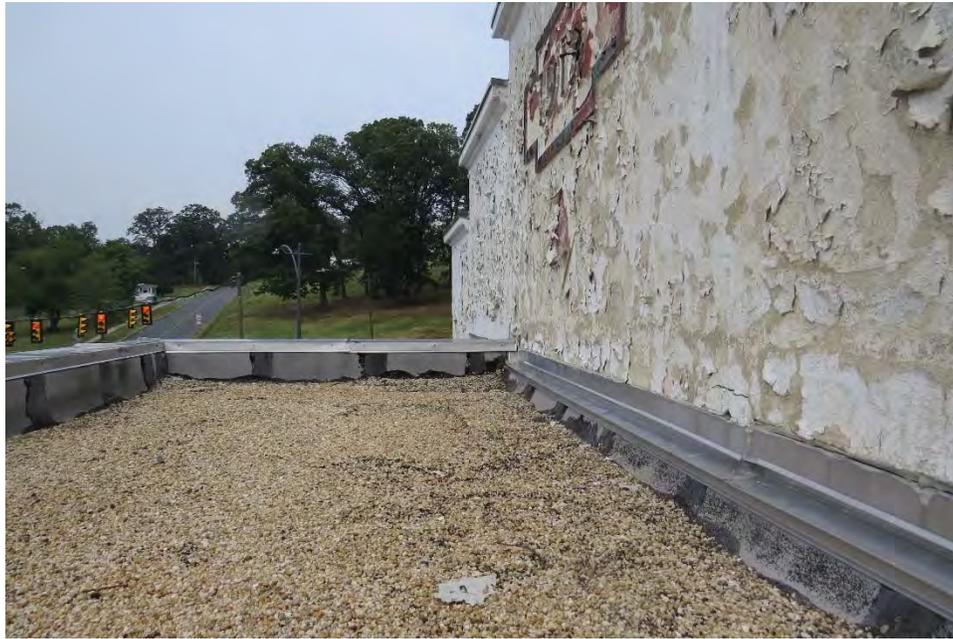
**Photo 69:** Overview of the upper gravel surfaced Built-up roof.

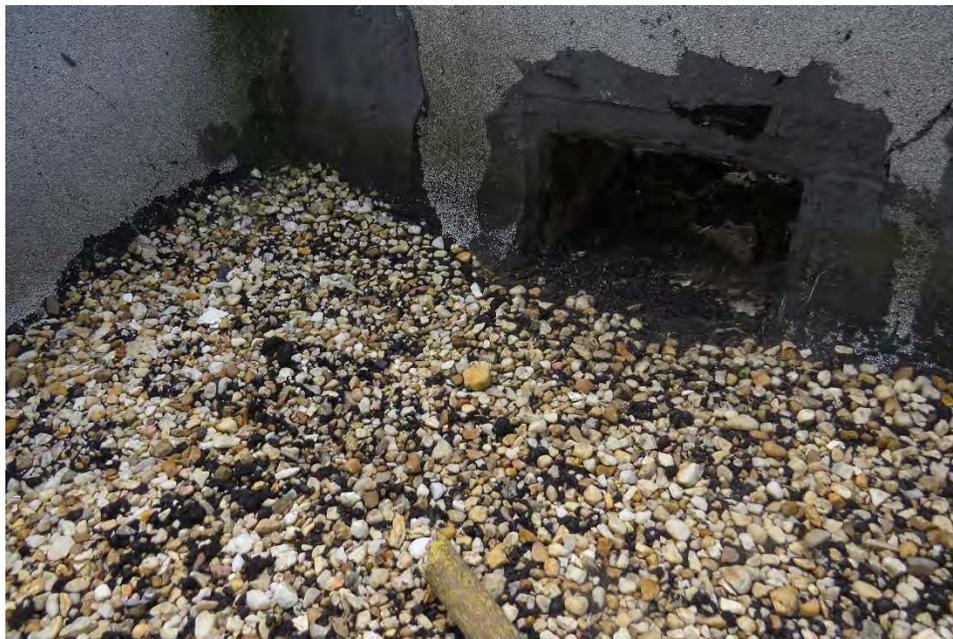
**Photo 70:** View of the scupper.

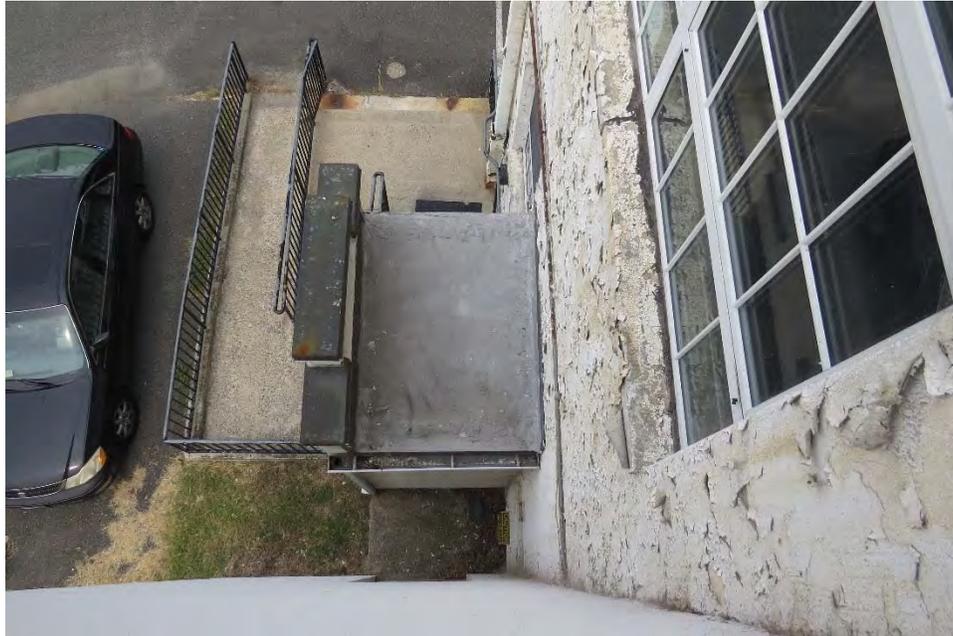
**Photo 75:** Overview of the Lower smooth surfaced Built-up roof at the front vestibule.

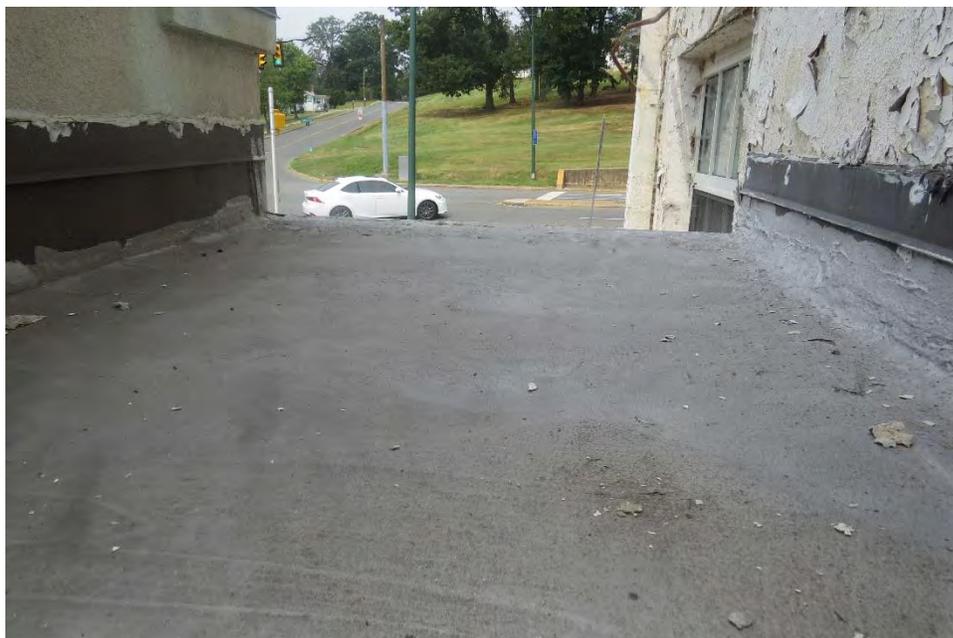
**Photo 76:** View of the membrane covering the front vestibule.

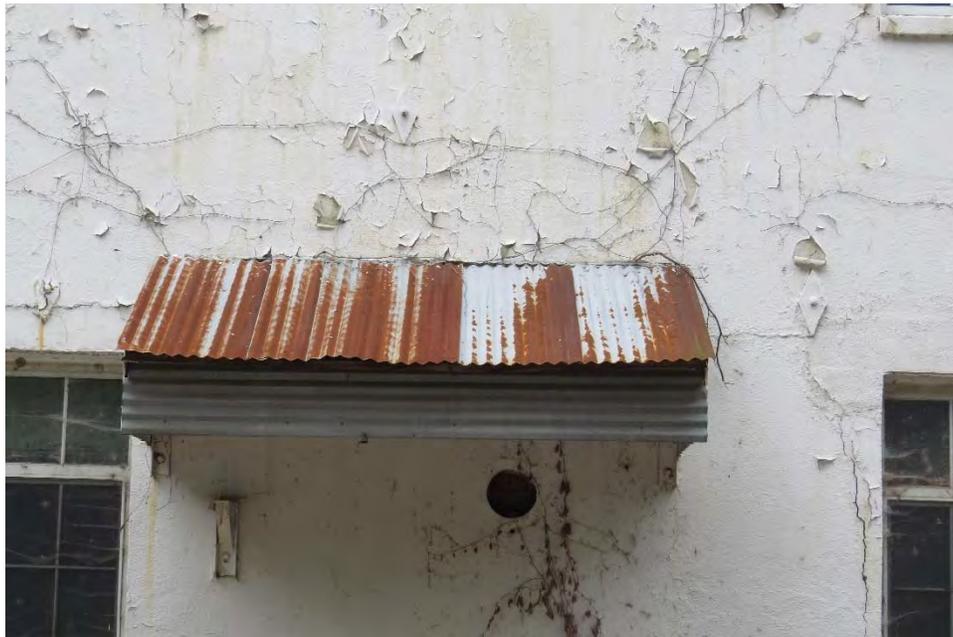
**Photo 80:** View of the shingle overhang at the western access door.

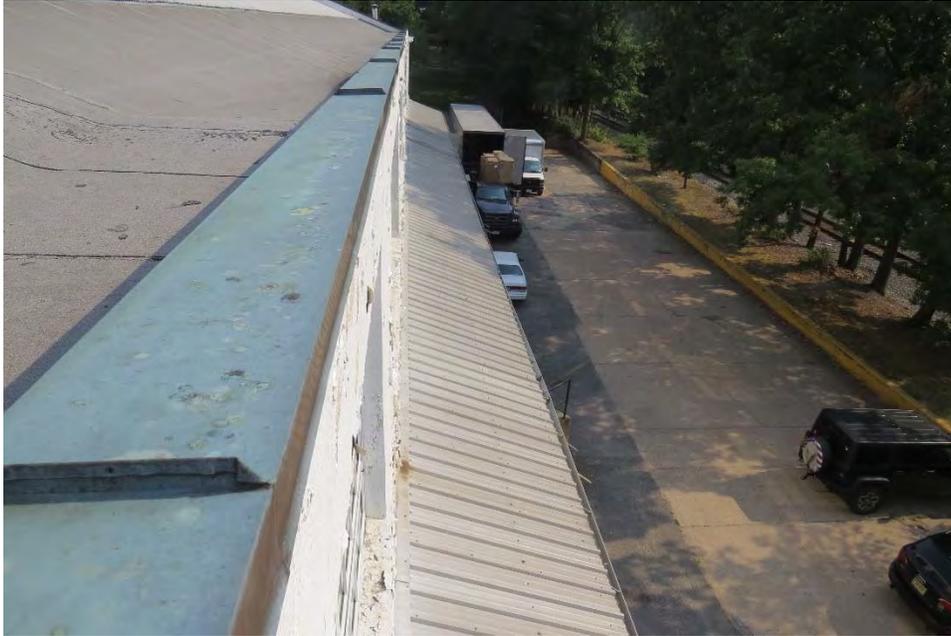
**Photo 81:** View of the metal roof covering the loading dock

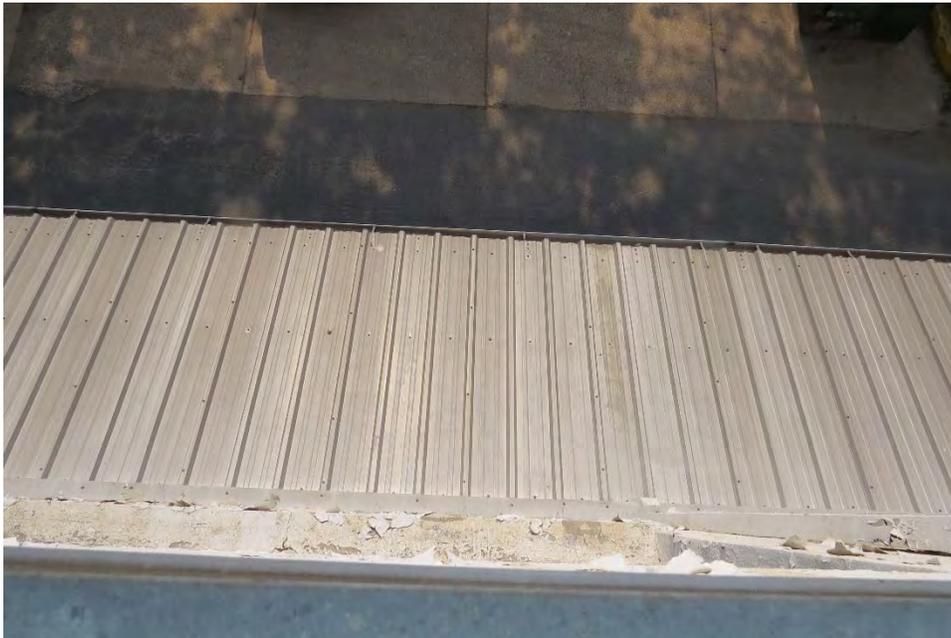
**Photo 82:** View of the metal roof covering the loading dock.
