Limited Environmental Survey
Above Ground Steam Lines
Naval Station Great Lakes
Great Lakes, Illinois

EDI Project No. 1602.029.01

February 9, 2012 Approved for Release By

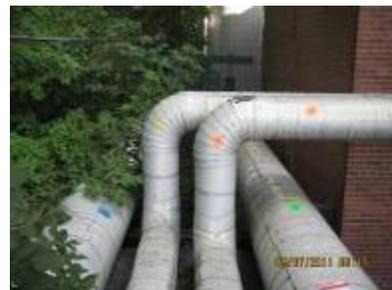
View of blue, yellow, orange, and green lines (left to right) above building 11B

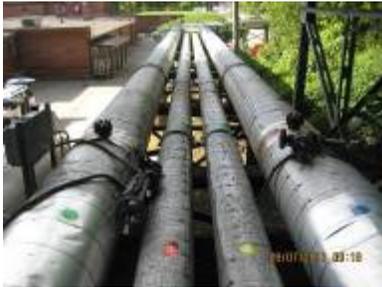
View of green, orange, yellow, & blue lines looking south from building 11B

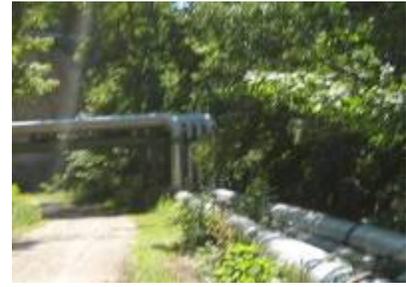
View of end of elevated lines along Crosley Dr. north of Sampson St. Bridge

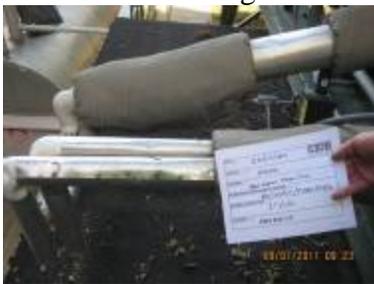
View of 2 inch pipes above building 11B with non-suspect materials.

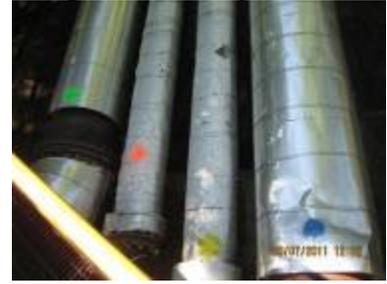
View of blue, yellow, green, and orange lines at creek crossing along Crosley Dr.

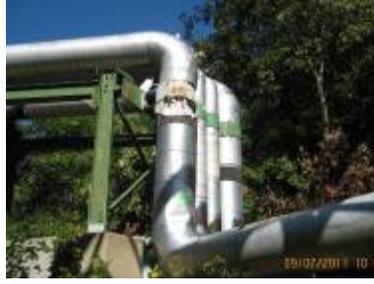
Start of elevated green, orange, yellow, and blue lines along Crosley Dr.

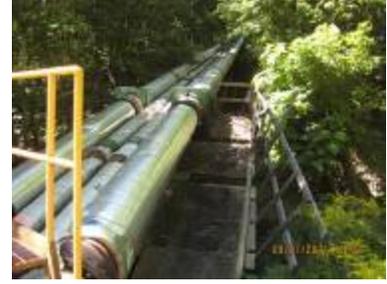
View of lines ascending slope from creek towards building 180

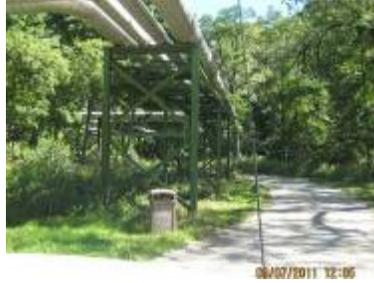
Continuation of elevated lines along Crosley Dr.

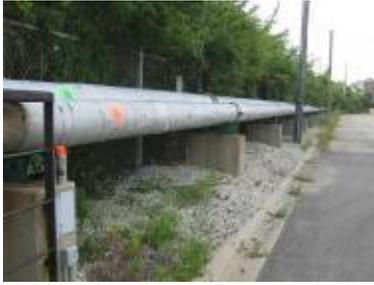
View of green and orange lines along Iowa St. between pits 241 & 243

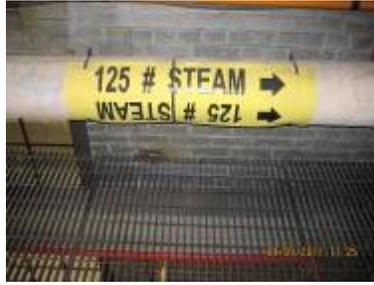
View of white line origination in building 11

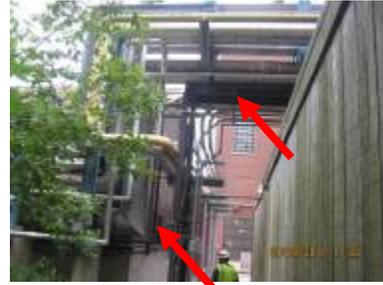
TSI over Fiberglass White Line & a Patching material (HA17 & HA18): The insulation over the fiberglass on the white line tested positive for asbestos, reported as 20% Chrysotile. A patch material observed at one location on the white line tested positive for asbestos, reported as PC 1.5% Chrysotile.

View of white line and 2 other lines continuing in larger steel pipe

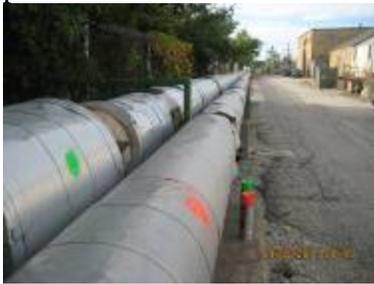
View of green and orange lines along Iowa St. between pits 247 & 248

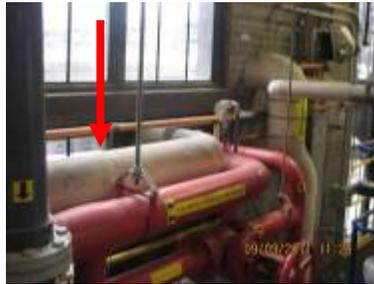
View of white line exiting building 11 with 2 other non-steam lines

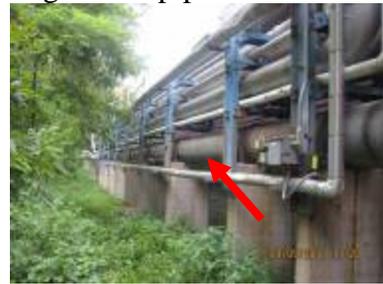
View of white line and 2 other lines continuing in larger steel pipe

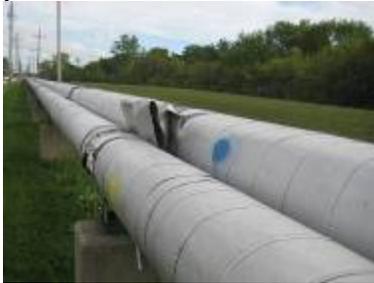
View of blue and yellow lines along Ohio St. south of pit 400

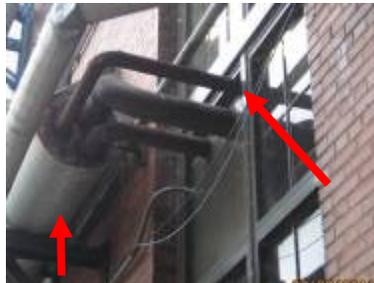
View of white line exiting building 11 with 2 other lines into larger steel pipe

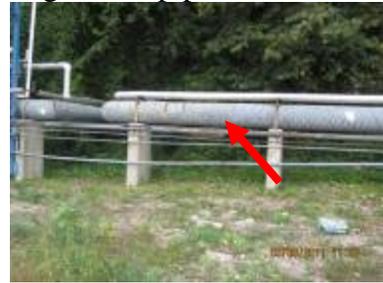
View of white line and 2 other lines continuing in larger steel pipe

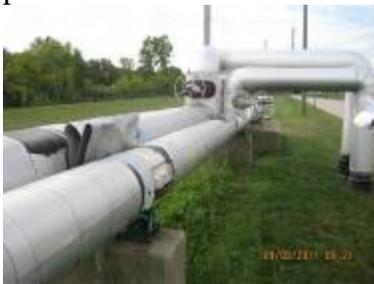
View of blue and yellow lines along Ohio St. south of pit 400

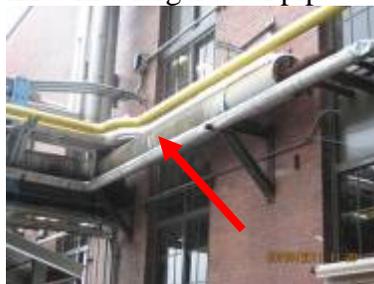
View of white line and 2 other lines continuing in larger steel pipe

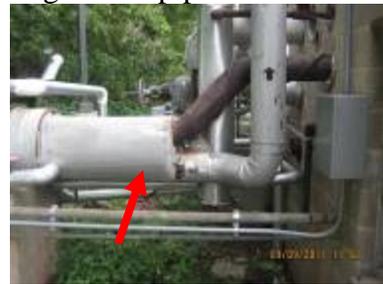
View of white line and 2 others emerging from larger pipe west of building 11G

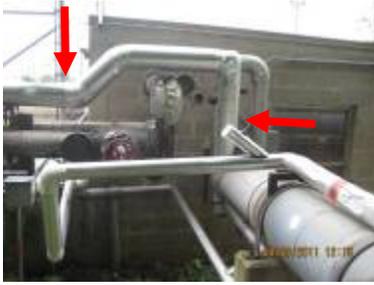
View of white line continuing north after emergence from larger pipe

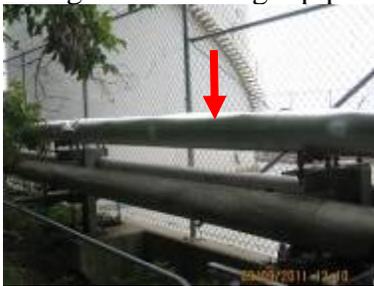
Continuation of white line north to building 11E; No suspect materials on line
