Photolog of Steam Pits

Naval Station Great Lakes
Basewide Steam Lines Targeted for Demolition
Photolog of Steam Pits
Week 1: June 6-10 2011
Photographed by Alpna Chaudhary

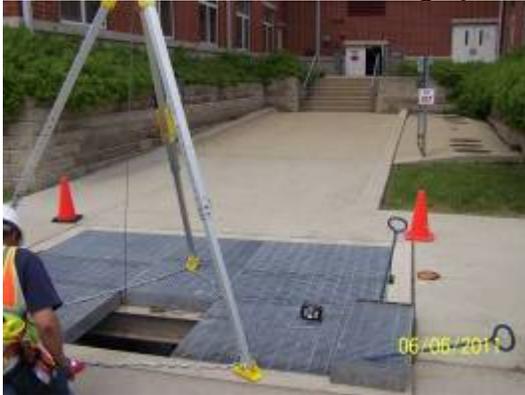
Photo 1: Equipment setup at Great Lakes Naval Station at steam pit 417.

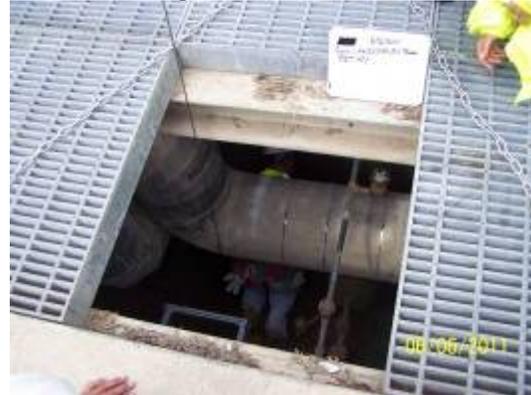
Photo 4: Steam pit 417: view of 18" pipe.

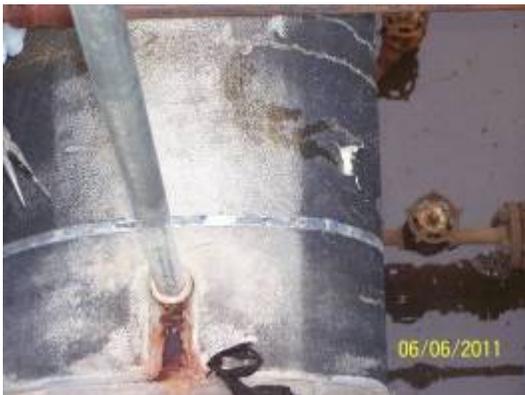
Photo 2: Steam pit 416: view of 18" pipe sample location - Sample P-416-HA-1-01.

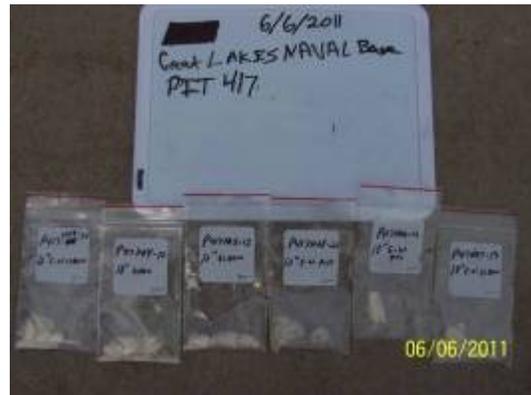
Photo 5: Samples taken from steam pit 417. - Samples: P-417-HA-4-10, P-417-HA-5-13, P-417-HA-1-3, P-417-HA-4-12, and P-417-HA-2-6.

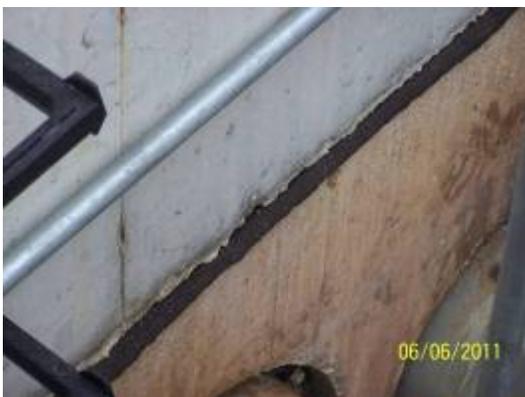
Photo 3: Steam pit 416: view of expansion joint - Sample P-416-HA-3-07.

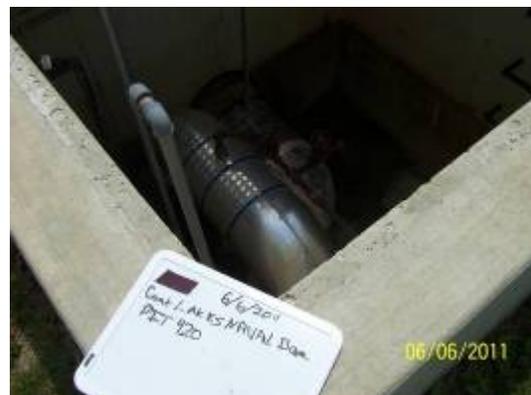
Photo 6: Steam pit 420: view of interior.

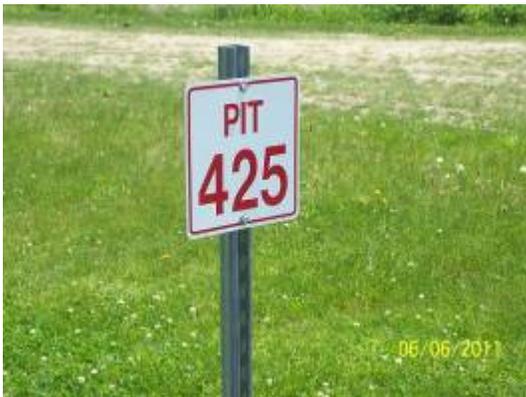
Photo 7: Steam pit 425: not entered due to more than one foot of standing water.

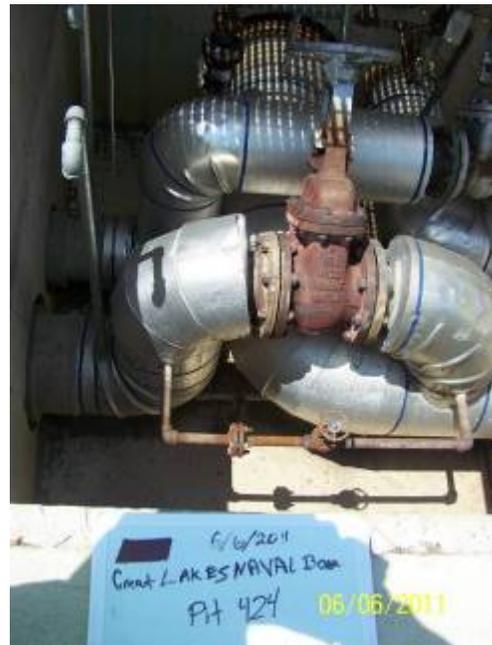
Photo 10: Steam pit 424: view of interior.

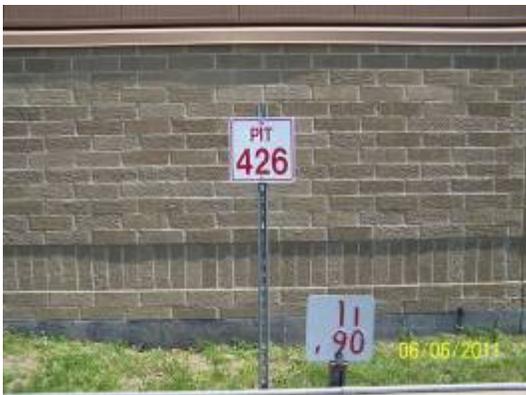
Photo 8: Steam pit 426: not entered due to more than one foot of standing water.

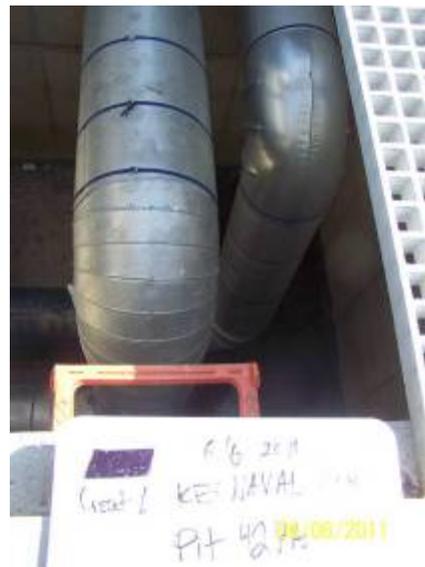
Photo 11: Steam pit 429A: view of interior.

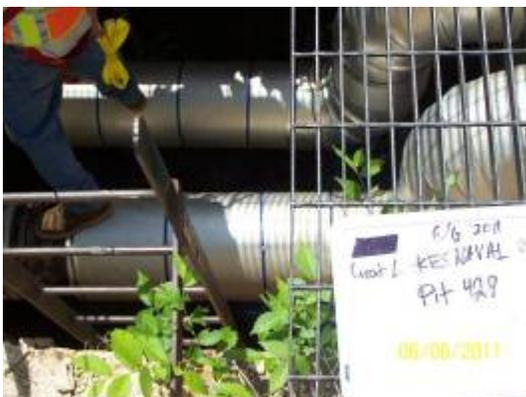
Photo 9: Steam pit 429: view of interior.

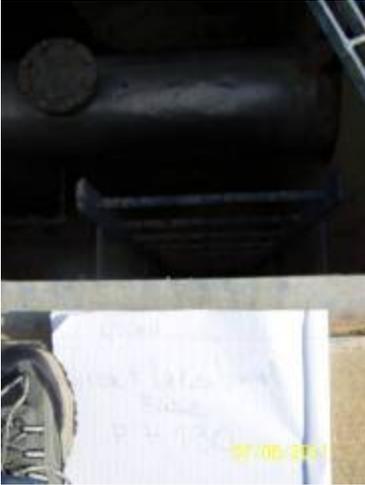
Photo 12: Steam pit 430: view of interior.

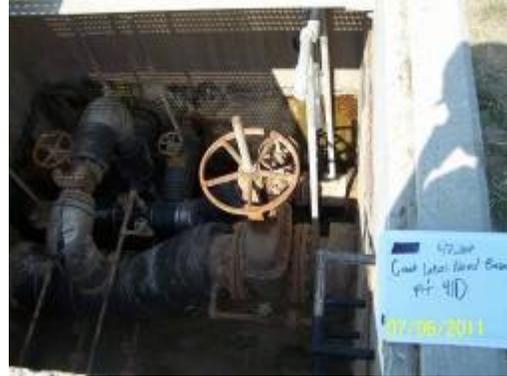
Photo 15: Steam pit 410: view of interior.

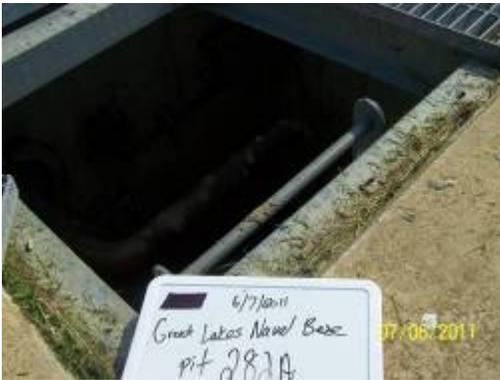
Photo 13: Steam pit 282A: view of interior.

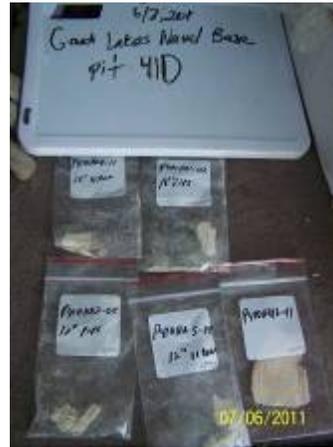
Photo 16: Samples taken from steam pit 410. - Samples: P-410-HA-4-11, P-410-HA-1-02, P-410-HA-2-05, P-410-HA-5-14, and P-410-HA-16-41.

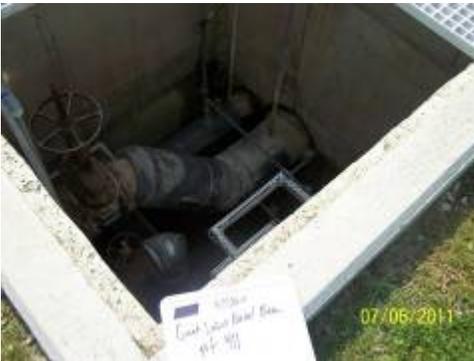
Photo 14: Steam pit 411: view of interior.

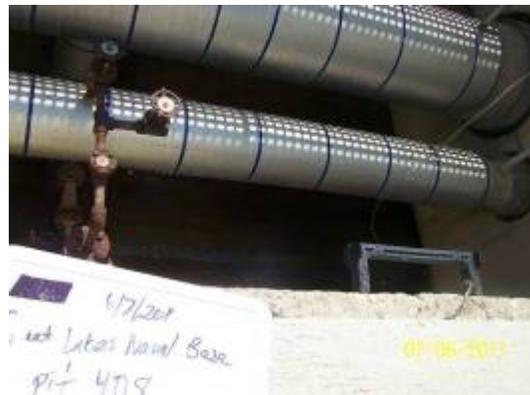
Photo 17: Steam pit 408: view of interior.

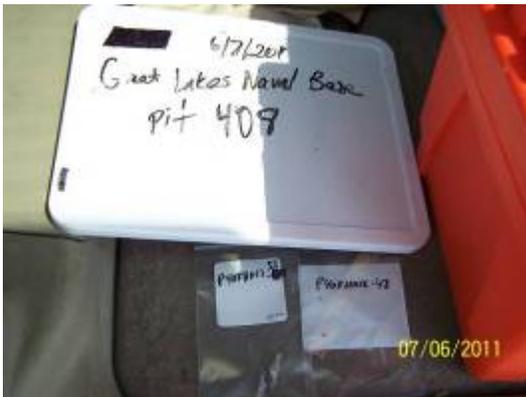
Photo 17: Samples taken from steam pit 408. - Samples P-408-HA-16-48 and P-408-HA-17-50.

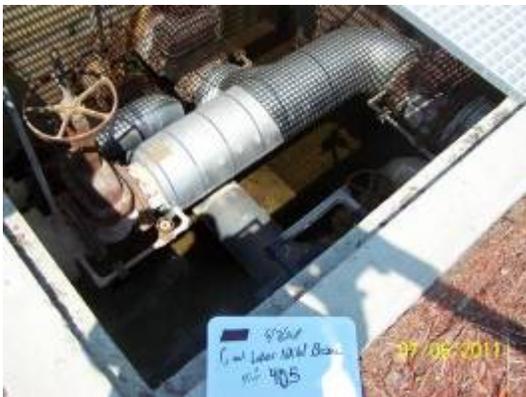
Photo 18: Steam pit 405: view of 18" and 12" pipe.

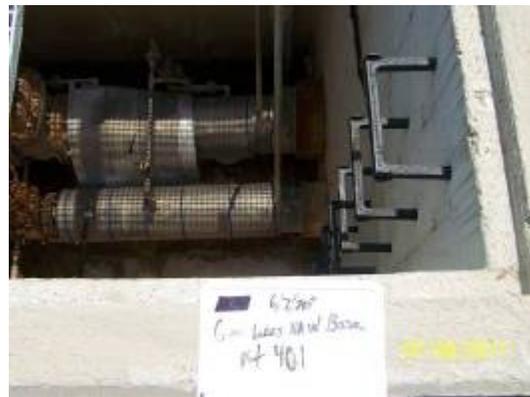
Photo 21: Steam pit 401: view of interior.

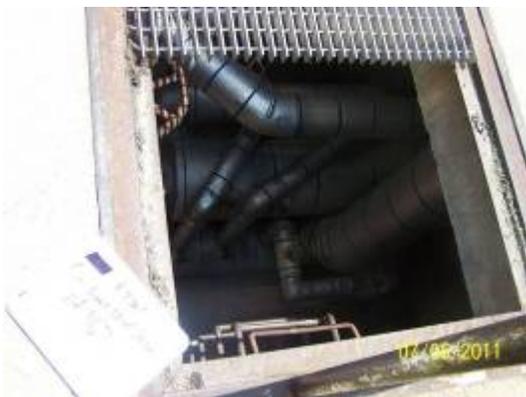
Photo 19: Steam pit 407: view of interior.

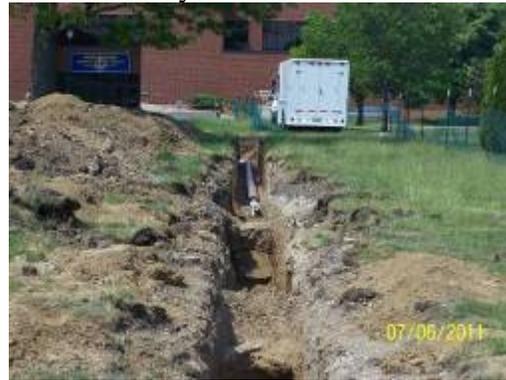
Photo 26: View of construction around steam pit 239.

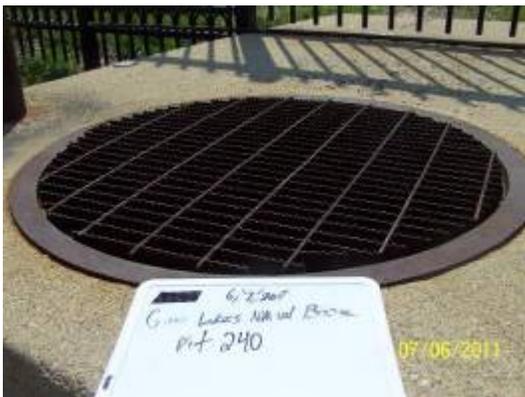
Photo 24: Steam pit 240: no entry due to elevated temperatures.

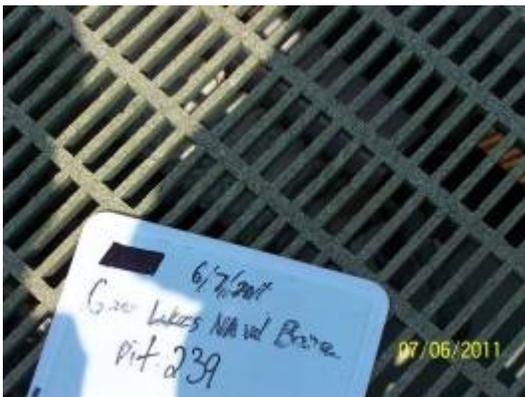
Photo 25: Steam pit 239: no entry due to construction.

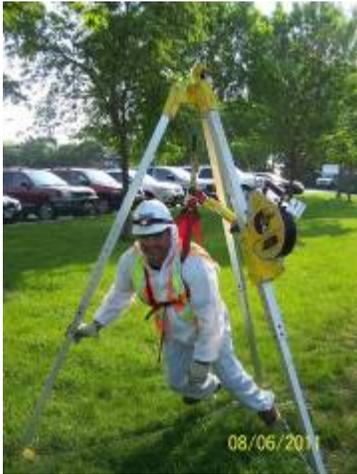
Photo 29: Asbestos Inspector testing equipment before entering steam pit 2.

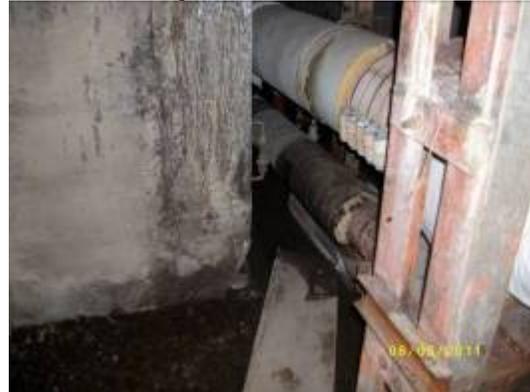
Photo 32: Steam pit 2: view of black pipe wrap.

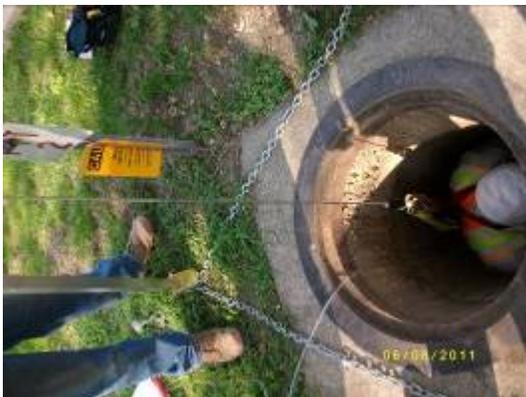
Photo 30: Steam pit 2: view of entry.

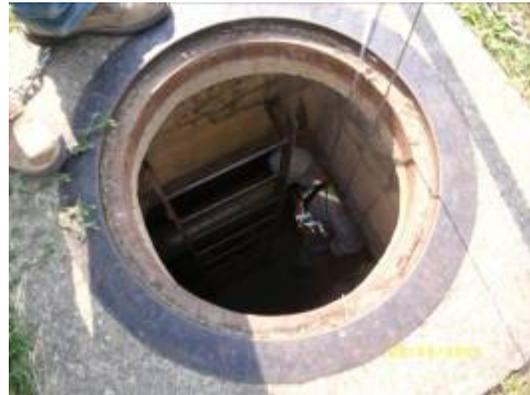
Photo 33: Steam pit 6: view of entry

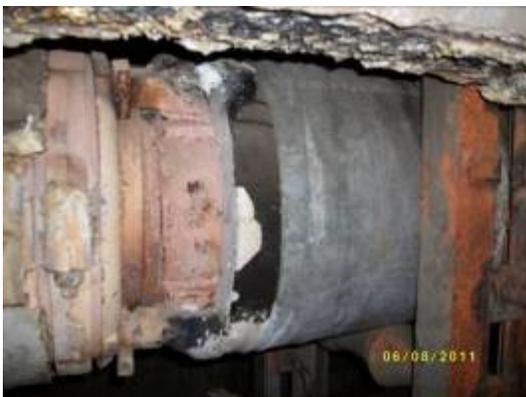
Photo 31: Steam pit 2: view of interior.

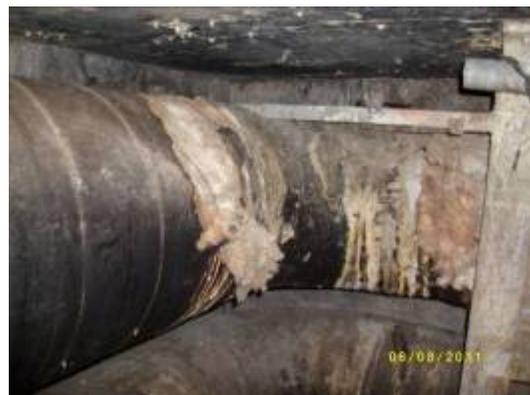
Photo 33: Steam pit 6: view of interior.

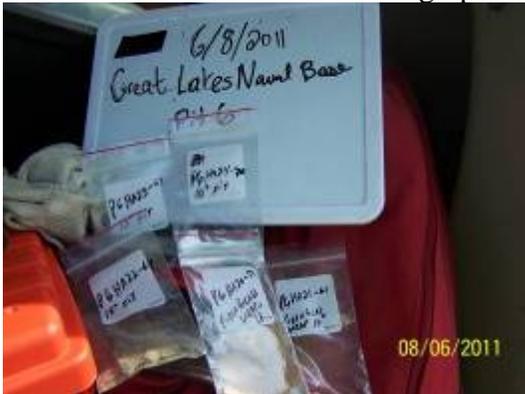
Photo 34: Samples taken from steam pit 6. - Samples: P-6-HA-20-58, P-6-HA-21-61, P-6-HA-22-64, P-6-HA-23-67, and P-6-HA-24-70.

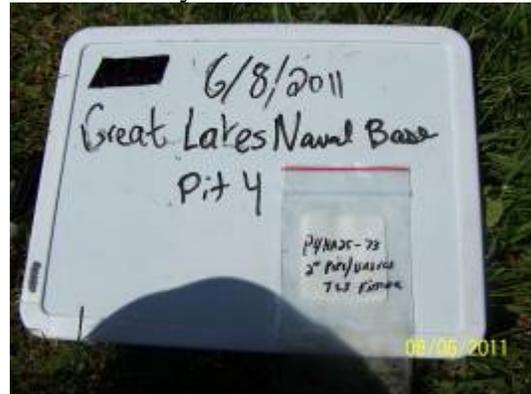
Photo 37: Sample taken from steam pit 4. - Sample P-4-HA-25-73.

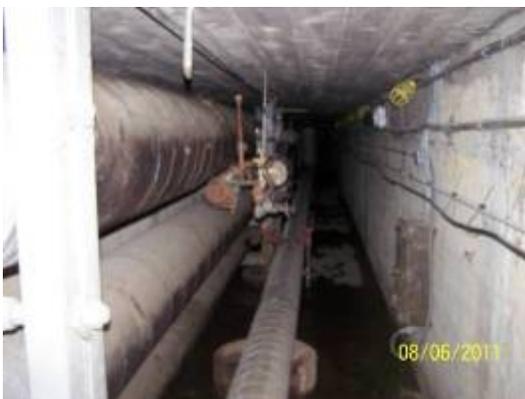
Photo 35: Steam pit 4: view of interior.

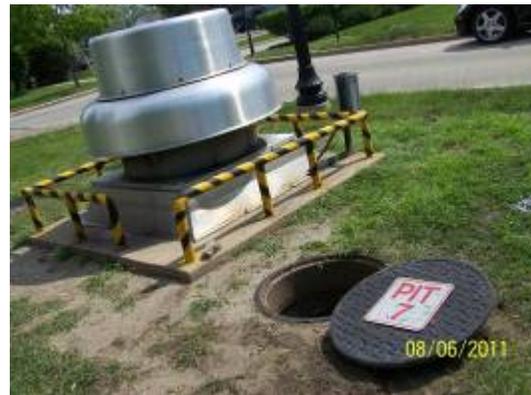
Photo 38: Steam pit 7: no entry due to exhaust fan.

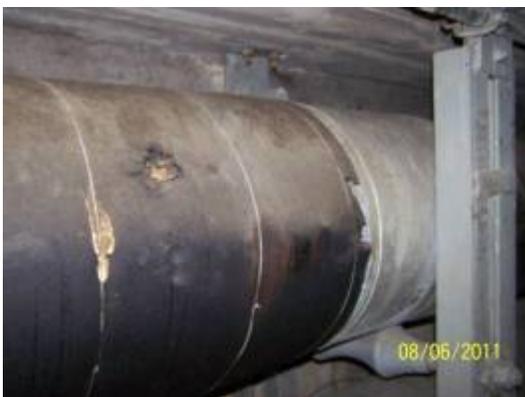
Photo 36: Steam pit 4: view of damaged pipe jacket.

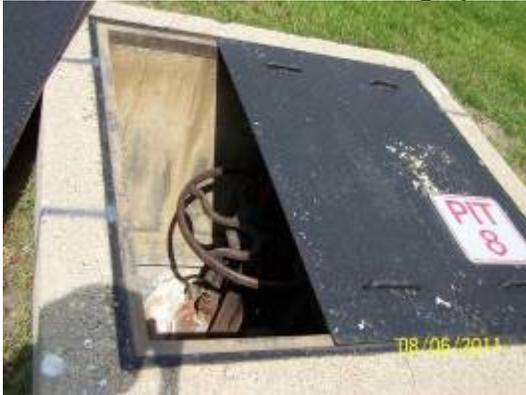
Photo 40: Steam pit 8: no entry due to inaccessibility.

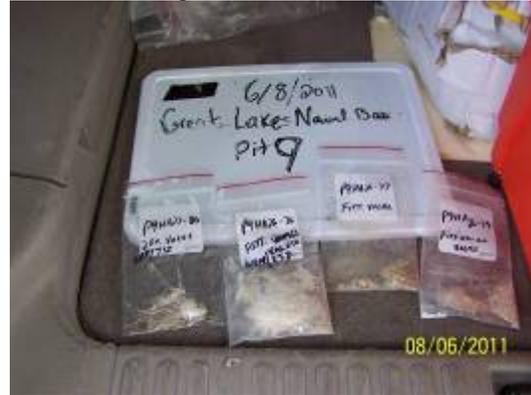
Photo 43: Samples taken from steam pit 9. - Samples: P-9-HA-26-76, P-9-HA-26-77, P-9-HA-26-79, and P-9-HA-27-80.

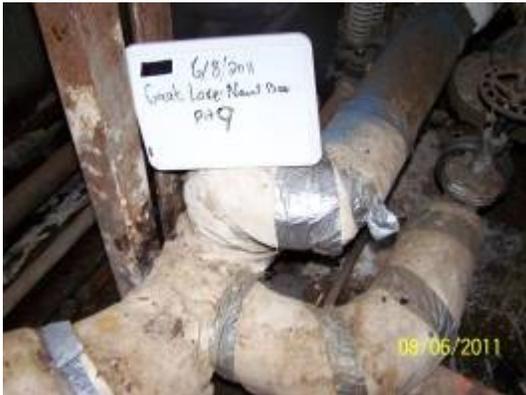
Photo 41: Steam pit 9: view of insulation wrap.

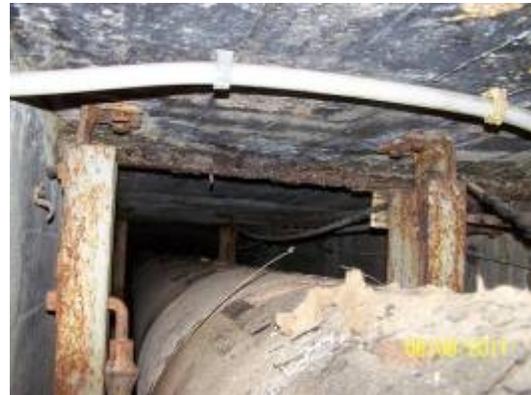
Photo 44: Steam pit 10: view of interior

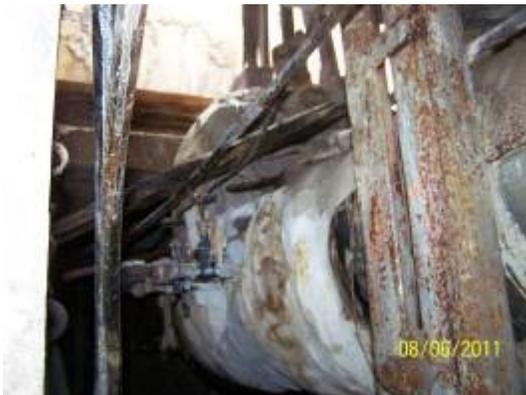
Photo 42: Steam pit 9: view of insulation wrap and fitting insulation.

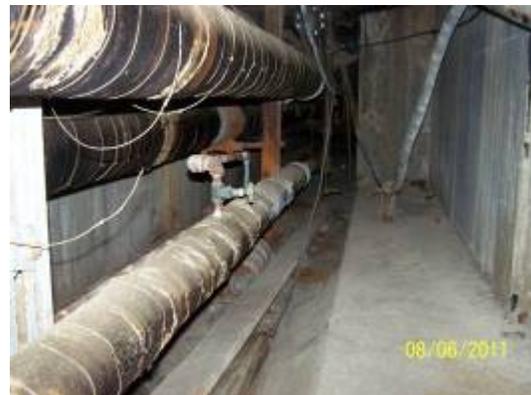
Photo 45: Steam pit 11: view of interior fiberglass runs.

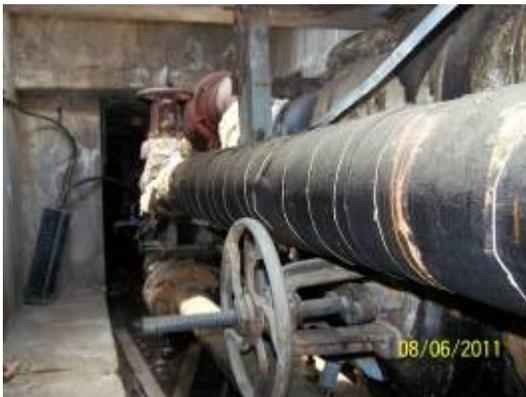
Photo 46: Steam pit 11: view of interior.

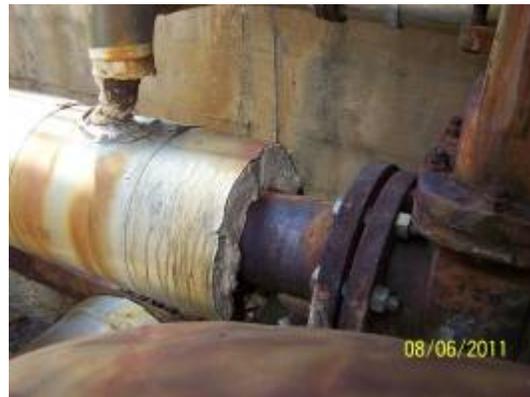
Photo 49: Steam pit 14: view of interior.

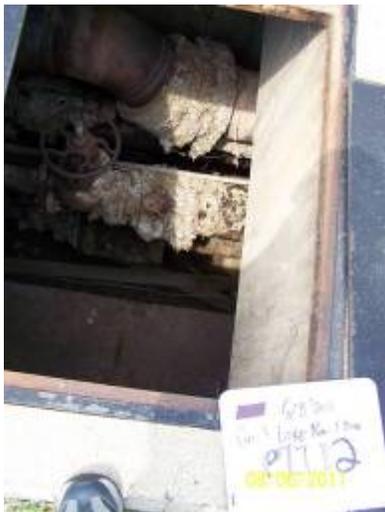
Photo 47: Steam pit 12: view of mineral wool.

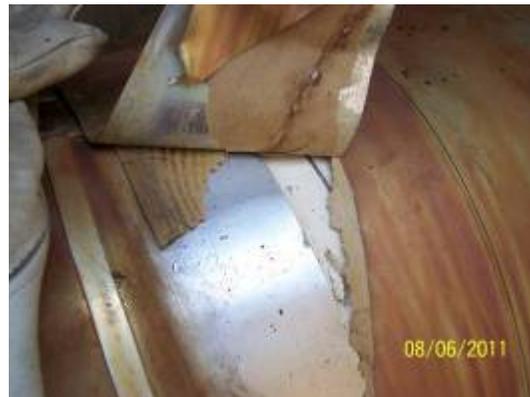
Photo 50: Steam pit 14: view of brown paper between metal jacket.

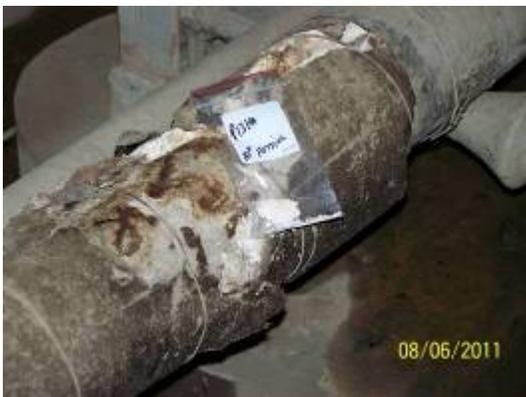
Photo 48: Steam pit 13 - 10" pipe fitting.
- Sample P-13-HA-28-83.

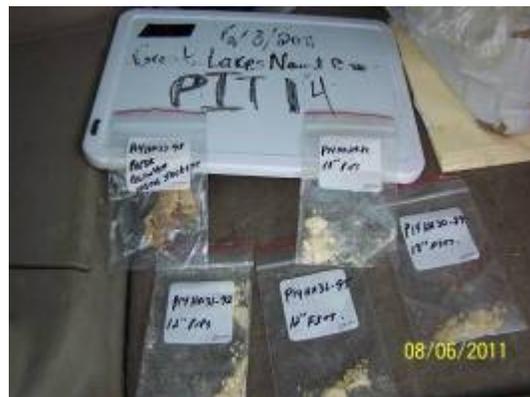
Photo 51: Samples taken from steam pit 14. - Samples: P-14-HA-29-86, P-14-HA-30-89, P-14-HA-30-90, P-14-HA-31-92, P-14-HA-32-95, P-34-HA-32-96, and P-14-HA-33-98.

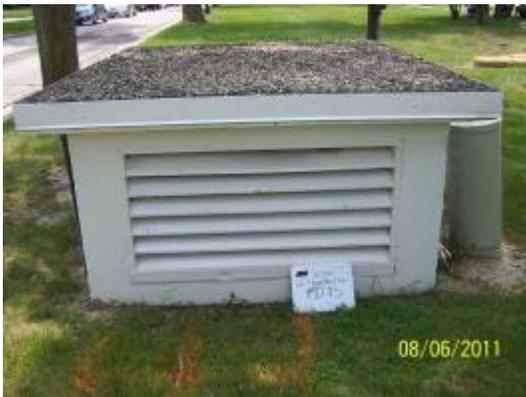
Photo 52: Steam pit 15- no entry due to inaccessibility.

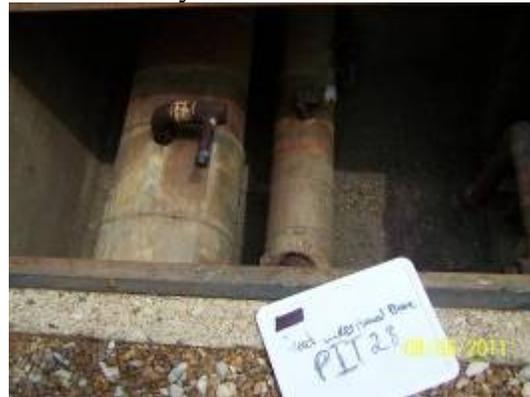
Photo 54: Steam pit 28: view of interior.

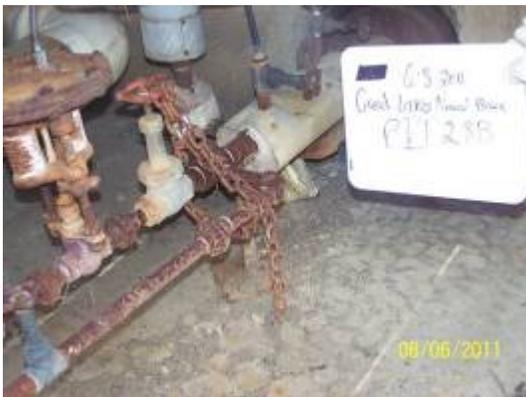
Photo 53: Steam pit 28B: view of interior.

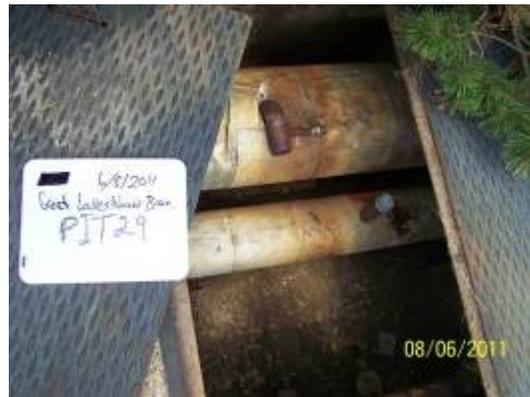
Photo 55: Steam pit 29: view of interior.

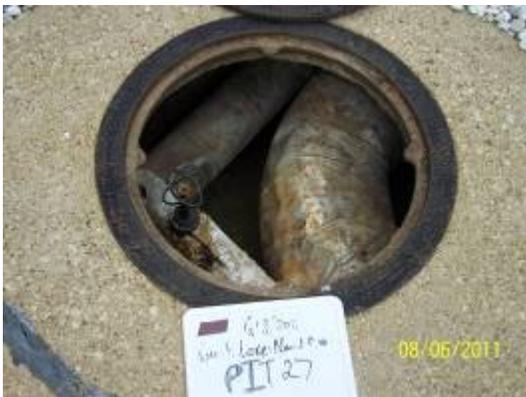
Photo 54: Steam pit 27: view of fiberglass.

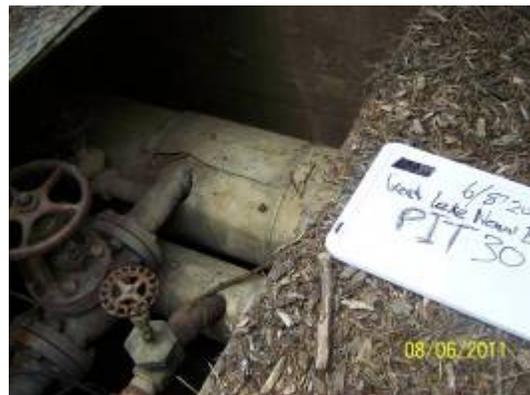
Photo 56: Steam pit 30: view of interior.

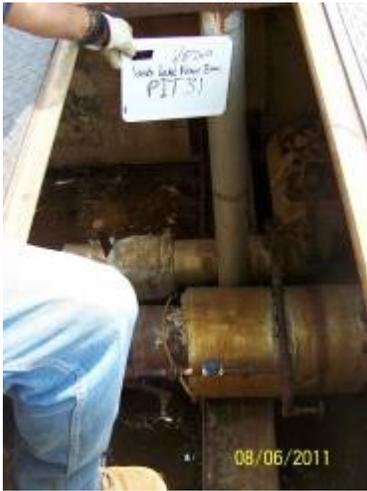
Photo 57: Steam pit 31: view of interior.

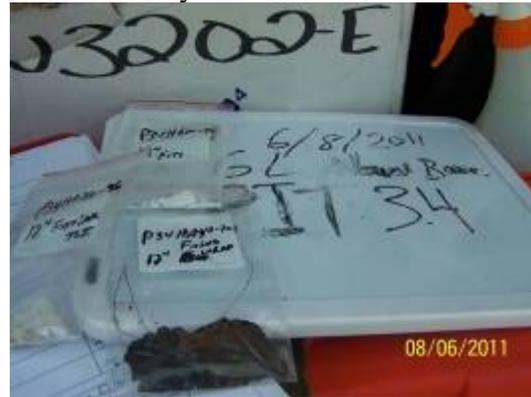
Photo 60: Samples taken from steam pit 34. - Samples P-34-HA-32-96 and P-14-HA-33-98.

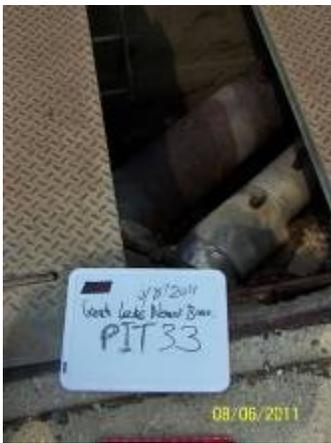
Photo 58: Steam pit 33: view of interior

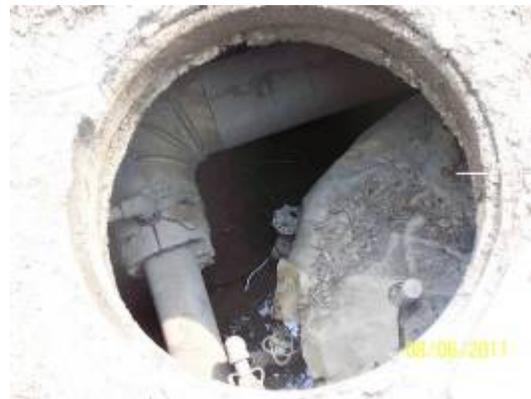
Photo 61: Steam pit 35: view of interior.

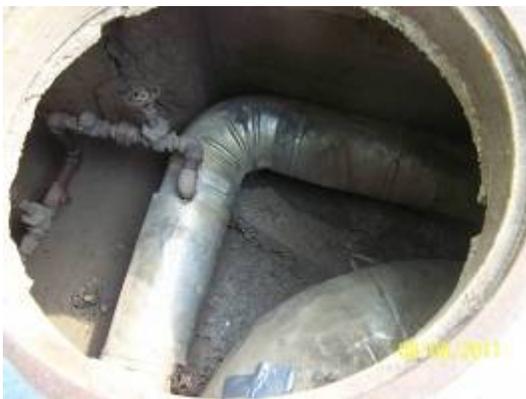
Photo 59: Steam pit 34: view of interior.

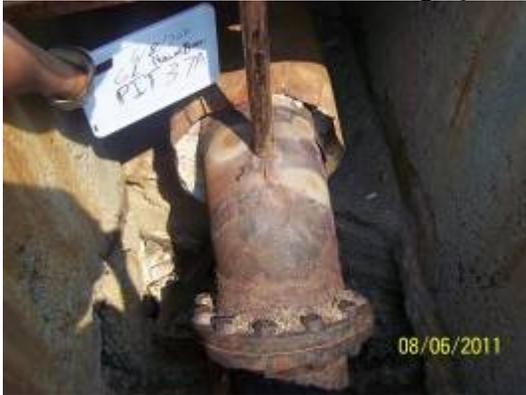
Photo 63: Steam pit 37A: view of interior.

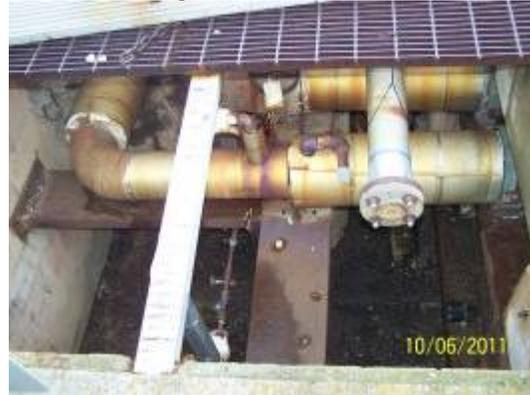
Photo 66: Steam pit 87: view of interior.

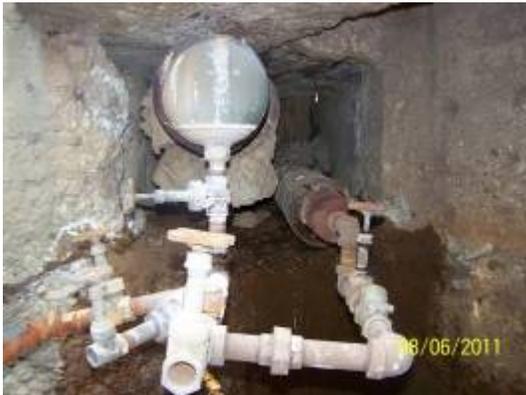
Photo 64: Steam pit 37: view of interior.

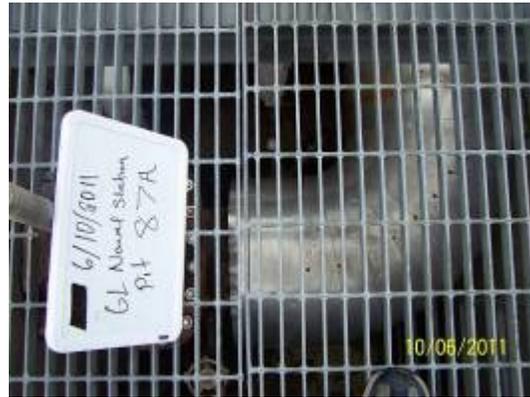
Photo 67: Steam pit 87A: view of interior through grate.

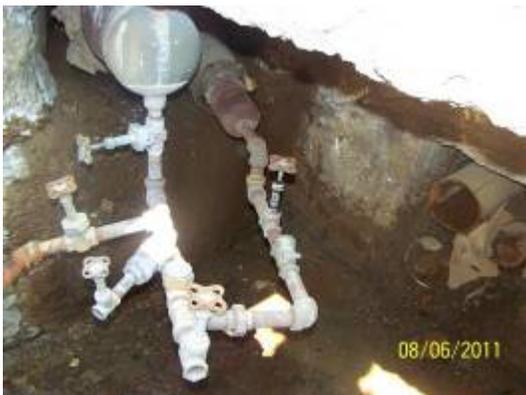
Photo 65: Steam pit 37: view of interior pipes cut off.

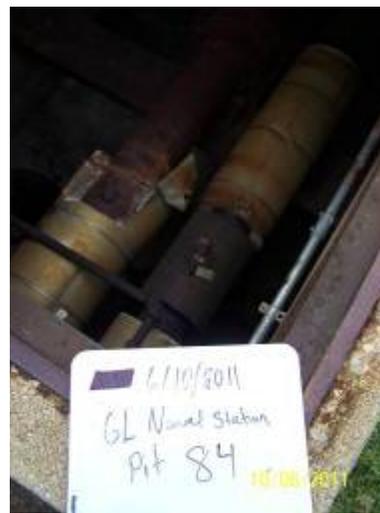
Photo 68: Steam pit 84: view of interior.

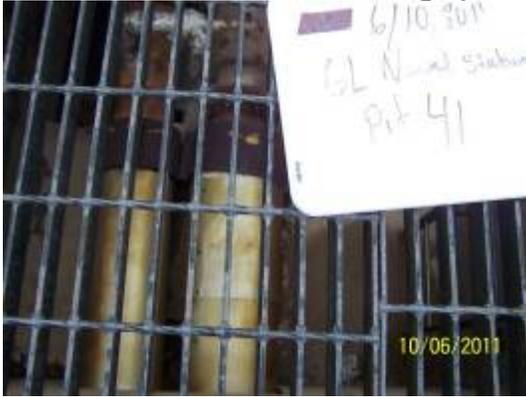
Photo 69: Steam Pit 41: view of interior through grate.

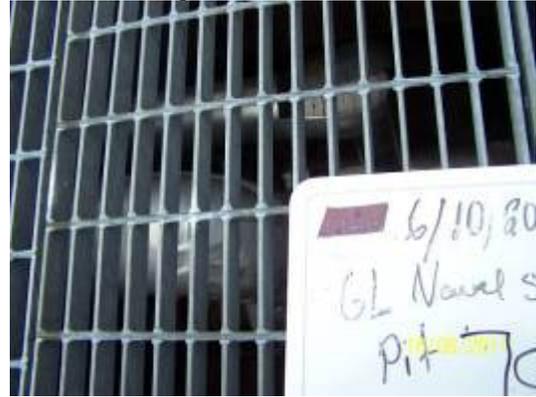
Photo 72: Steam pit 70: view of interior through grate.

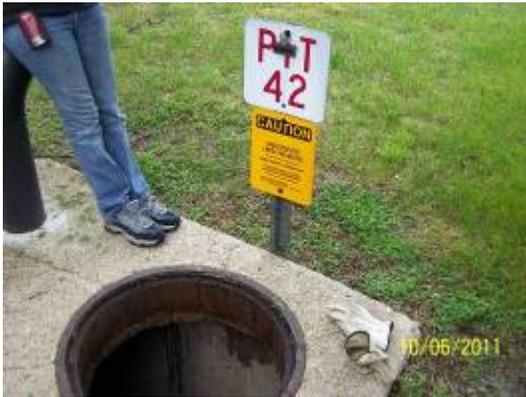
Photo 70: Steam pit 42: view of interior.

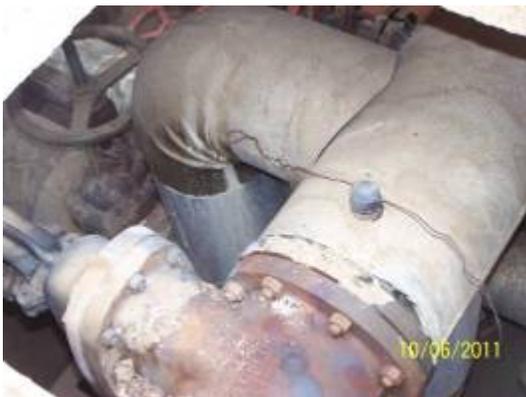
Photo 71: Steam pit 43: view of interior.

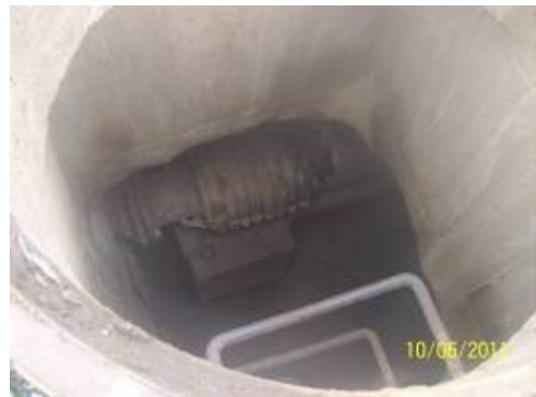
Photo 74: Steam pit 40: view of interior.

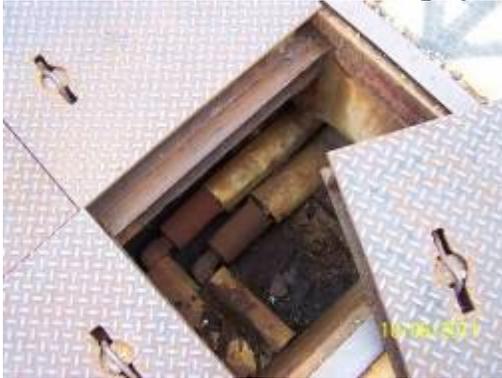
Photo 75: Steam pit 38: view of interior.

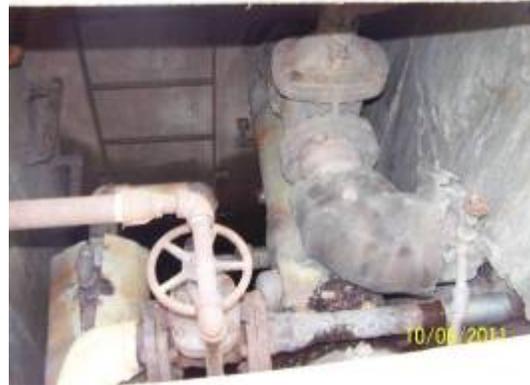
Photo 78: Steam pit 80: view of interior.

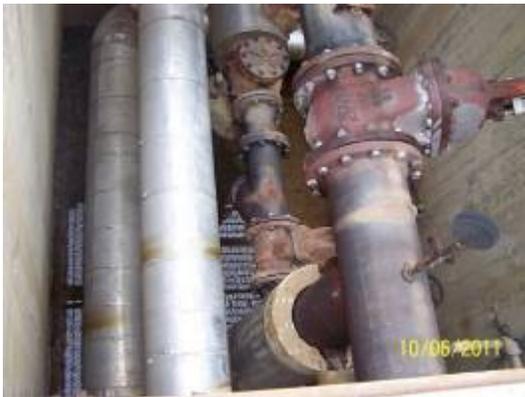
Photo 76: Steam pit 83: view of interior.

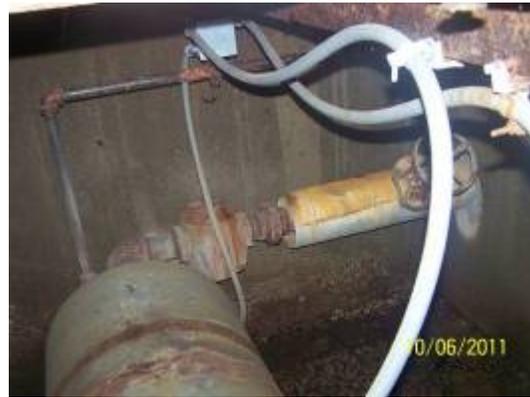
Photo 79: Steam pit 83A: view of interior.

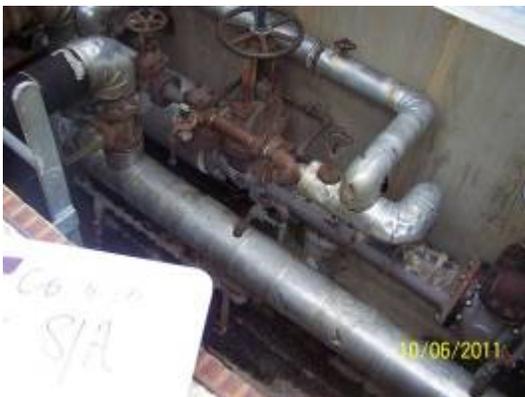
Photo 77: Steam pit 81A: view of interior.

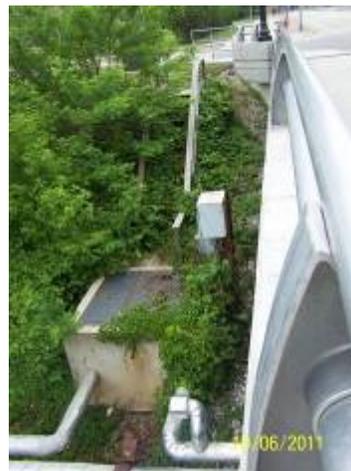
Photo 80: Steam pit 83A: View of surface expression.

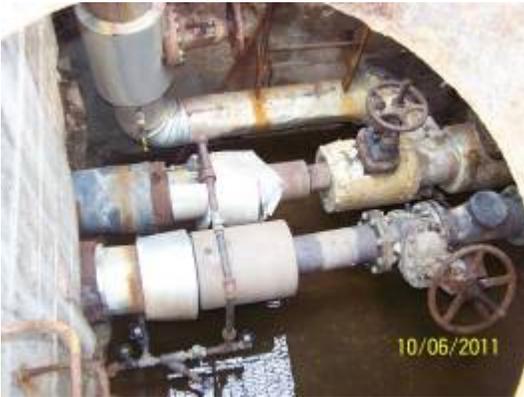
Photo 81: Steam pit 44: view of interior.

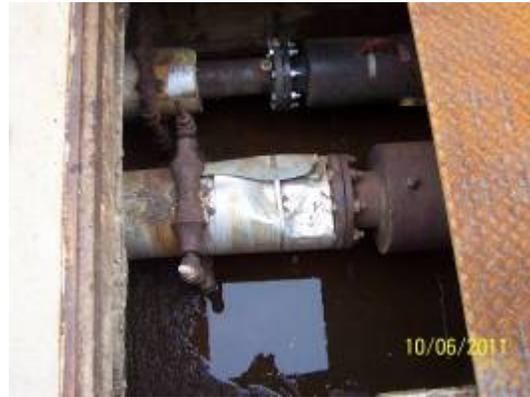
Photo 84: Steam pit 47: view of interior.

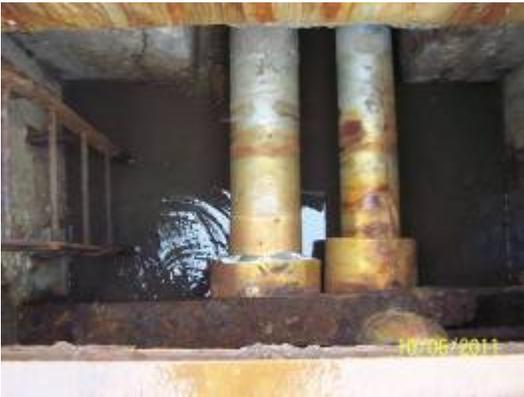
Photo 82: Steam pit 45: view of interior.

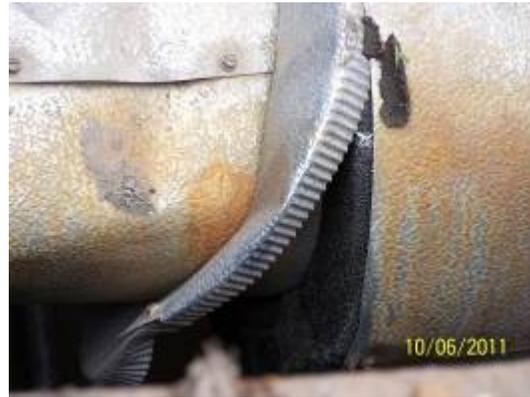
Photo 85: Steam pit 50: view of black foam insulating 12'' pipe.

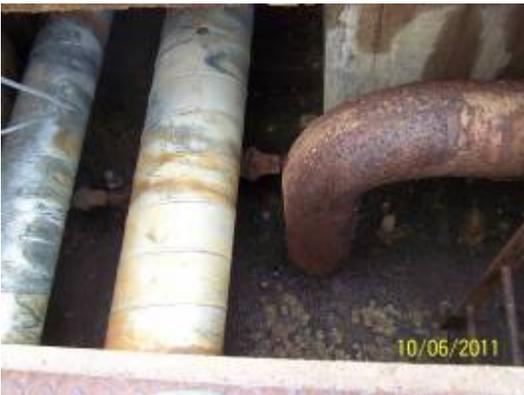
Photo 83: Steam pit 46: view of interior.

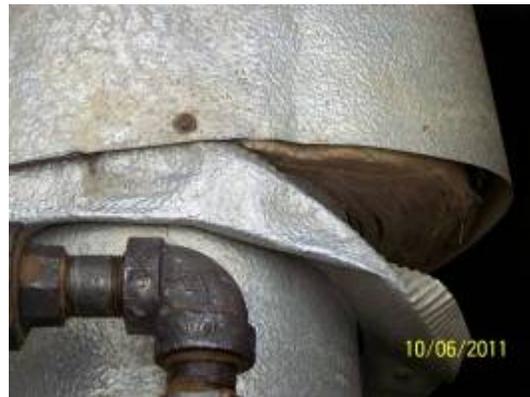
Photo 86: Steam pit 50: view of fiberglass insulation 18'' pipe.

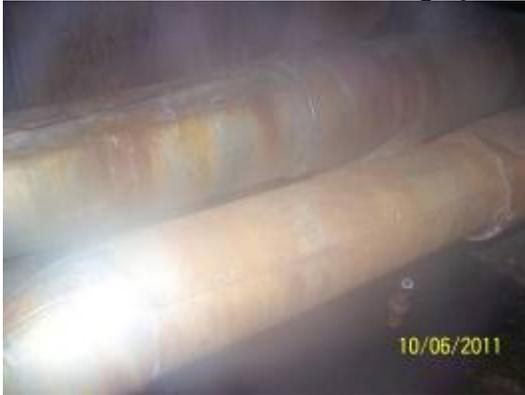
Photo 87: Steam pit 49: view of interior.

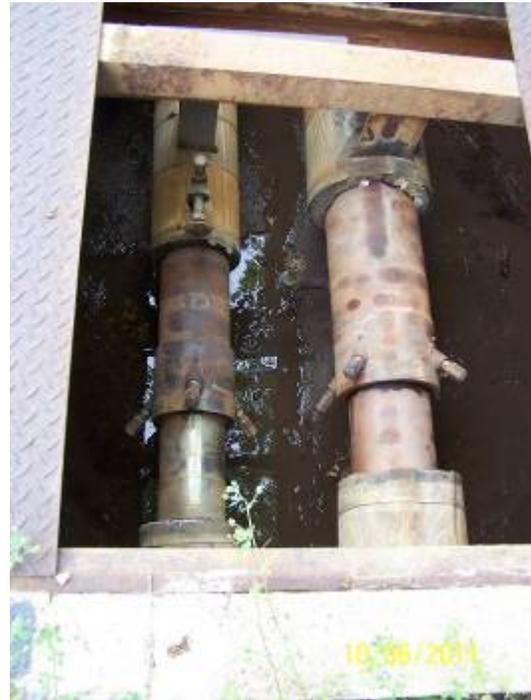
Photo 89: Steam pit 102: view of interior.

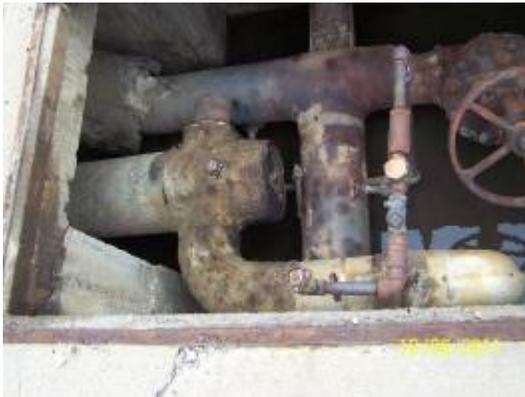
Photo 88: Steam pit 98: view of interior.

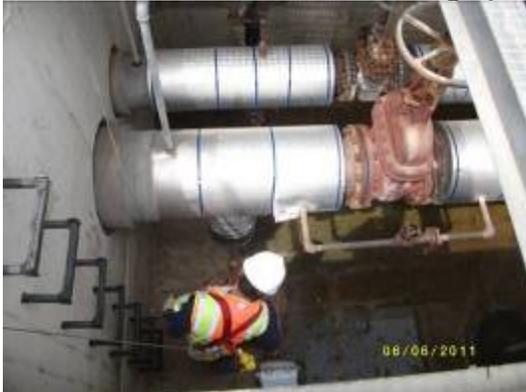
Photo 1: Steam pit 419: View of entry by asbestos inspector.

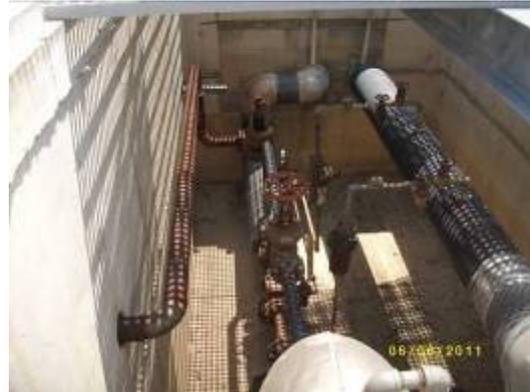
Photo 4: Steam pit 423: View of pit.

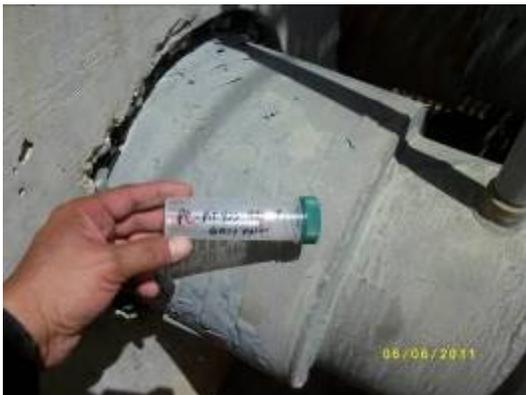
Photo 2: Steam pit 423: View of grey paint sample. - Sample PC-423-HA-3-7

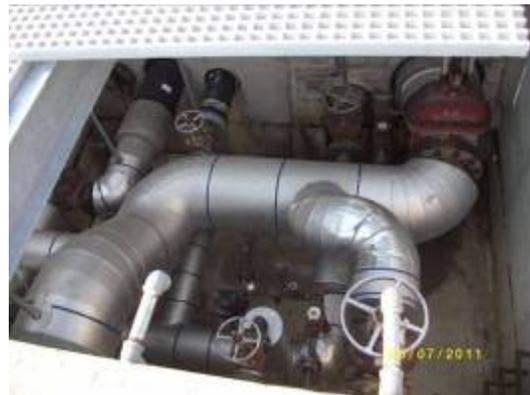
Photo 5: Steam pit 414: View of pit.

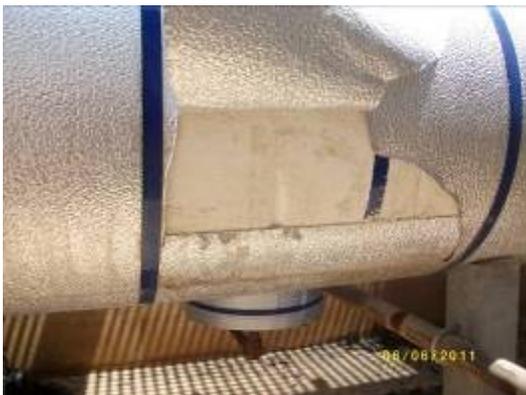
Photo 3: Steam pit 423: View of white insulation under metal wrapping.

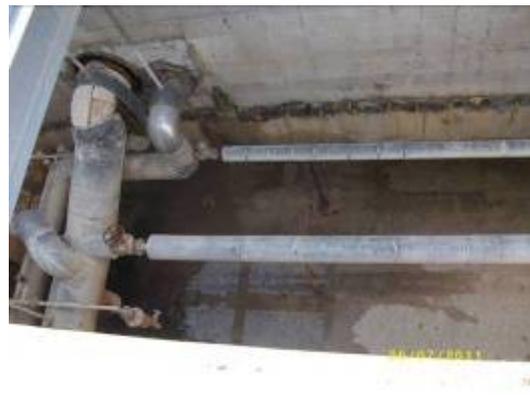
Photo 6: Steam pit 412: View of pit.

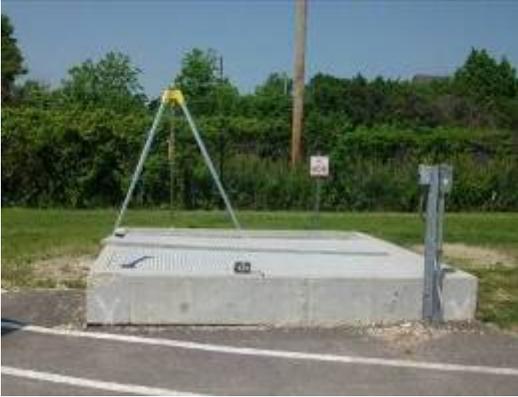
Photo 7: Steam pit 406: View of tripod rescue system setup.

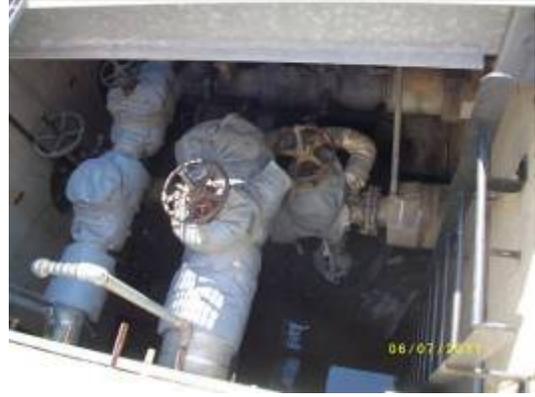
Photo 10: Steam pit 244A: View of pit.

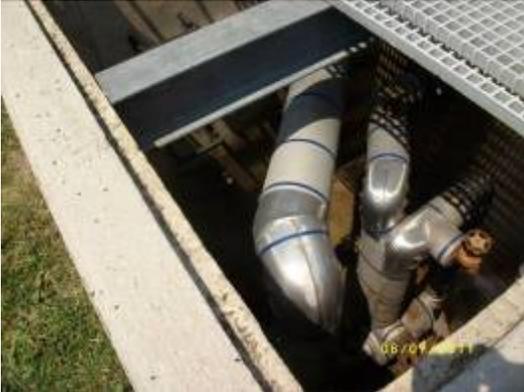
Photo 8: Steam pit 407A: View of pit

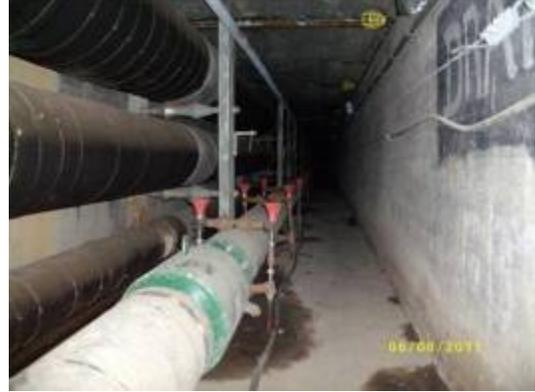
Photo 11: Steam pit 6: View of piping in tunnel.

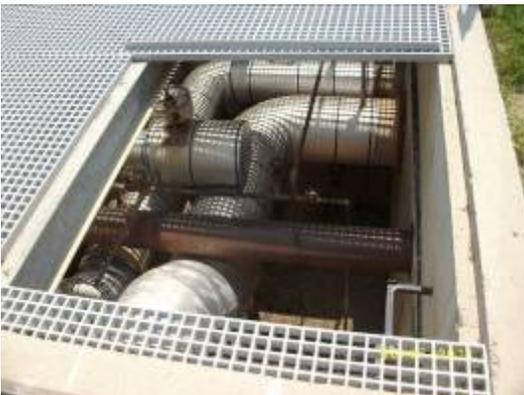
Photo 9: Steam pit 404: View of pit.

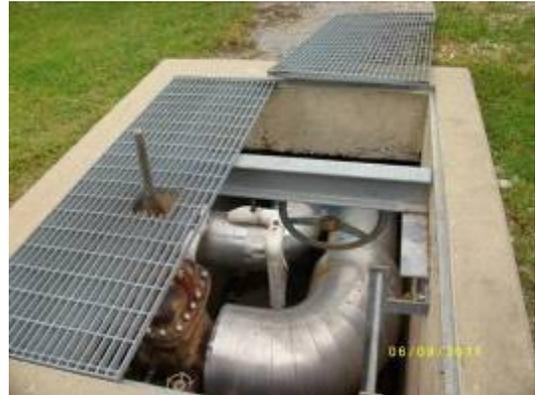
Photo 12: Steam pit 87A: View of pit.

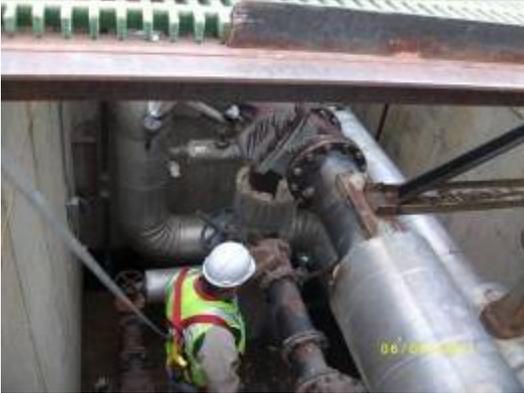
Photo 13: Steam pit 83: View of entry by asbestos inspector.

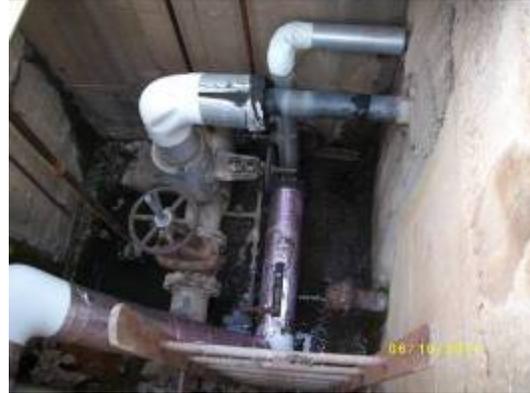
Photo 16: Steam pit 88: View of pit.

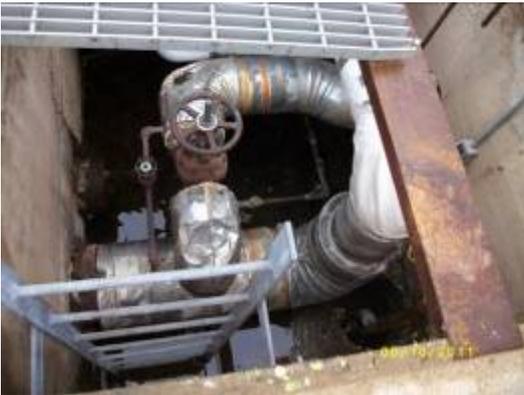
Photo 14: Steam pit 90: View of pit.

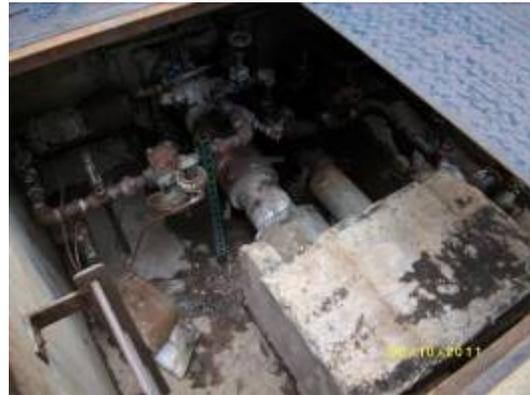
Photo 17: Steam pit 104: View of pit.

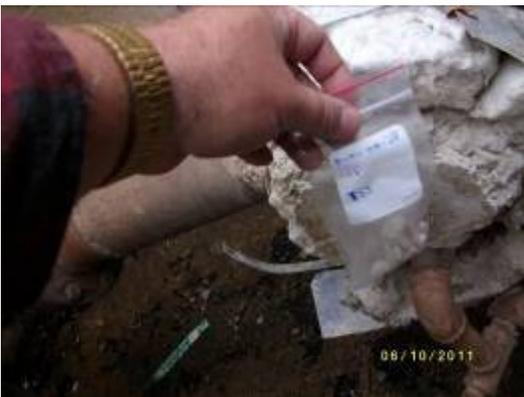
Photo 15: Steam pit 91: View of white insulation and sample taken. - Sample P-91-HA-218-02

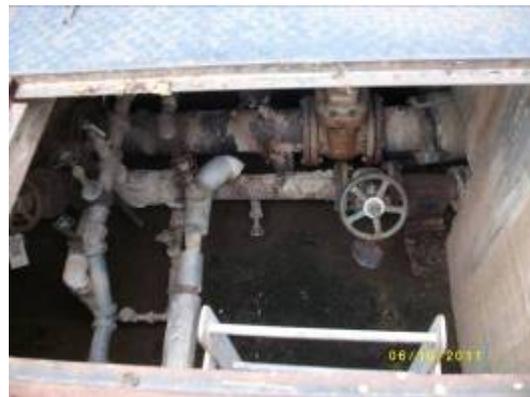
Photo 18: Steam pit 110: View of pit

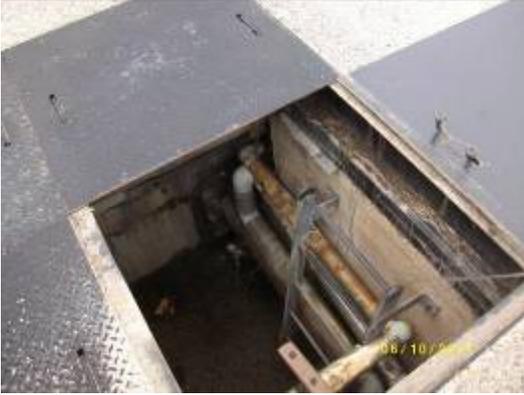
Photo 19: Steam pit 93: View of pit.
