Photolog of Steam Pits

Naval Station Great Lakes
Basewide Steam Lines Targeted for Demolition
Photolog of Steam Pits
Week 1: June 6-10 2011
Photographed by Alpna Chaudhary

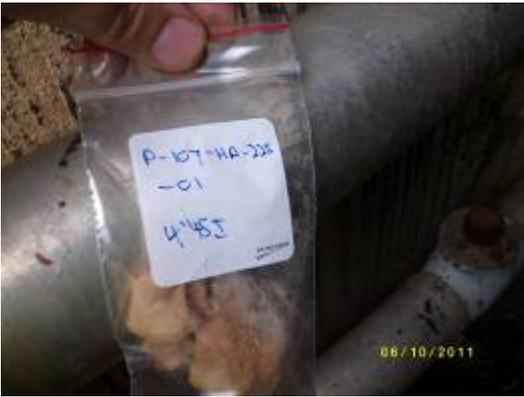
Photo 20: Steam pit 107: View of insulation sampled from 4" line behind sample bag. - Sample P-107-HA-225-01

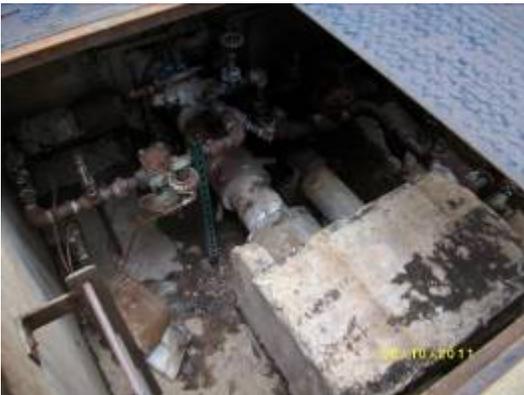
Photo 21: Steam pit 104: View of pit.

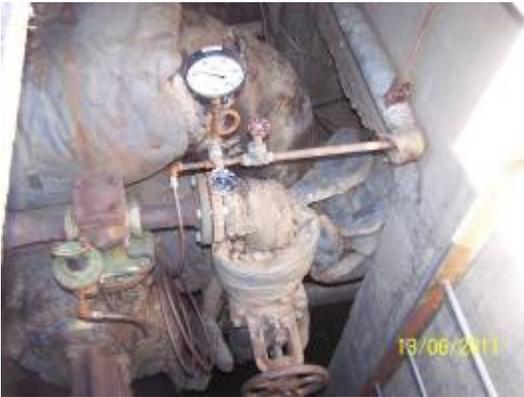
Photo 1: Steam pit 158A: view of interior.

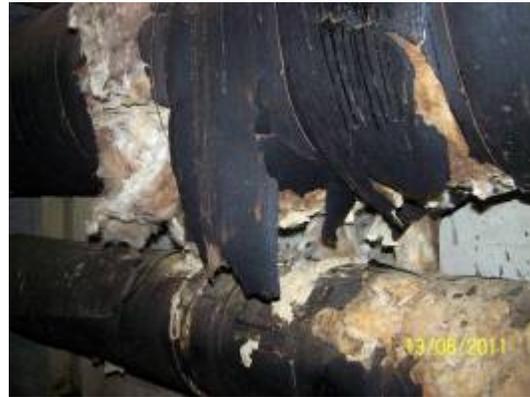
Photo 4: Steam pit 157: Fiberglass w/ Black paper wrap.

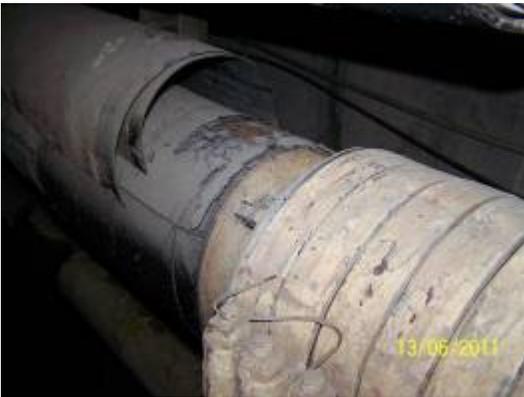
Photo 2: Steam pit 158: view of interior.

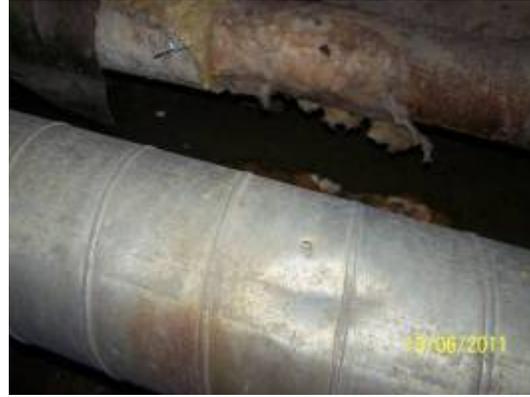
Photo 5: Steam pit 157: view of 18" and 12" exposed fiberglass pipes.

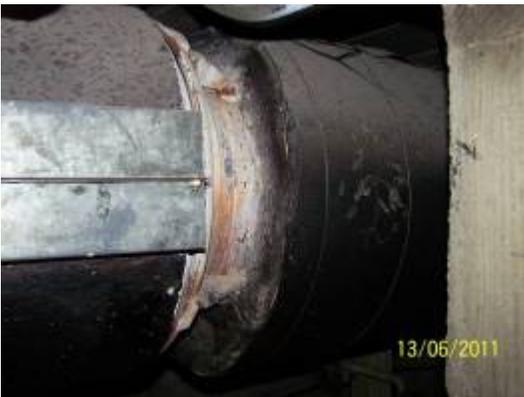
Photo 3: Steam pit 158: view of interior.

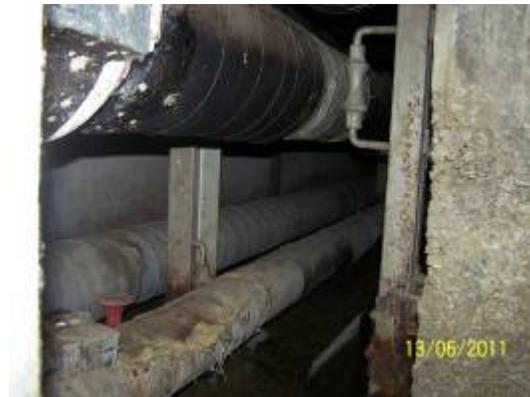
Photo 6: Steam pit 156: view of interior.

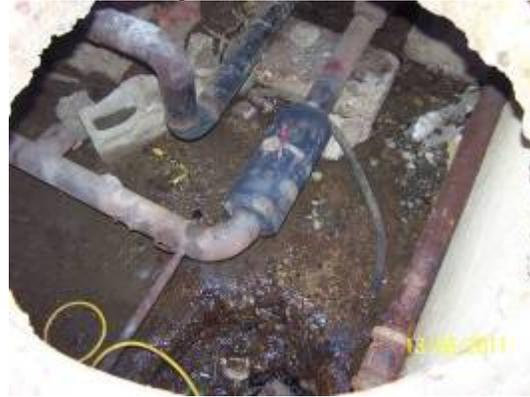
Photo 10: Steam pit 154A: view of interior.

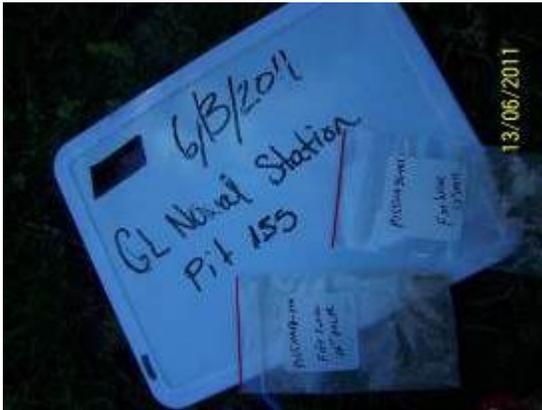
Photo 8: Samples taken at steam pit 155.
- Samples P-155-HA-36-107 and P-155-HA-37-110

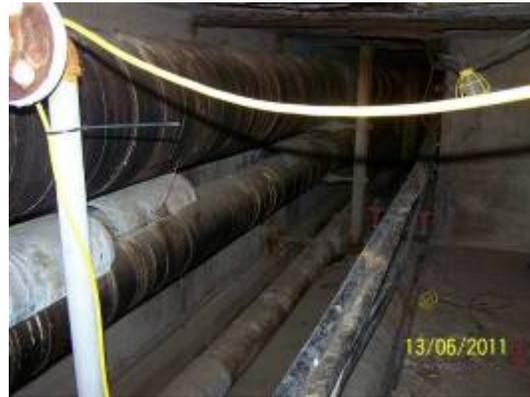
Photo 11: Steam pit 153: 18", 10", 10" and 12" Bare pipes (top left to bottom right).

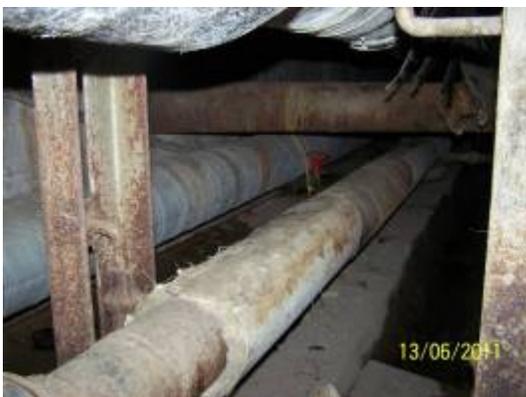
Photo 9: Steam pit 154: Insulation.

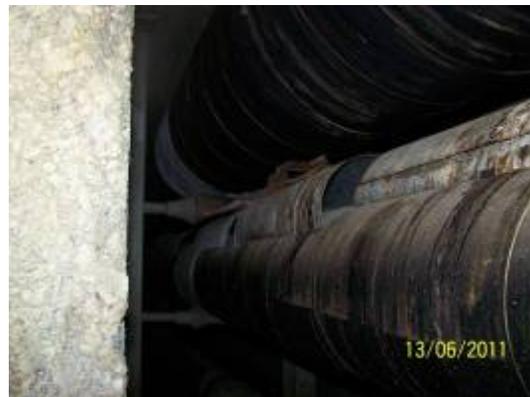
Photo 12: Steam pit 152: view of interior.

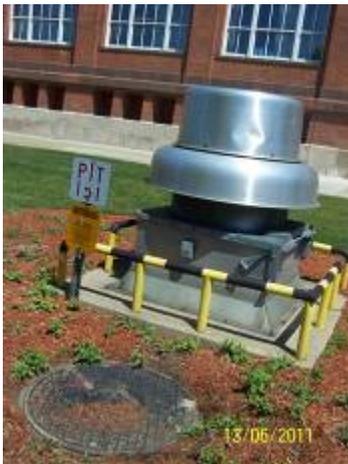
Photo 13: Steam pit 151: No access due to exhaust fan.

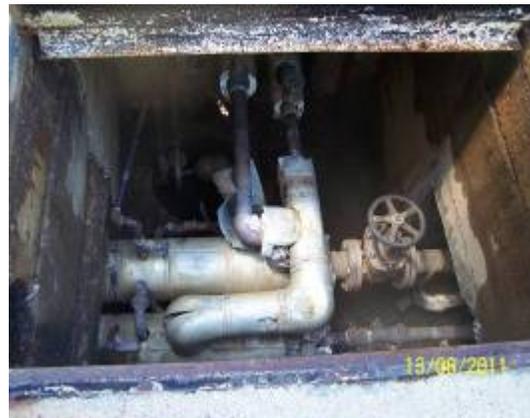
Photo 16: Steam pit 147: view of interior.

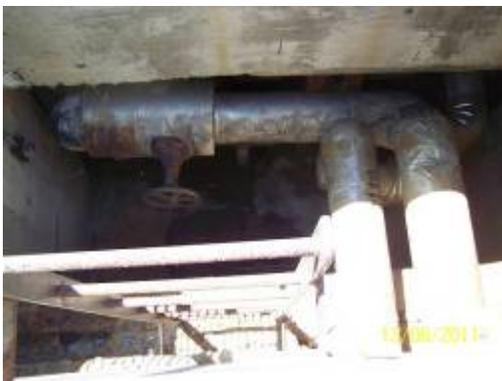
Photo 14: Steam pit 146: view of interior.

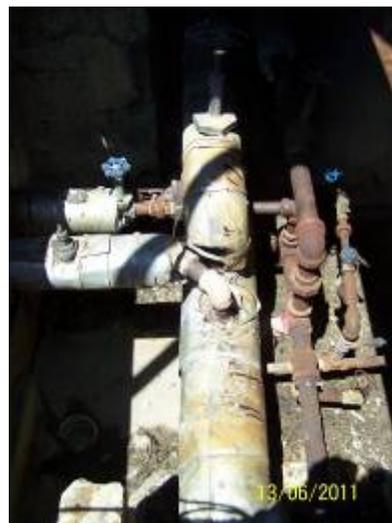
Photo 18: Steam pit 150: Note 4” & 2” Bare Pipe (right side).

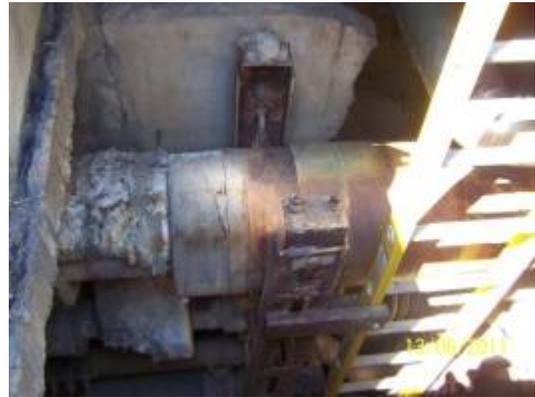
Photo 22: Steam pit 138: view of interior.

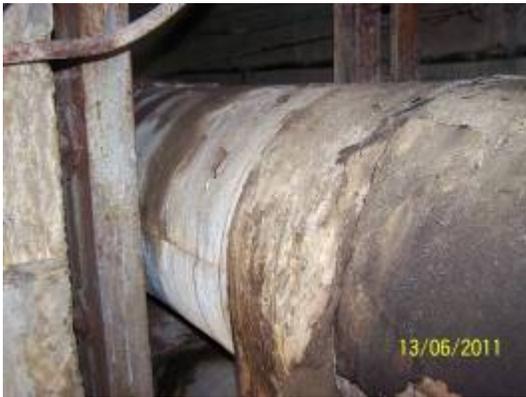
Photo 20: Steam pit 144: view of interior.

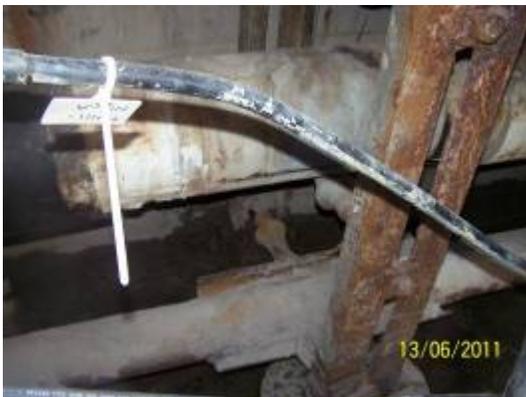
Photo 21: Steam pit 142: view of interior.

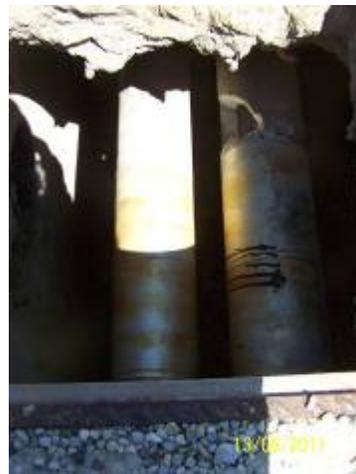
Photo 24: Steam pit 139: 18'' & 12'' Pipe.

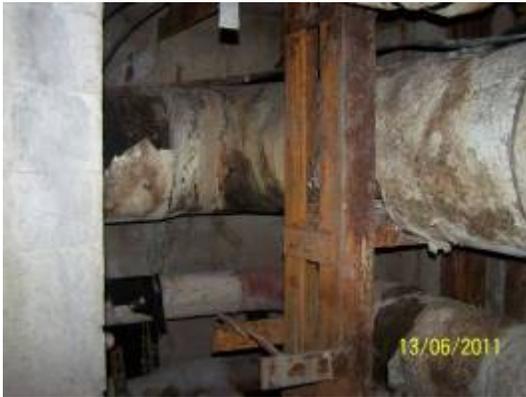
Photo 25: Steam pit 137: view of 18", 12" and Two 10" Pipes.

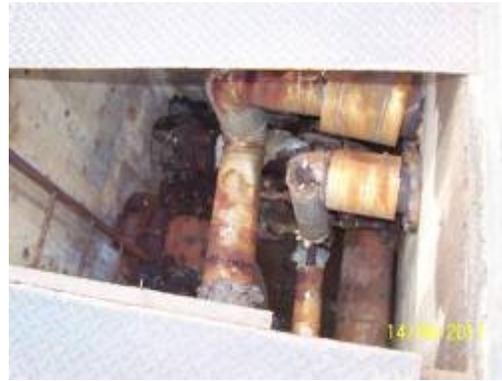
Photo 28: Steam pit 173: view of interior.

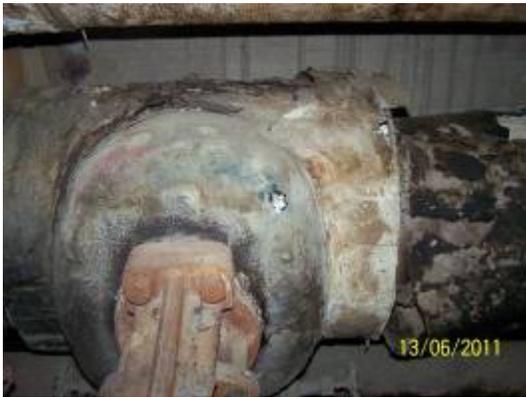
Photo 26: Steam pit 137: view of fitting. - Sample P-137-HA-37-112.

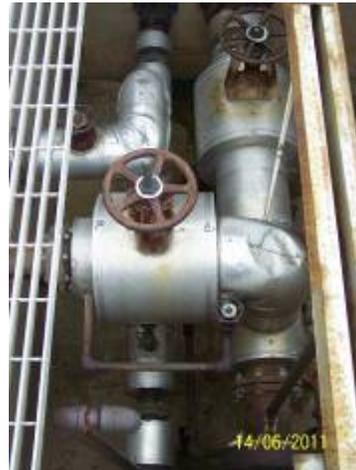
Photo 29: Steam pit 172A: view of 12" & 18" pipe.

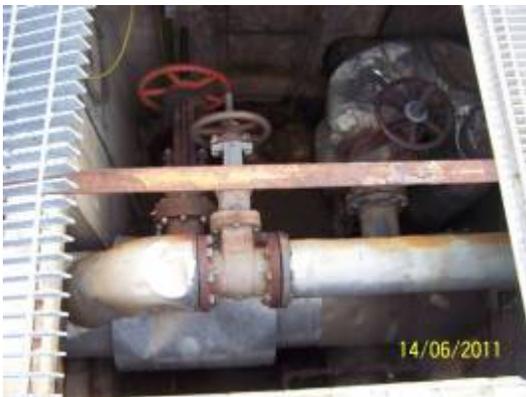
Photo 27: Steam pit 172: view of interior.

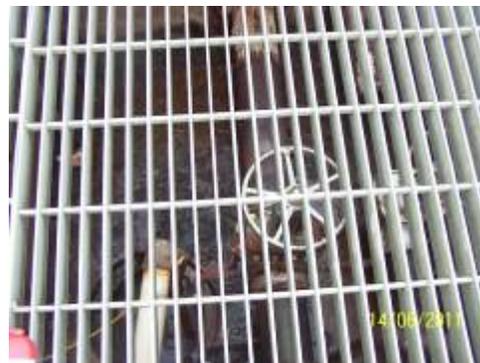
Photo 30: Steam pit 171: view of bare pipes through grate.

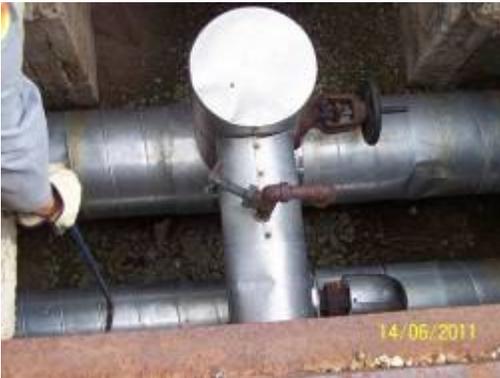
Photo 31: Steam pit 170: view of interior.

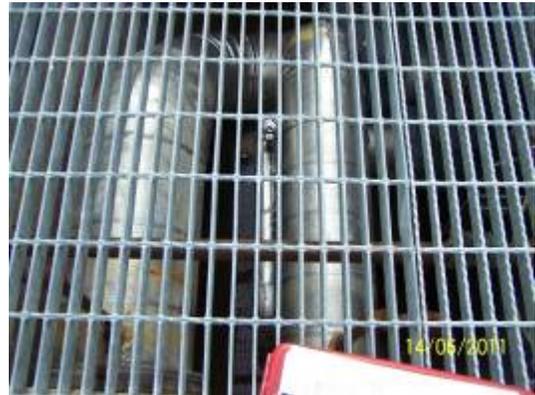
Photo 34: Steam pit 168: view of interior through grate.

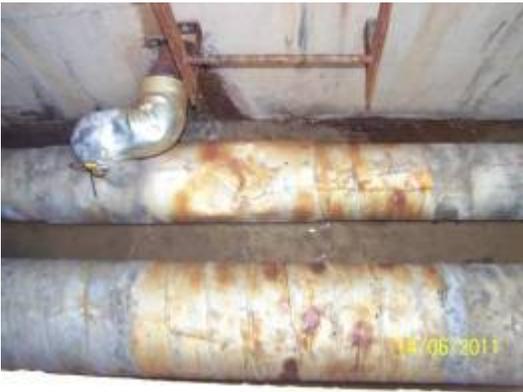
Photo 32: Steam pit 169: view of 18" & 12" pipes.

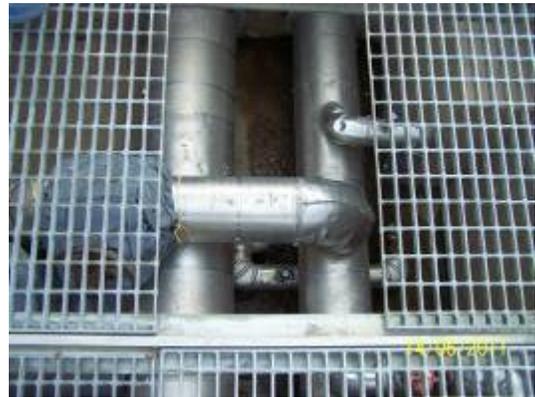
Photo 35: Steam pit 167: view of interior.

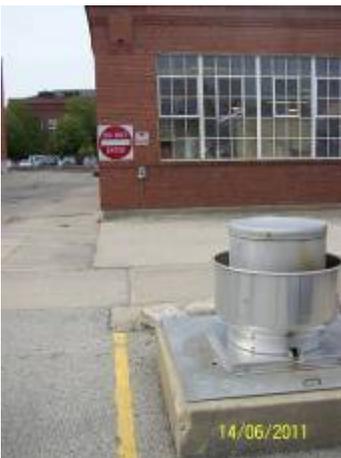
Photo 33: Steam pit 168A: no access due to exhaust fan.

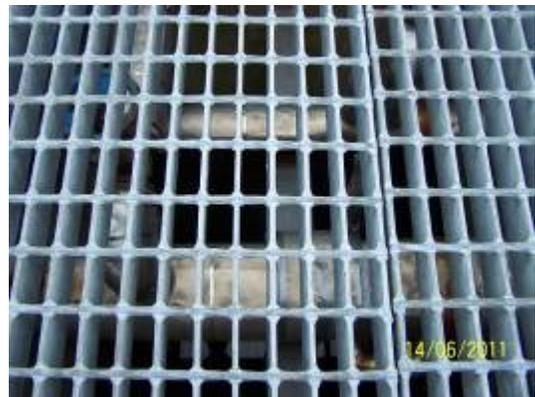
Photo 36: Steam pit 167A: view of interior through grate.

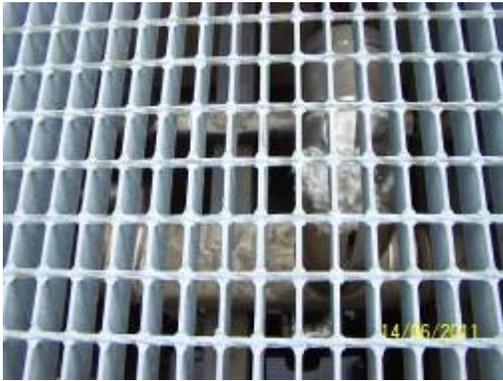
Photo 37: Steam pit 167B: view of interior through grate.

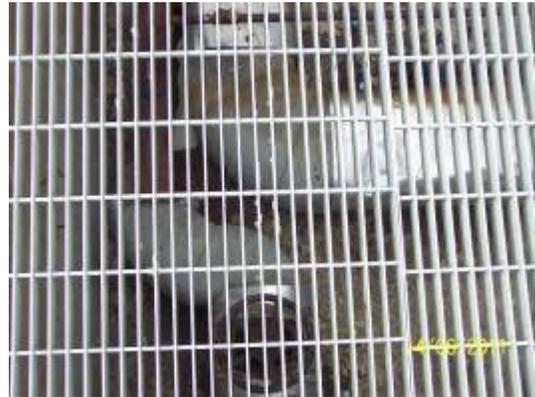
Photo 40: Steam pit 185: view of interior through grate.

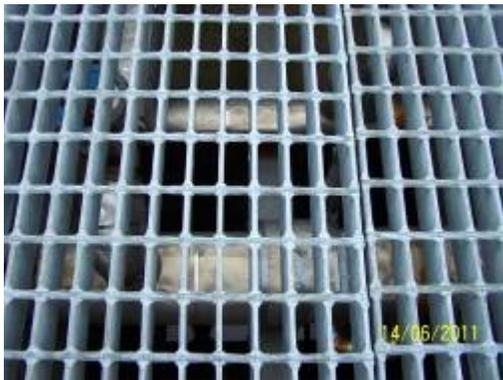
Photo 38: Steam pit 167C: view of interior through grate.

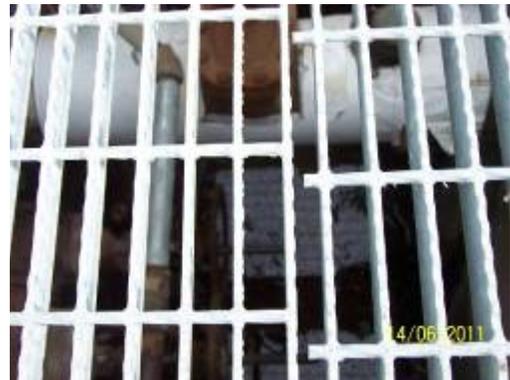
Photo 41: Steam pit 187: view of interior through grate.

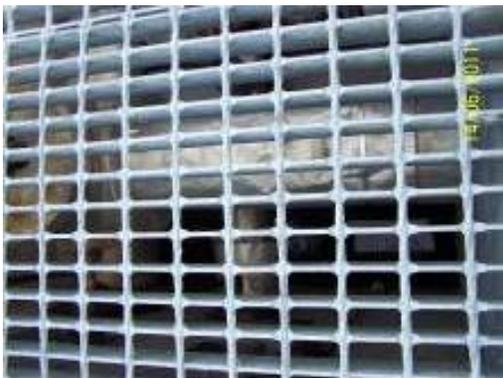
Photo 39: Steam pit.167D: view of interior through grate.

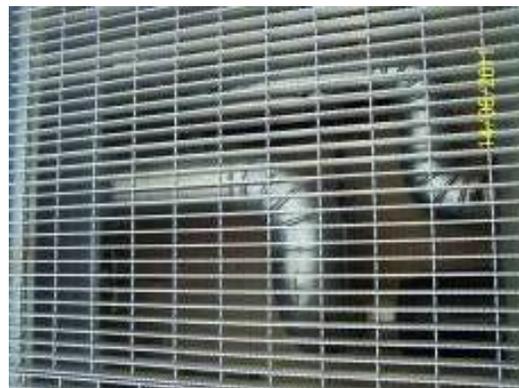
Photo 42: Steam pit 166: view of interior through grate.

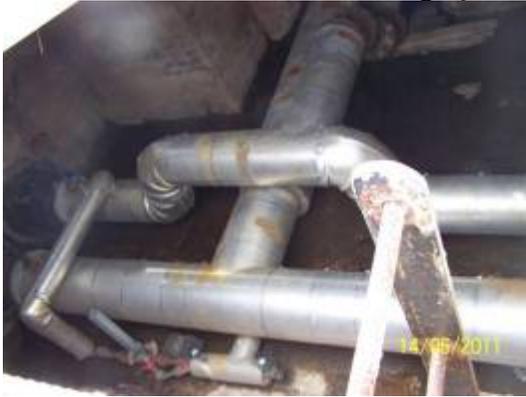
Photo 43: Steam pit 161: view of 18”&12” pipe.

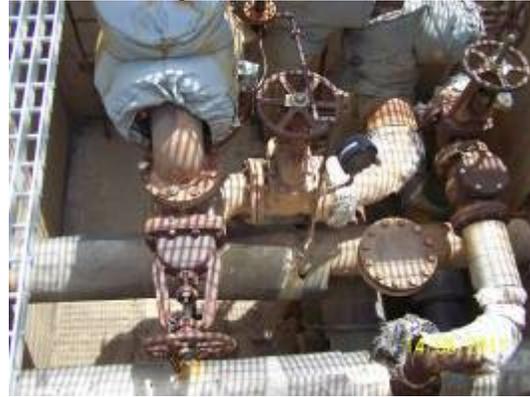
Photo 46: Steam pit 230: view of 18”&12” Pipe.

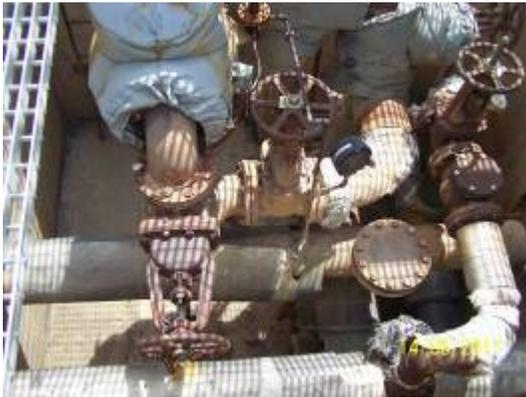
Photo 44: Steam pit 162: view of 18”&12” Pipe.

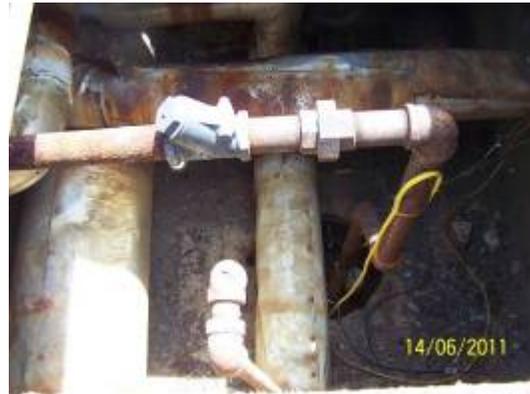
Photo 47: Steam pit 180: view of 18”& two 12” Pipes.

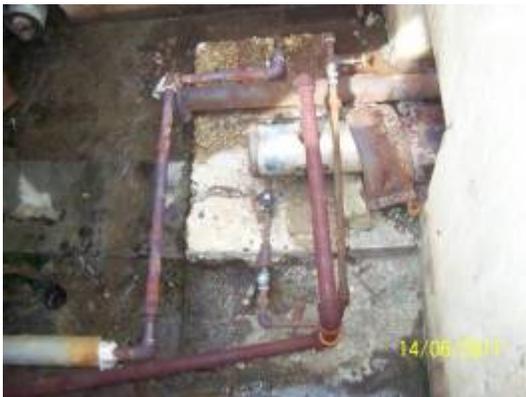
Photo 45: Steam pit 160-Bare pipe (center) & Fiberglass (lower left)

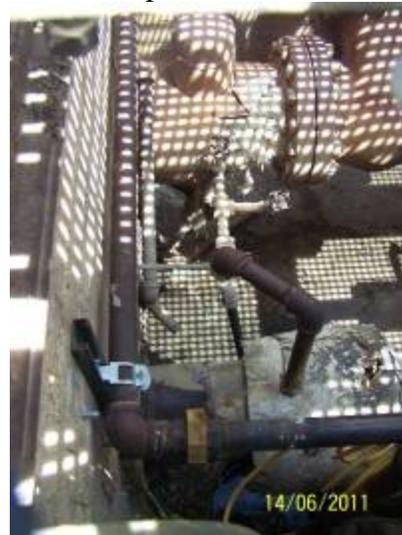
Photo 48: Steam pit 181: view of fiberglass & bare pipe.

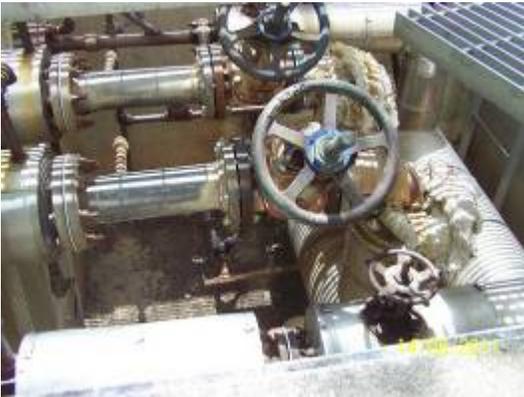
Photo 49: Steam pit 231: two 10", 18" & 12" pipes.

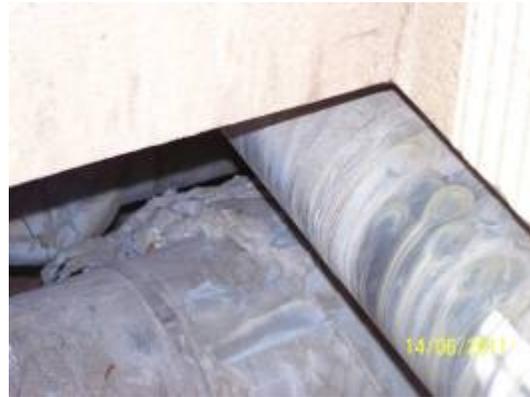
Photo 52: Steam pit 226: view of suspect material, fiberglass wool mix.

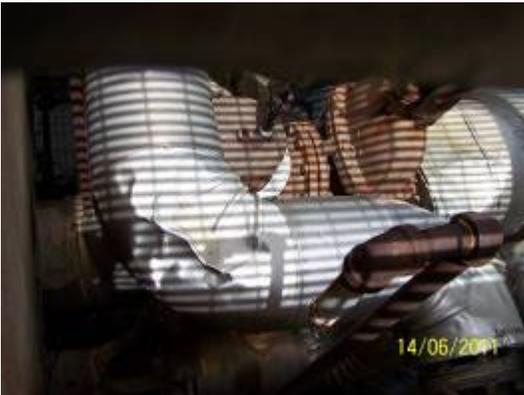
Photo 50: Steam pit 178: view of 18" & two 12" Pipes.

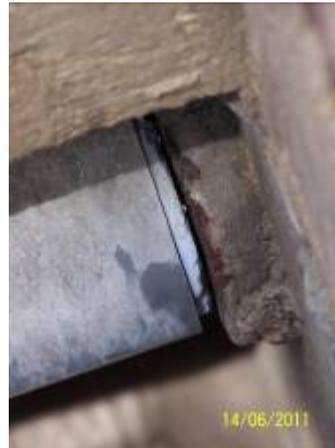
Photo 53: Steam pit 226: view of fiberglass and wool.

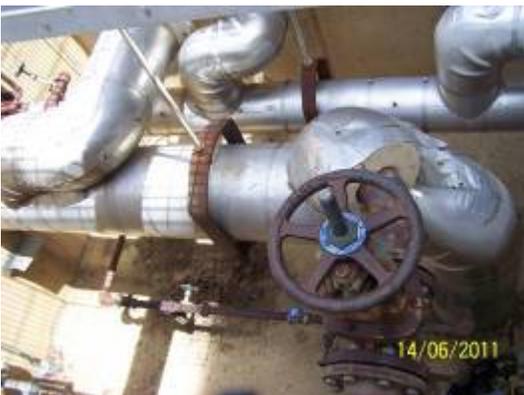
Photo 51: Steam pit 178A: view of 18" & 12" pipes.

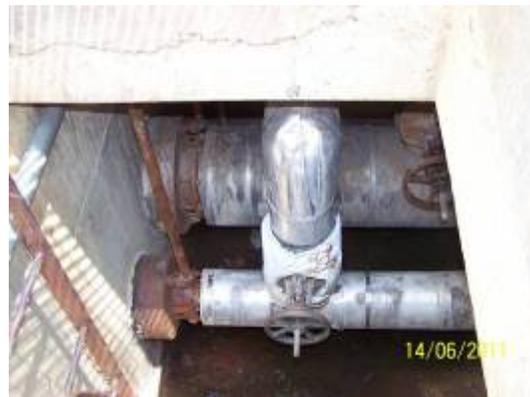
Photo 54: Steam pit 225: view of 18", 12" & 10" pipes.

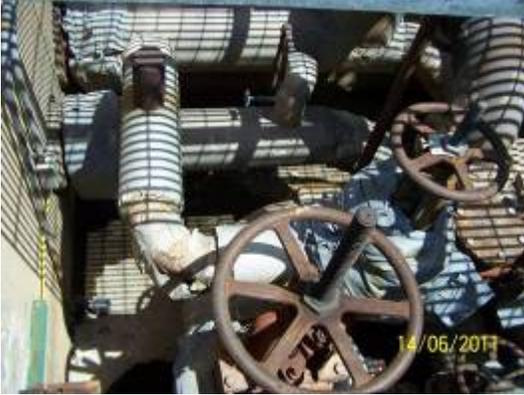
Photo 55: Steam pit 221: view of two 18" & two 12" Pipes.

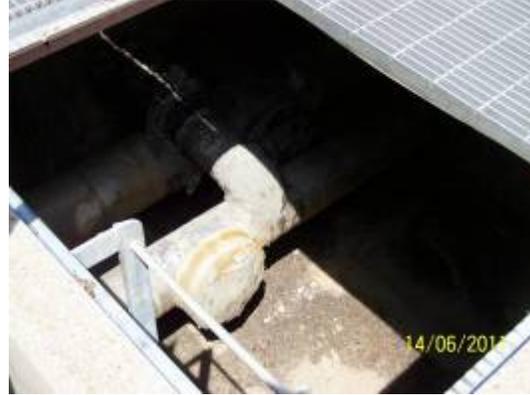
Photo 58: Steam pit 216: view of 18" & 12" pipes.

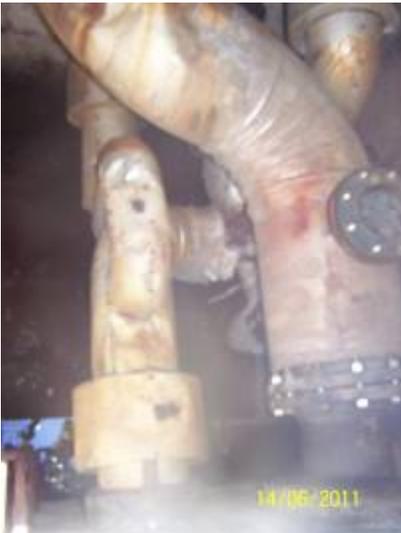
Photo 56: Steam pit 220: view of 18" & 12" pipes.

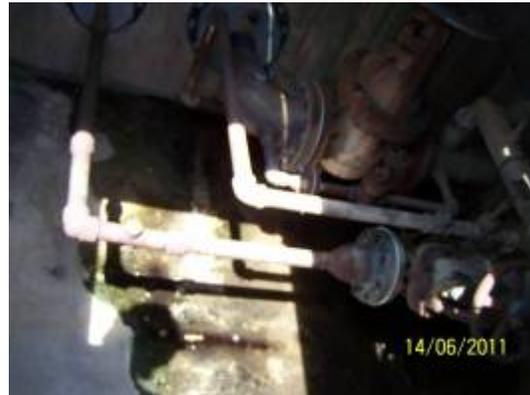
Photo 59: Steam pit 216A: view of 18", 16", and 12" bare pipes with fiberglass.

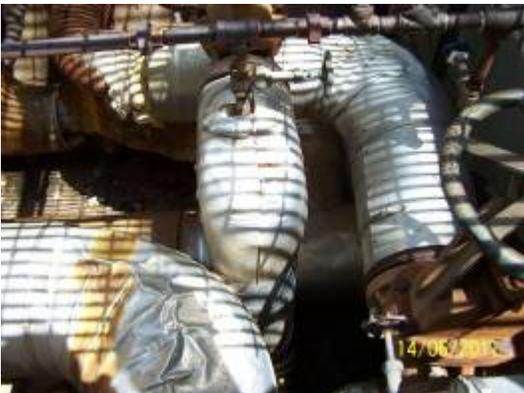
Photo 57: Steam pit 214: view of 12" & two 18" Pipes.

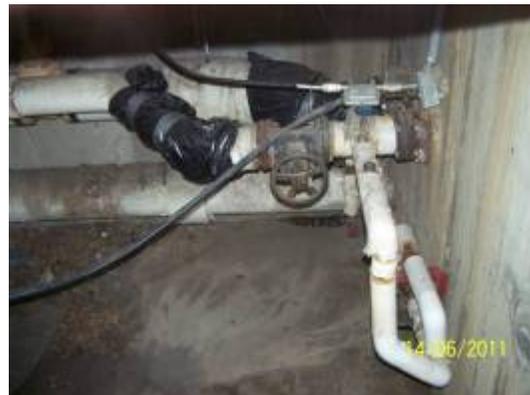
Photo 60: Steam pit 216B: view of 10" & 18" pipes.

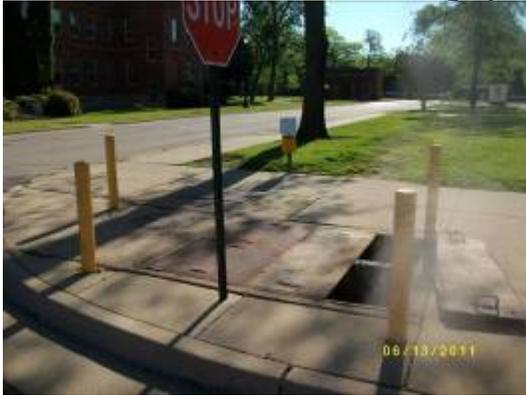
Photo 1: Steam pit 100: View of pit surface expression, pit temperature over 120° f, no entry into pit.

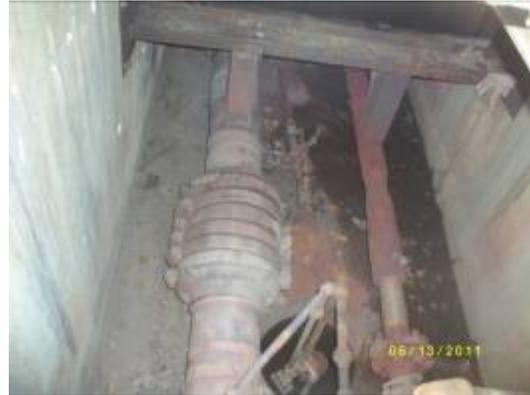
Photo 4: Steam pit 118: View of pit.

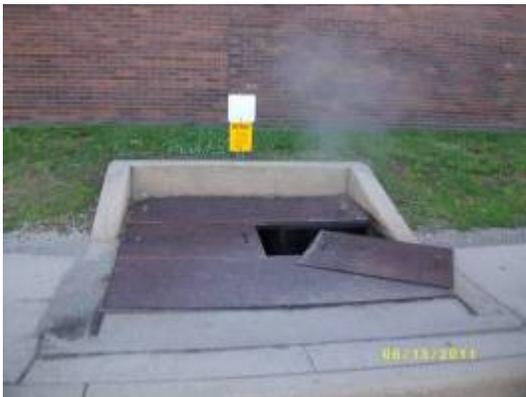
Photo 2: Steam pit 99: View of pit surface expression, pit temperature over 120° f, no entry into pit.

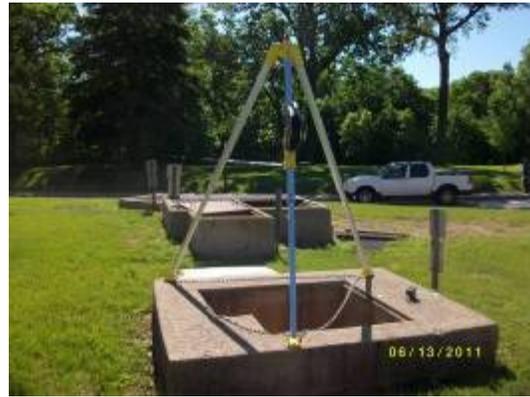
Photo 5: Steam pit 119: View of tripod rescue system setup. Pits 121, 122, and 123 visible behind tripod.

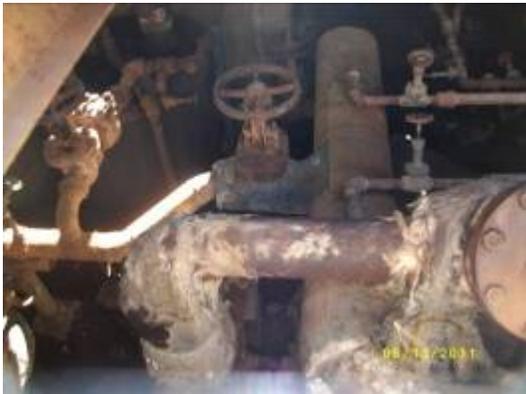
Photo 3: Steam pit 103: View of pit.

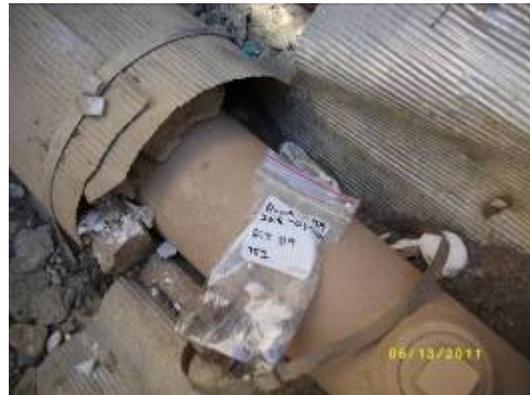
Photo 6: Steam pit 119: View of 12” steam line, insulation, and sample collected. - Sample P-119-HA-226-01.

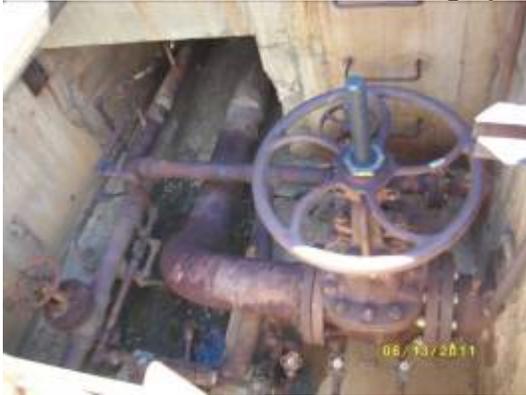
Photo 7: Steam pit 121: View of bare piping. Pit 121 also labeled as pit 123.

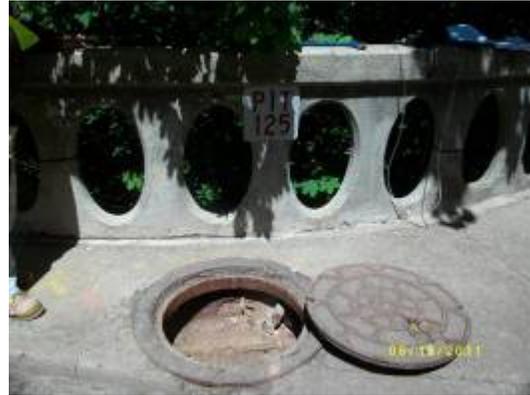
Photo 10: Steam pit 125: View of pit surface expression, no entry into pit due to restricted internal configuration.

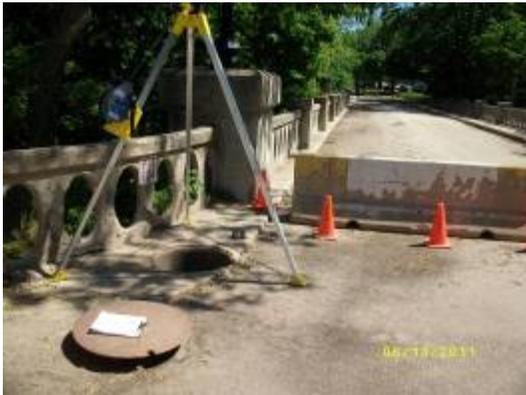
Photo 8: Steam pit 124: View of tripod rescue system setup.

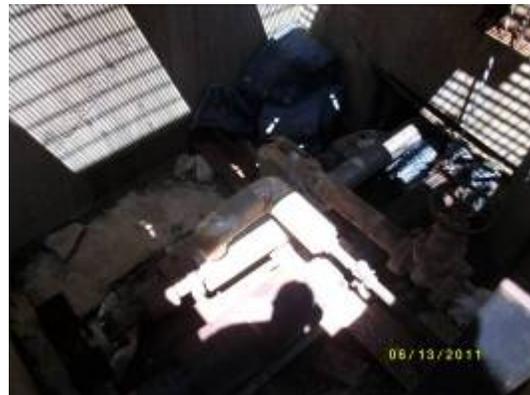
Photo 11: Steam pit 126: View of pit.

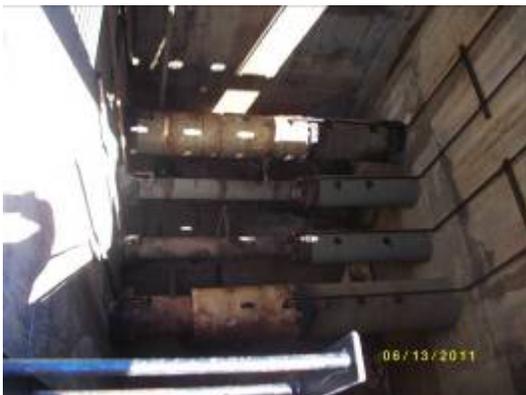
Photo 9: Steam pit 259B: View of 24" and 18" steam lines.

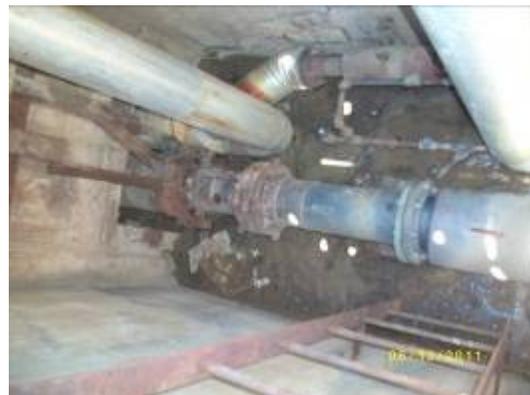
Photo 12: Steam pit 130: View of pit.

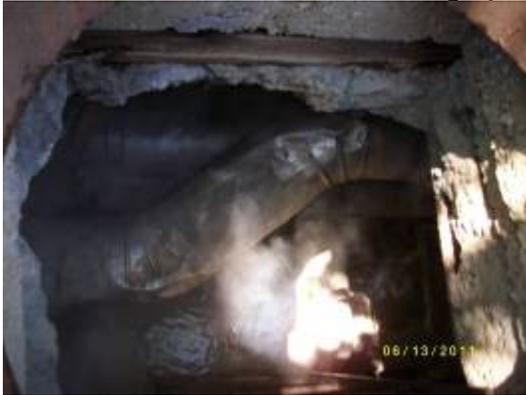
Photo 13: Steam pit 131: View of pit. No entry due to elevated temperatures and depth of standing water.

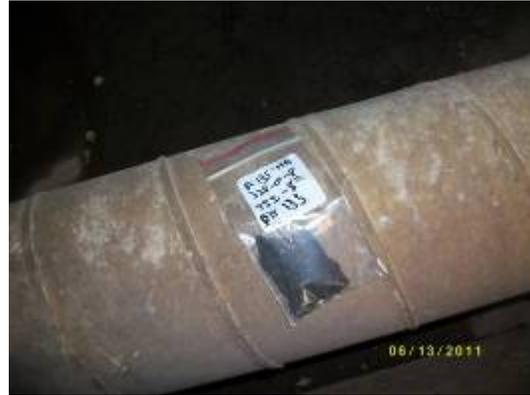
Photo 16: Steam pit 135: View of sample collected from 8” steam line. - Sample P-135-HA-228-01.

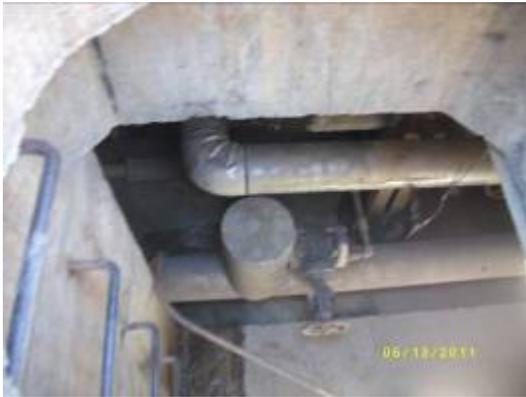
Photo 14: Steam pit 132: View of pit.

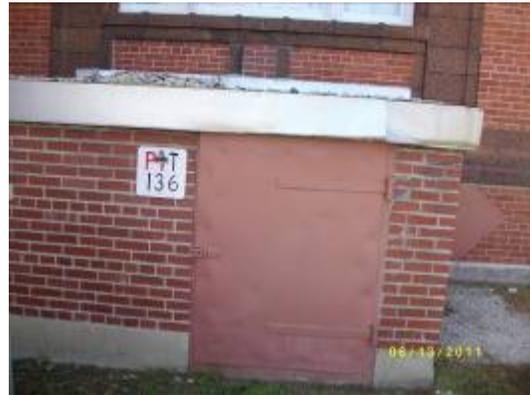
Photo 17: Steam pit 136: View of brick structure above pit. No entry due to lack of clearance for rescue equipment.

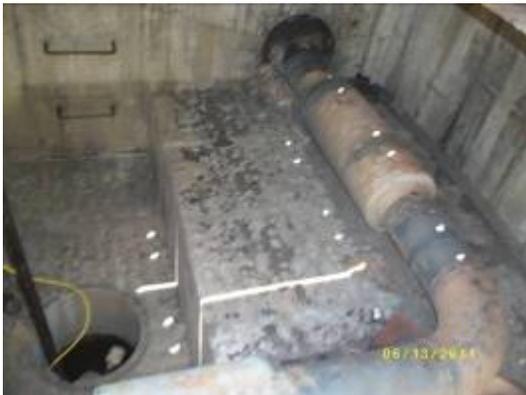
Photo 15: Steam pit 133: View of pit.

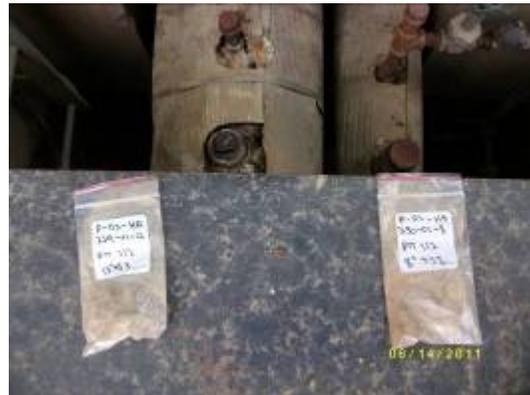
Photo 18: Steam pit 112: View of samples collected from 12” and 8” lines. - Samples P-112-HA-229-01 and P-112-HA-230-01.

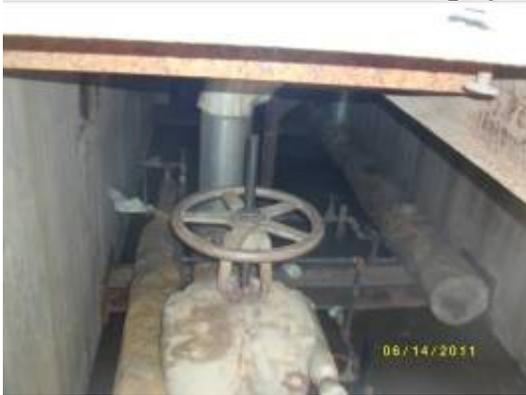
Photo 19: Steam pit 113: View of pit.

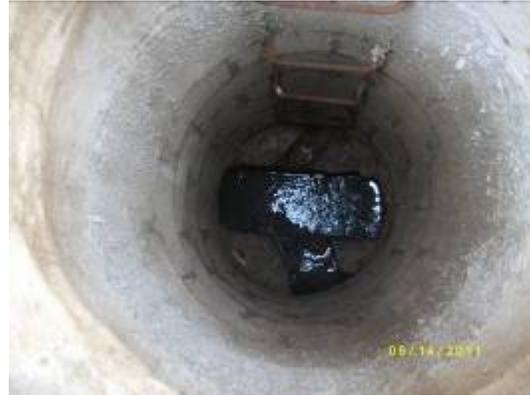
Photo 22: Steam pit 191A: View of sewer line. No unlabeled steam pit found in area of sign for pit 191A.

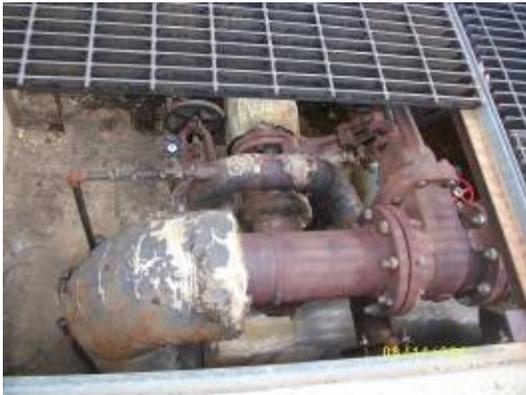
Photo 20: Steam pit 191: View of Pit.

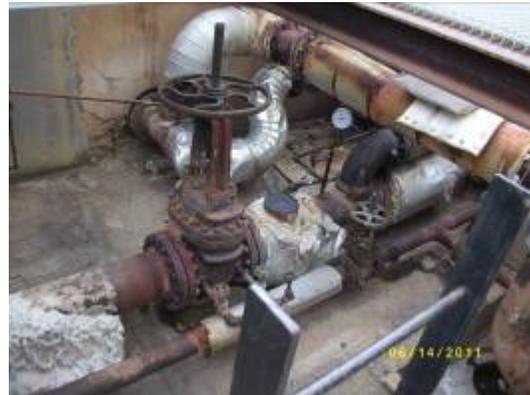
Photo 23: Steam pit 183: View of pit.

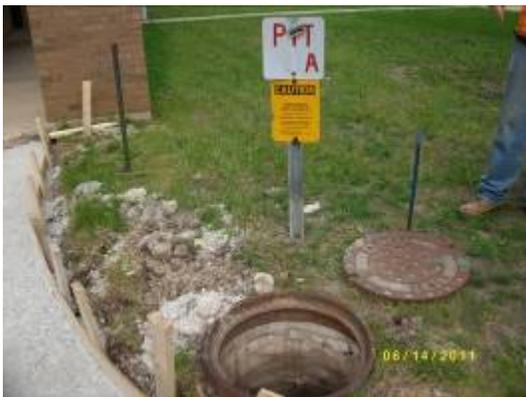
Photo 21: Steam pit 191A: View of sign and surface expression. Manhole at sign base found to be part of sewer line.

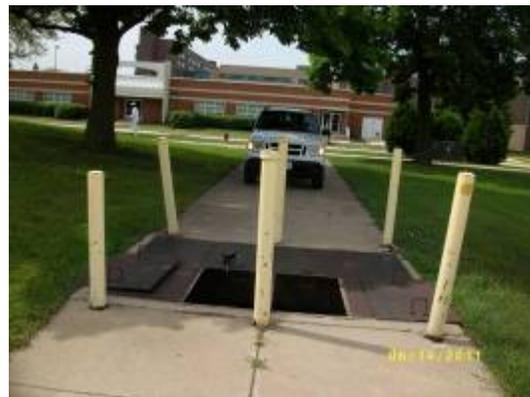
Photo 24: Steam pit 196: View of pit surface expression.

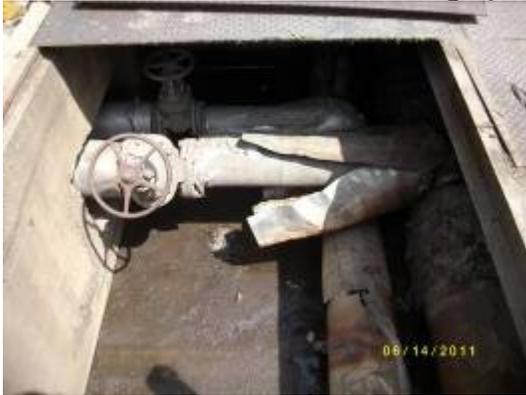
Photo 25: Steam pit 199: View of pit.

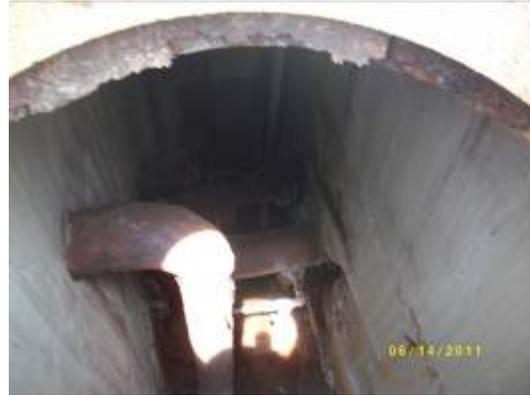
Photo 28: Steam pit 259A: View of pit.
No entry due to elevated temperatures.

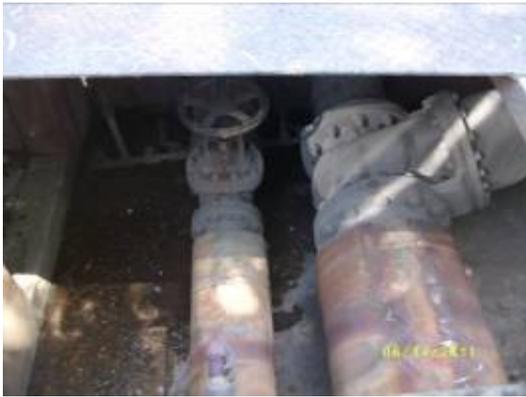
Photo 26: Steam pit 200: View of pit.

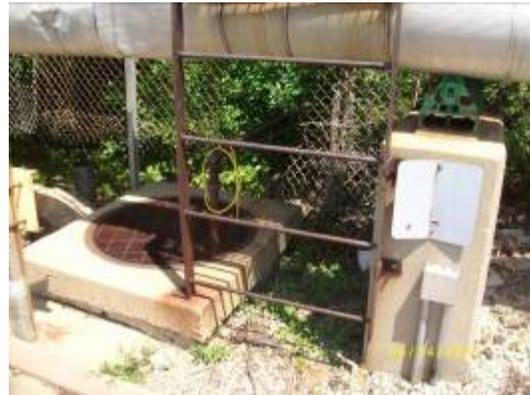
Photo 29: Steam pit 241: No entry due to
elevated temperatures.

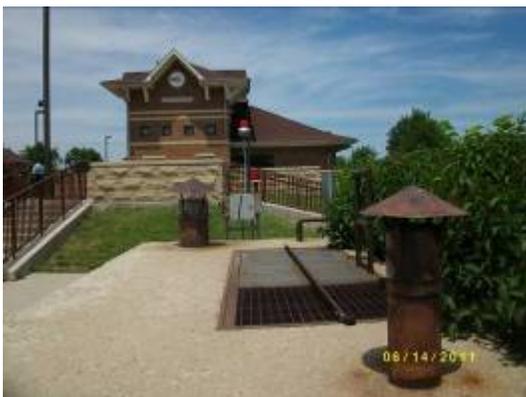
Photo 27: Steam pit 259: View of pit
surface expression. No entry due to pit
being secured and locked.

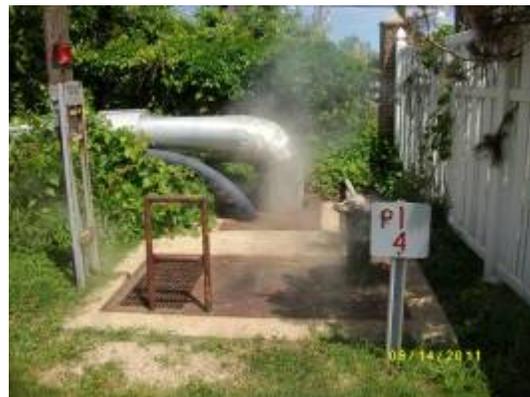
Photo 30: Steam pit 243: No entry due to
elevated temperatures.

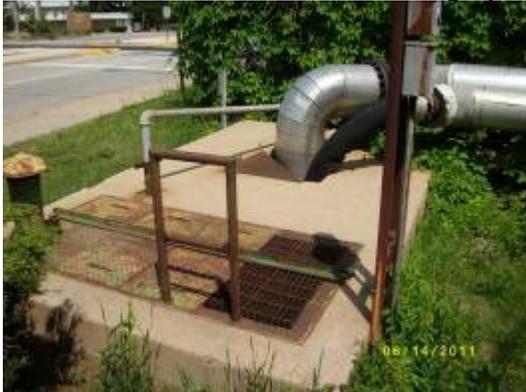
Photo 31: Steam pit 247: No entry due to pit being secured and locked.

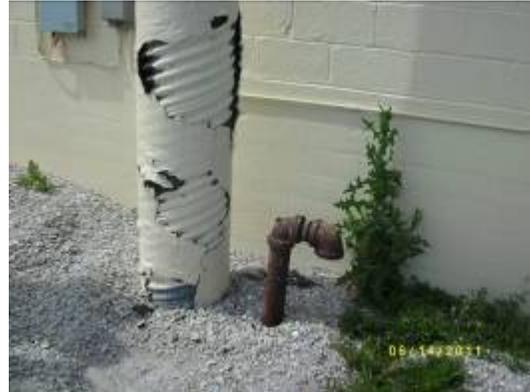
Photo 34: Steam pit 9 along Maryland St.: No pit found, piping emerges directly from ground.

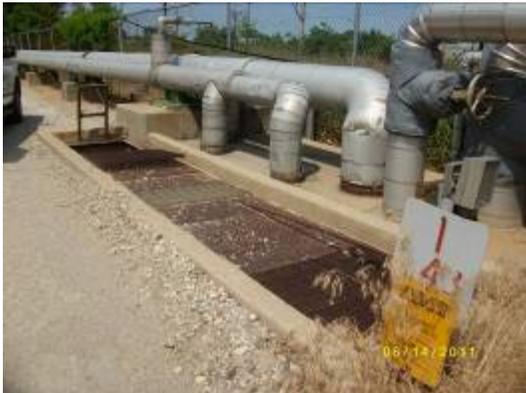
Photo 32: Steam pit 248: View of surface expression. No entry due to elevated temperatures.

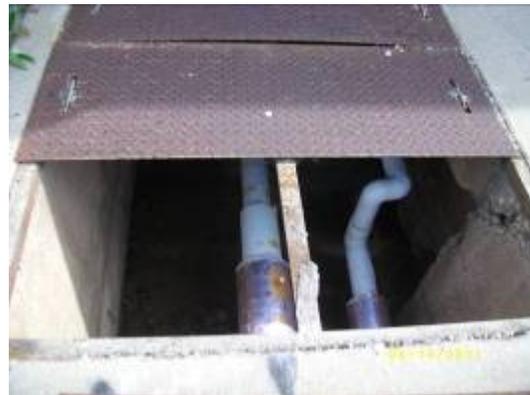
Photo 35: Steam pit 6 along Maryland St.: View of Pit.

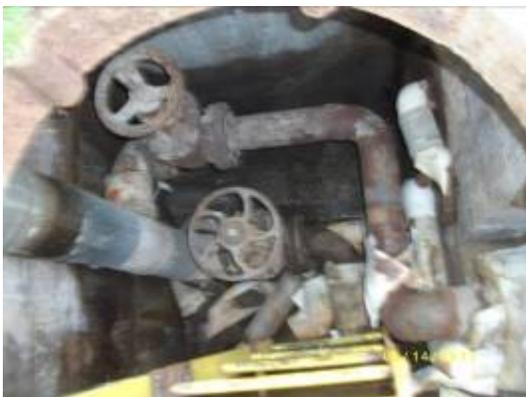
Photo 33: Steam pit 5 along Maryland St.: View of pit.

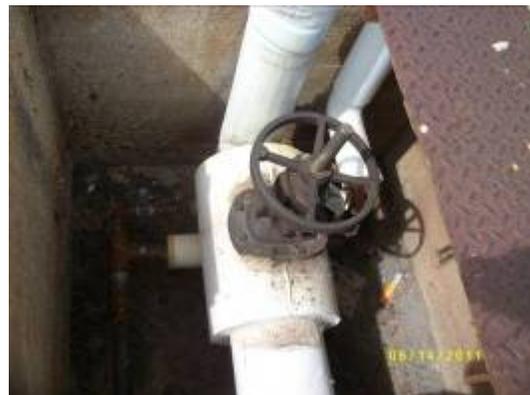
Photo 36: Steam pit 8 along Maryland St.: View of piping in pit.
