**CONTRACTOR REPORT
CR-NAVFAC EXWC-CIOFP-DRAFT
Volume II of III - Bulkheads**

**WATERFRONT FACILITIES
INSPECTIONS AND ASSESSMENTS AT
NORFOLK NAVAL STATION
NORFOLK, VIRGINIA**

On Site: Jan-29-2013

Norfolk Naval Station Norfolk, Virginia

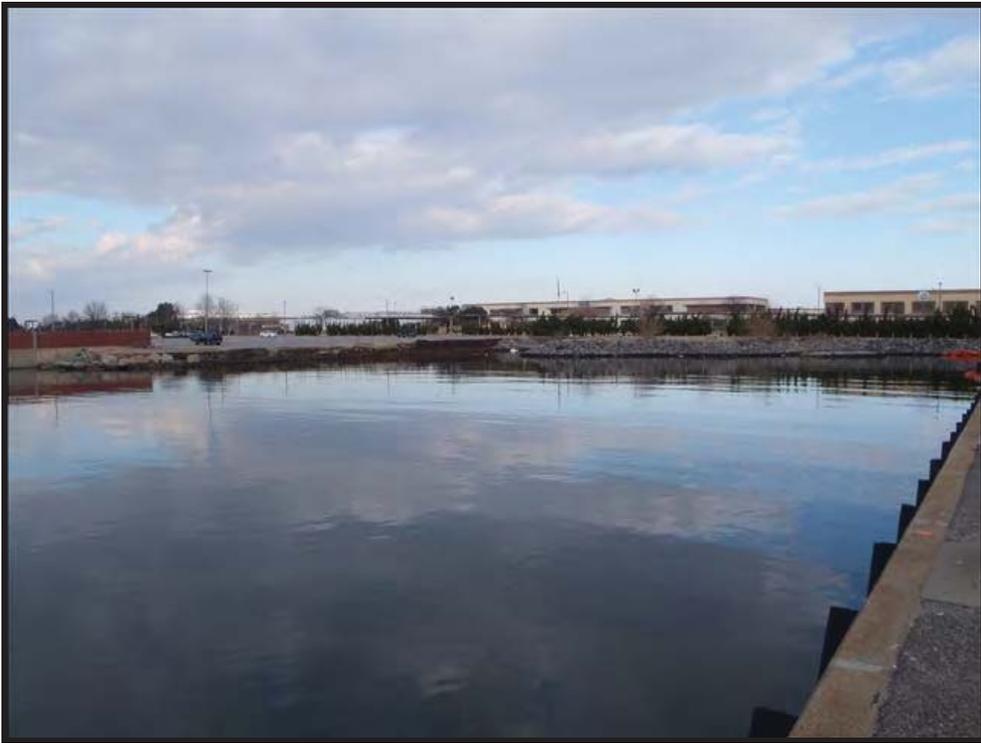
Photo 3.5-2: Overview of Patriot Point from CEP176 Bulkhead, looking east.

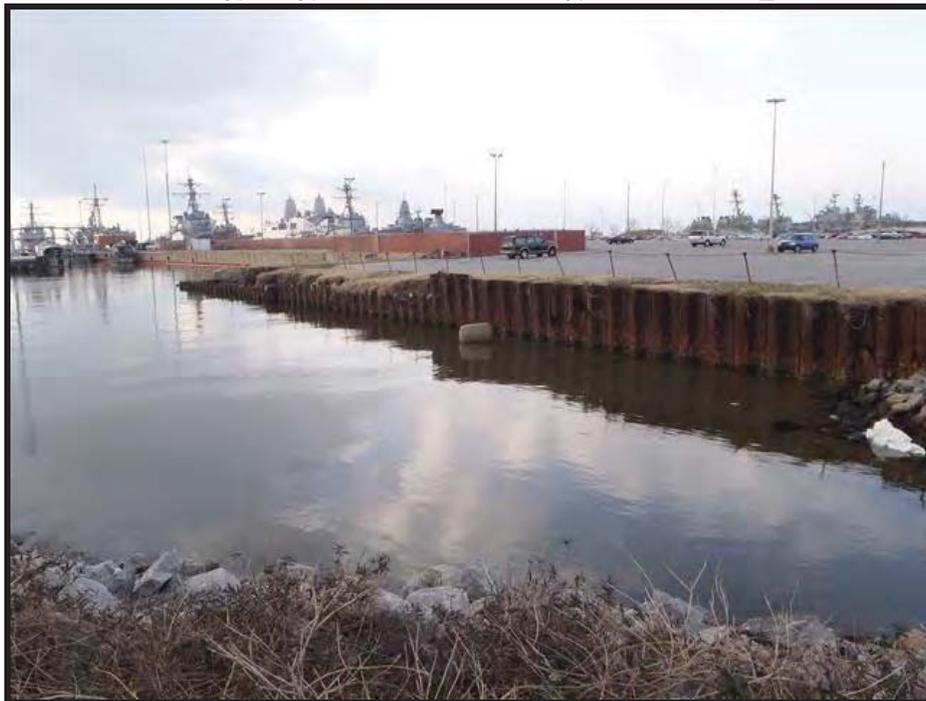
Photo 3.5-3: Overview of the steel sheet pile bulkhead from the Patriot Point stone revetment, looking northwest.

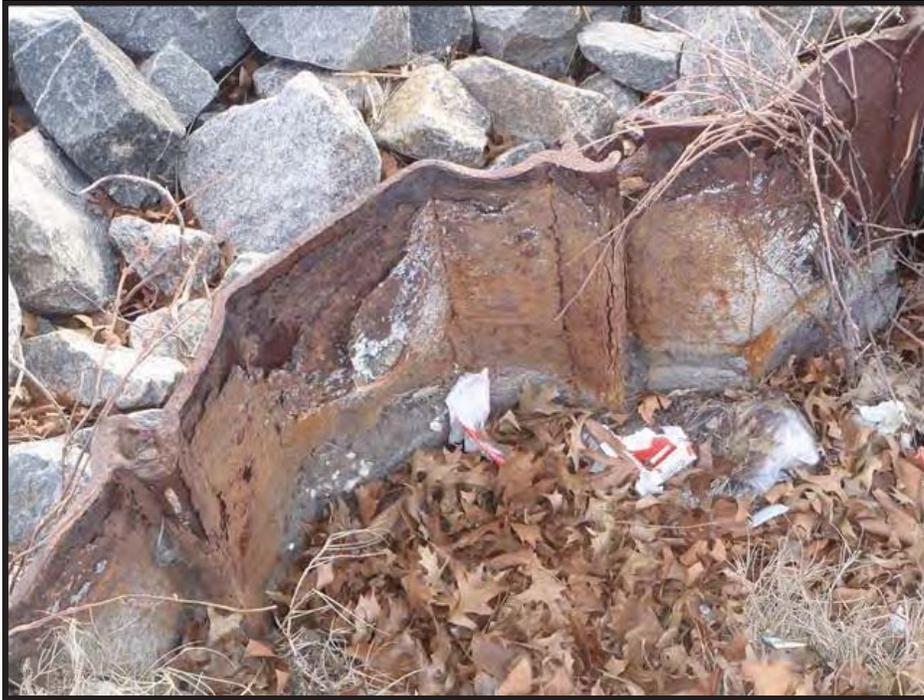
Photo 3.5-4: View of U-shaped sheet piles comprising the bulkhead.

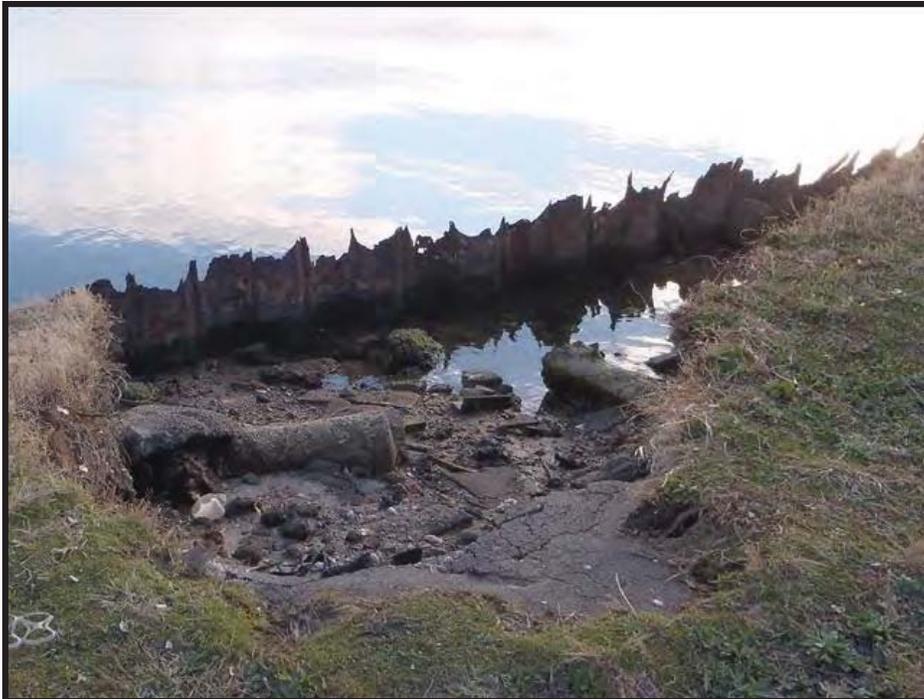
Photo 3.5-5: Typical view of the top of steel sheet piles broken off at western 150 linear ft of bulkhead and a resulting wash-out of the shoreline.

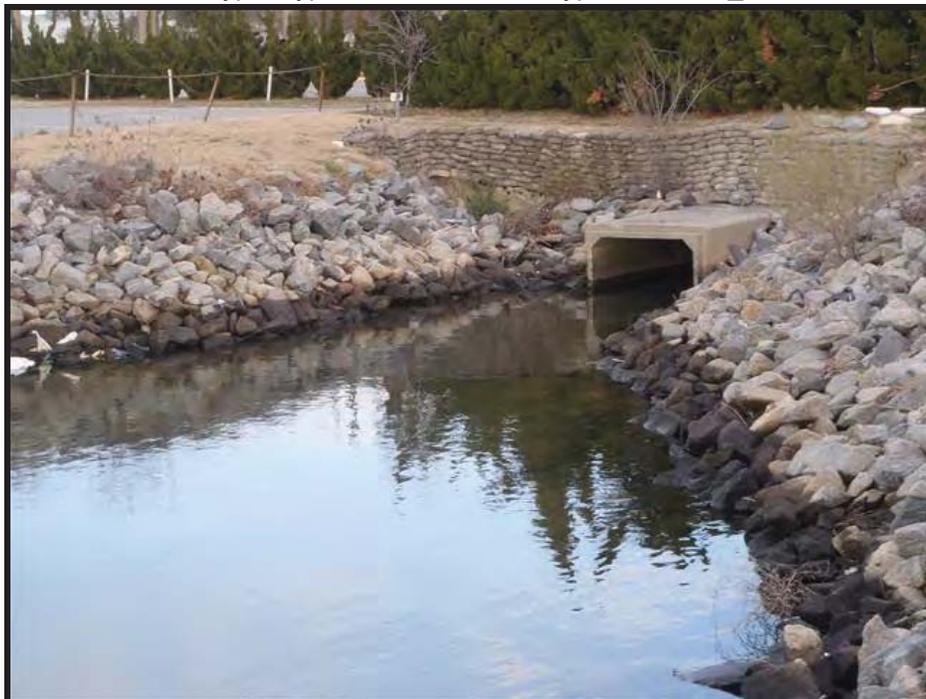
Photo 3.5-7: View of the stone revetment, box culvert, and grout bag wall, looking east.

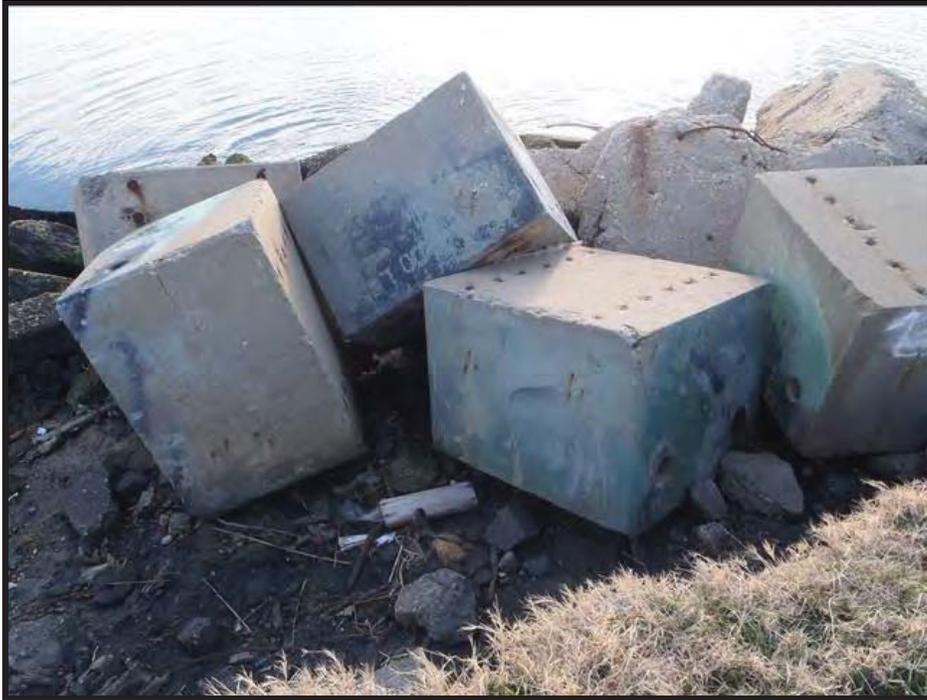
Photo 3.5-8: Typical view of the concrete blocks comprising the revetment at the northwest corner of Patriot Point.

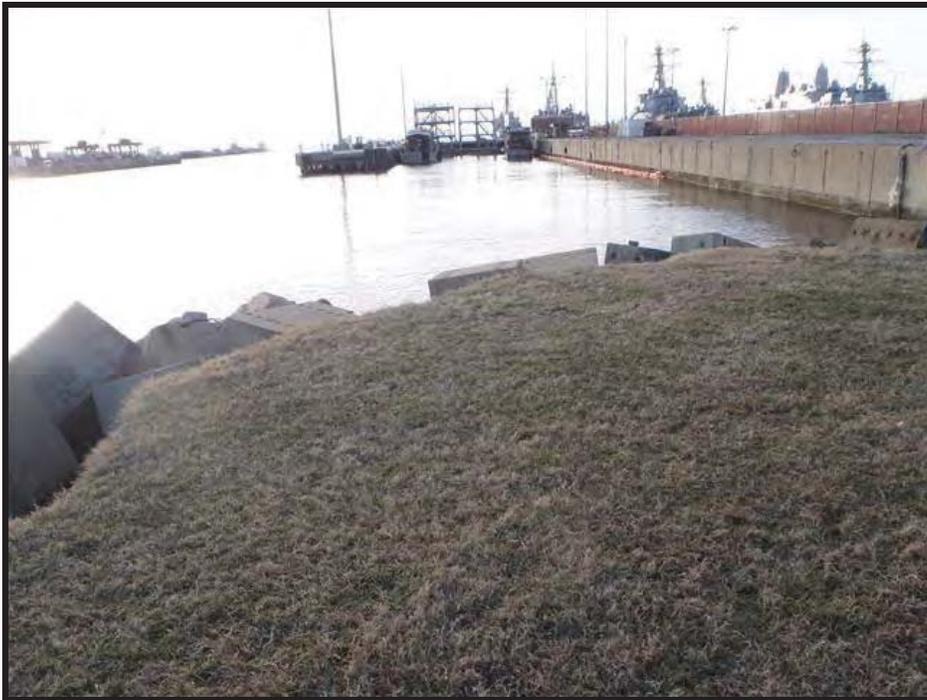
Photo 3.5-9: View of the eroded slope at the concrete block revetment.

Patriot Point is in Poor Condition overall with a Condition Index (CI) rating of 40 and Operation Capability (OC) rating of C3. The current condition ratings are unchanged from the previous inspection conducted in 2007. Eroded shoreline areas should be monitored for encroachment into an adjacent parking lot. It is recommended that the steel sheet pile bulkhead be replaced with a new bulkhead and the backfill upland of the bulkhead be restored. Concrete block slope protection should be replaced with an engineered rock revetment.

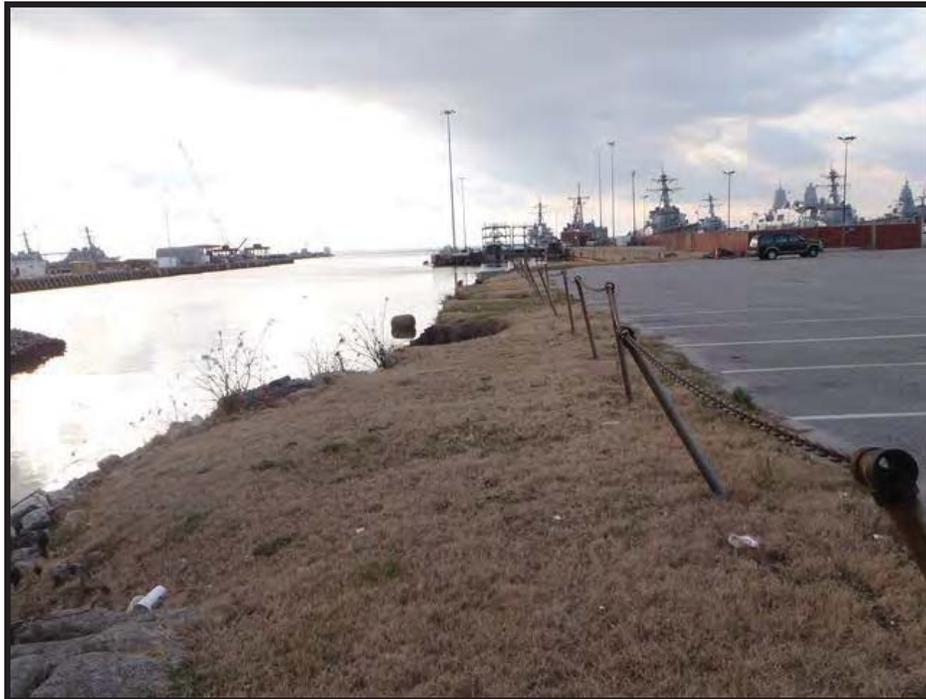
Photo 3.5-10: Overview of backfill behind the steel sheet pile bulkhead.

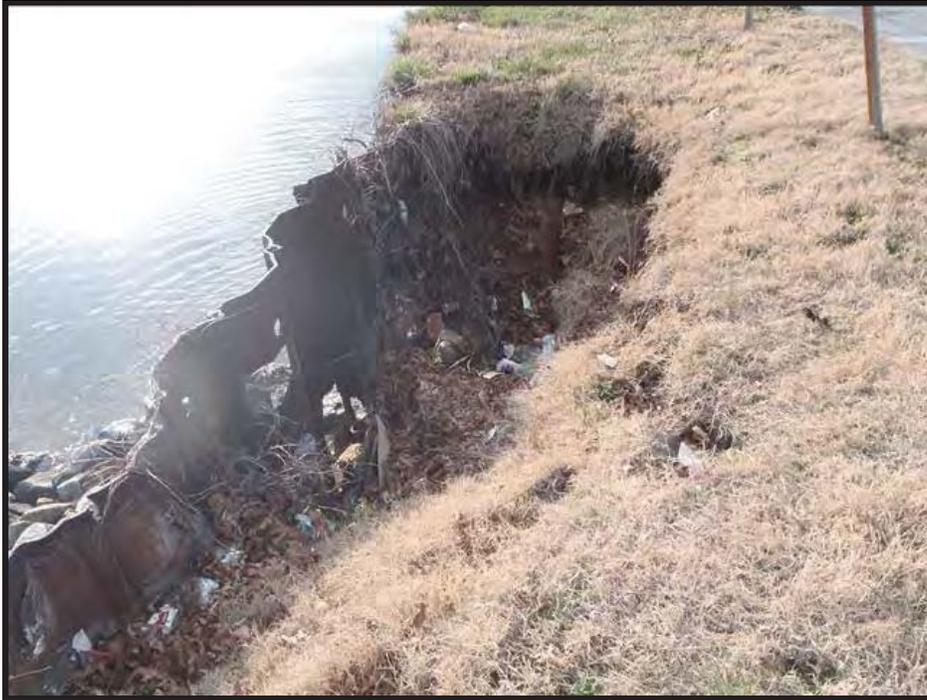
Photo 3.5-11: View of a wash-out behind the steel sheet pile bulkhead at Sta. 0+45.

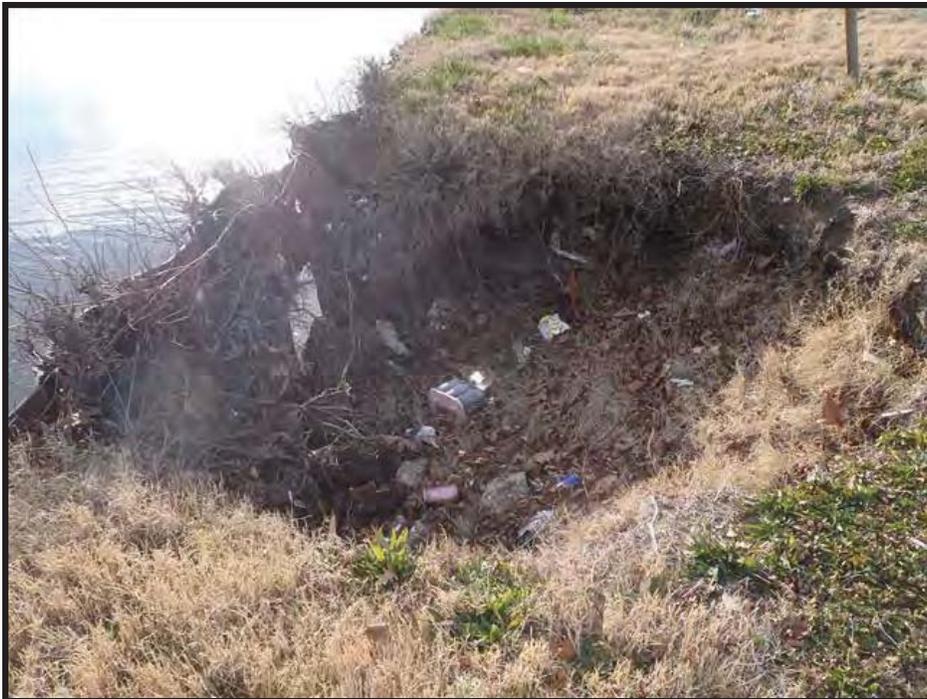
Photo 3.5-12: View of a wash-out behind the steel sheet pile bulkhead at Sta. 0+80.

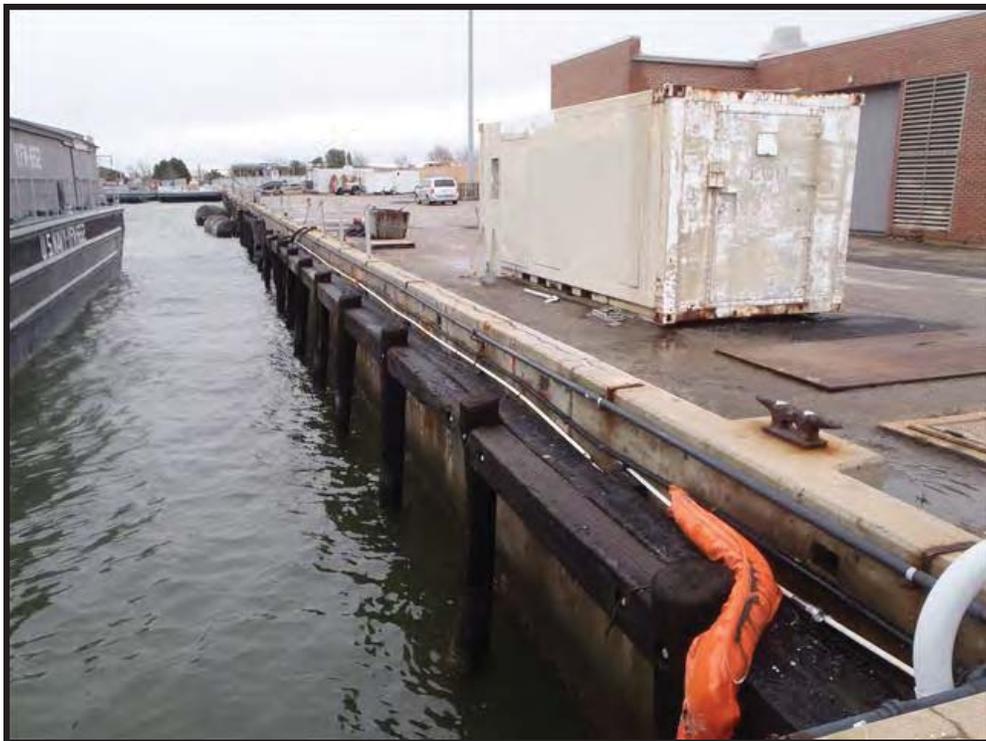
Photo 3.6-2: Overview of CEP102 Bulkhead from shore, Sta. 19+60, looking east.

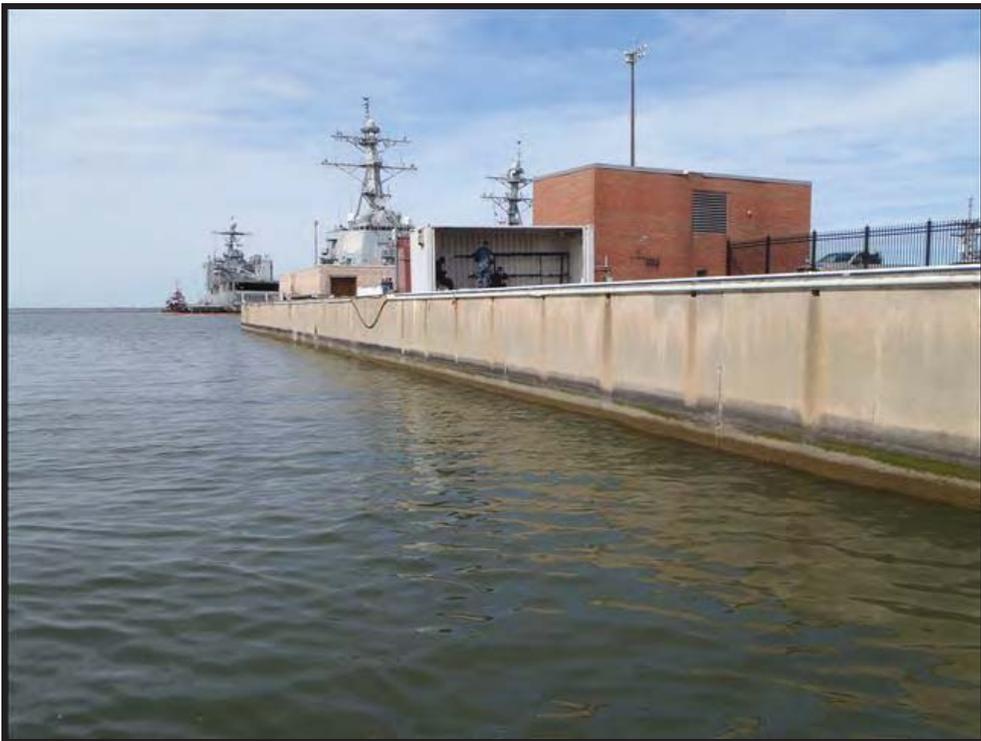
Photo 3.6-4: Overview of CEP175 Bulkhead and from the water, Sta. 6+40, looking west.

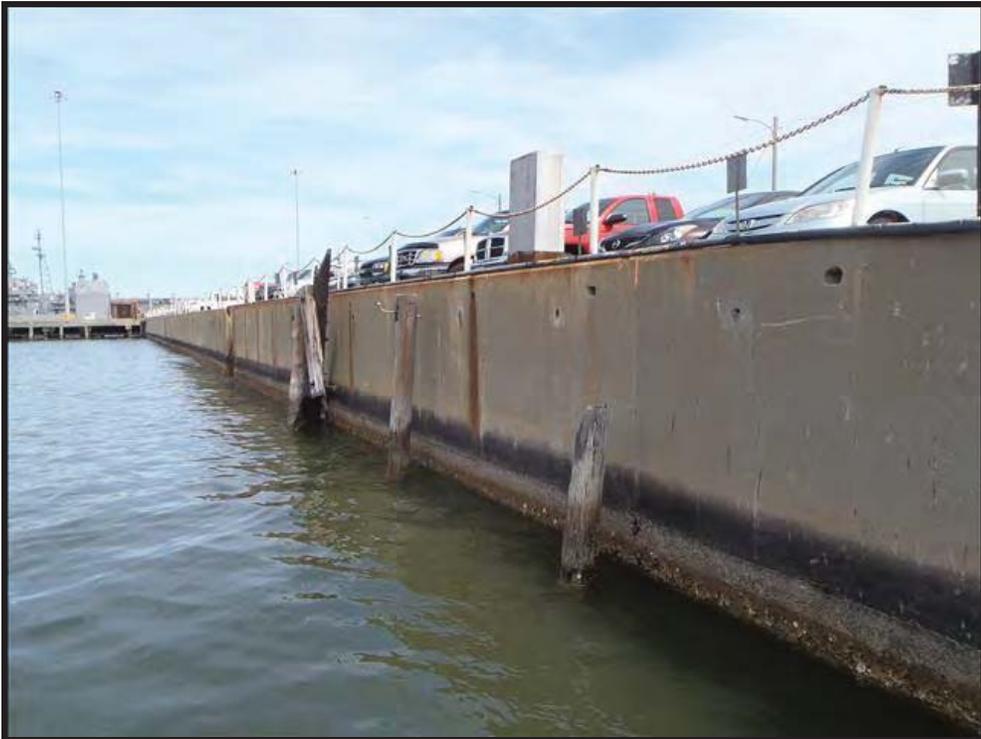
Photo 3.6-6: Overview of CEP175 Bulkhead from the water, Sta. 11+30, looking north.

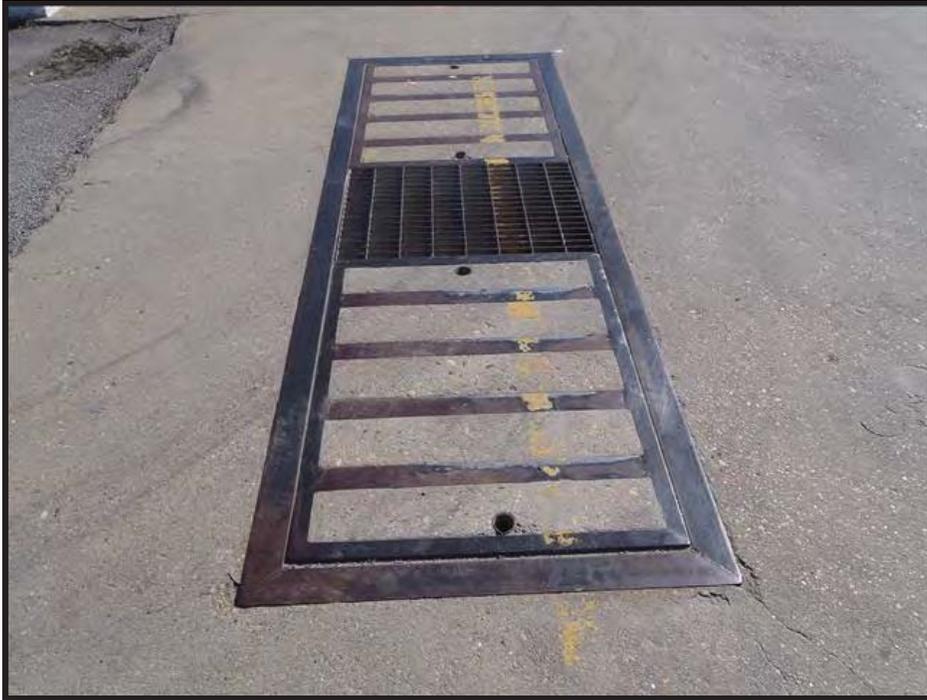
Photo 3.6-11: Typical view of the utility trench cover, Sta. 6+00.

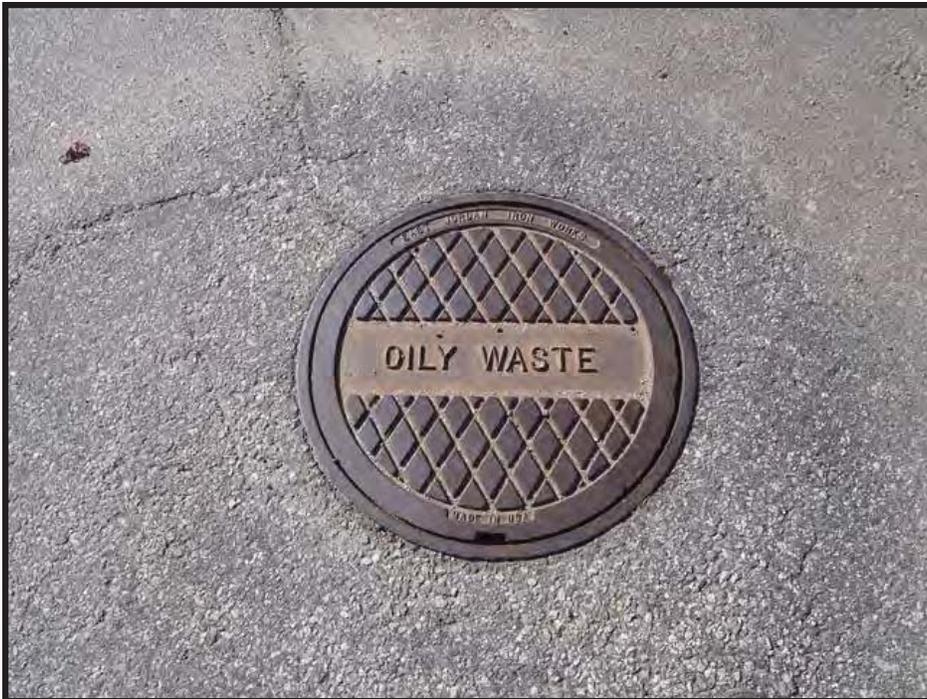
Photo 3.6-12: Typical view of a 24 in. diameter oily waste manhole cover, Sta. 5+89.

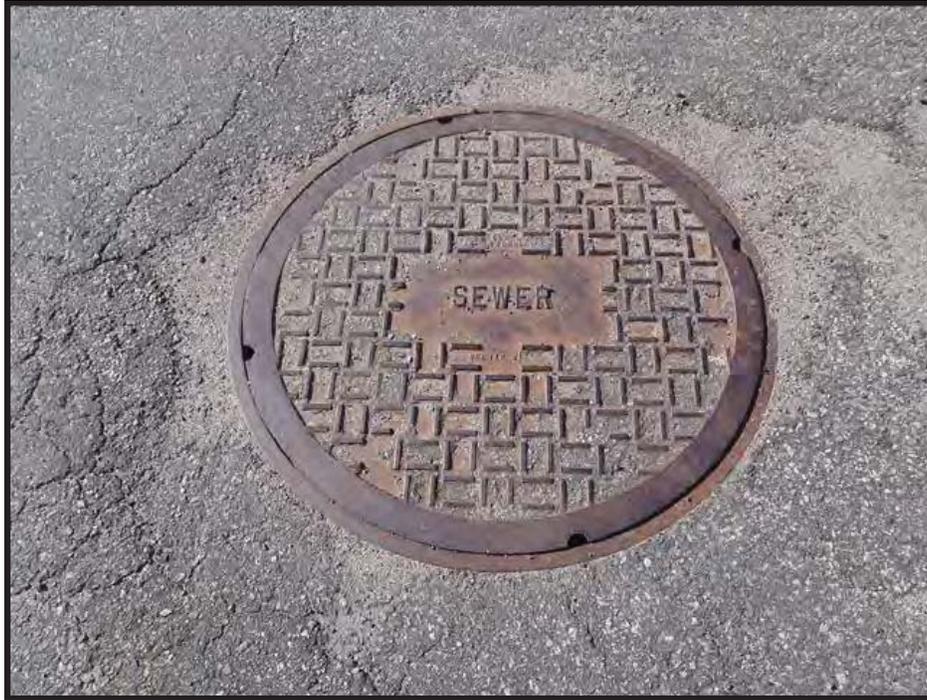
Photo 3.6-13: Typical view of the 39 in. diameter sanitary sewer manhole cover, Sta. 5+77.

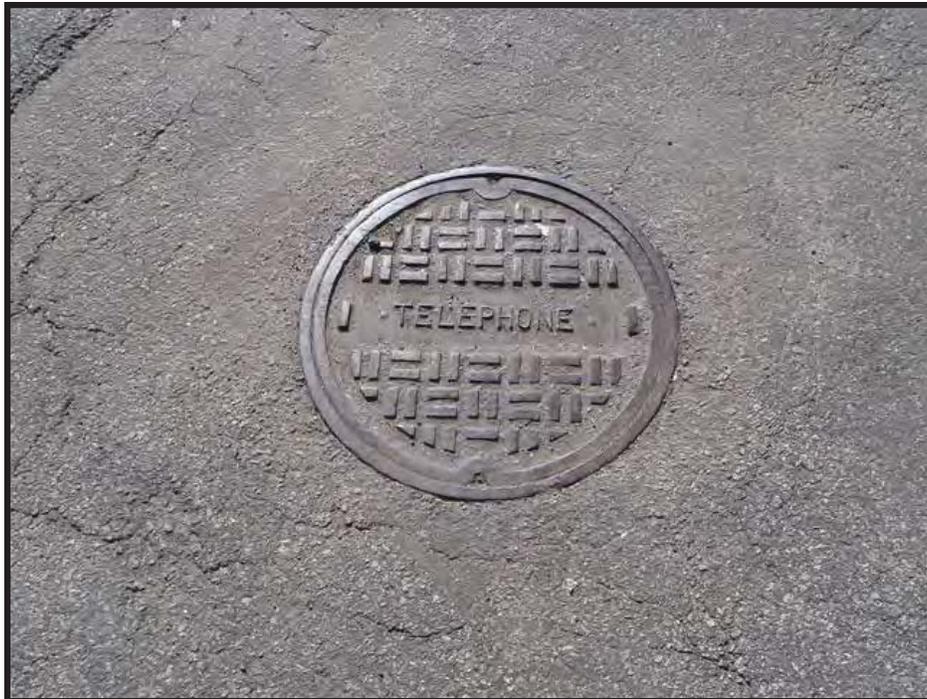
Photo 3.6-14: Typical view of a 24 in. diameter telephone manhole cover, Sta. 5+85.

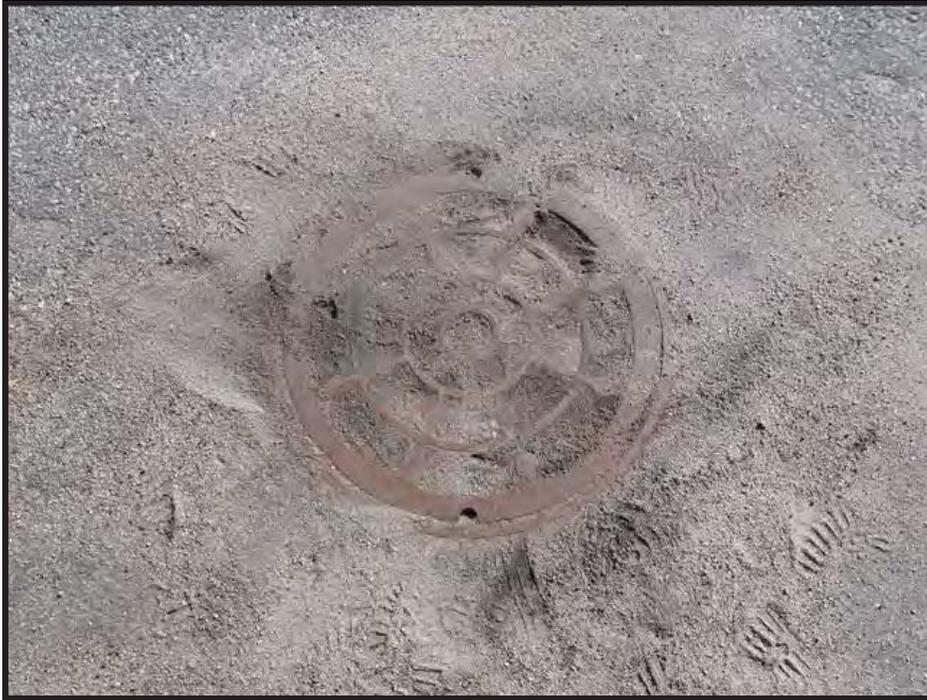
Photo 3.6-15: Typical view of the 24 in. unidentified manhole cover, Sta. 5+90.

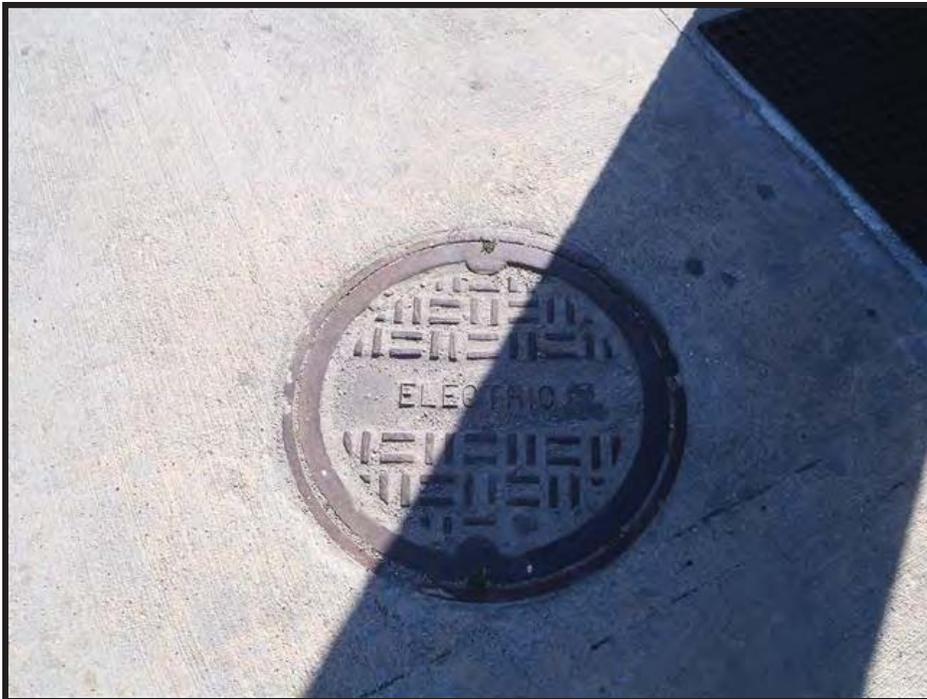
Photo 3.6-16: Typical view of the 24 in. electric manhole cover, Sta. 6+24.

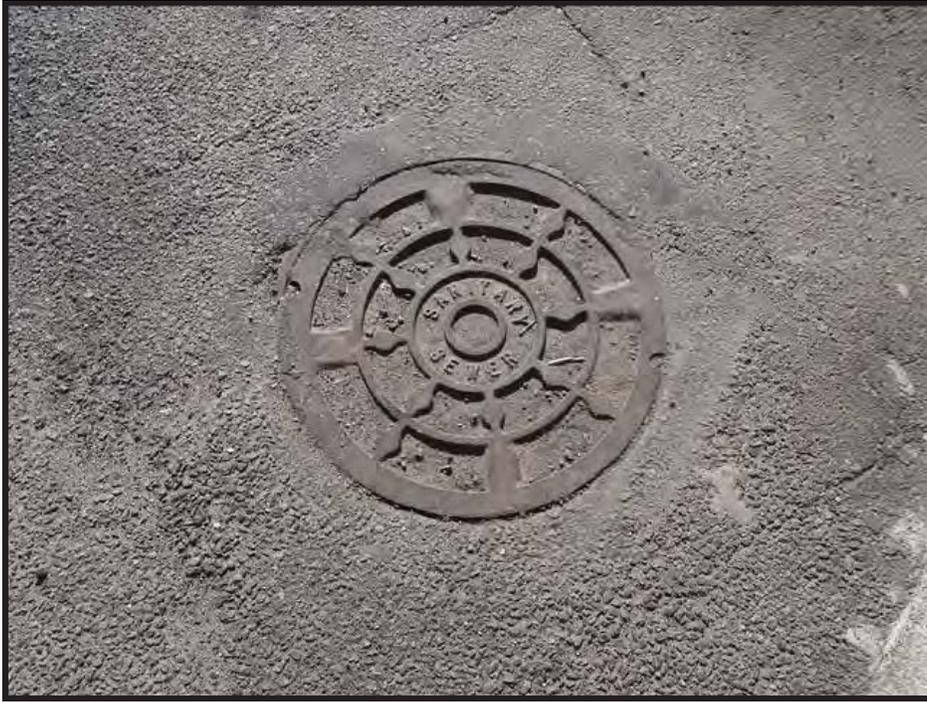
Photo 3.6-17: Typical view of the 24 in. sanitary sewer manhole cover, Sta. 6+34.

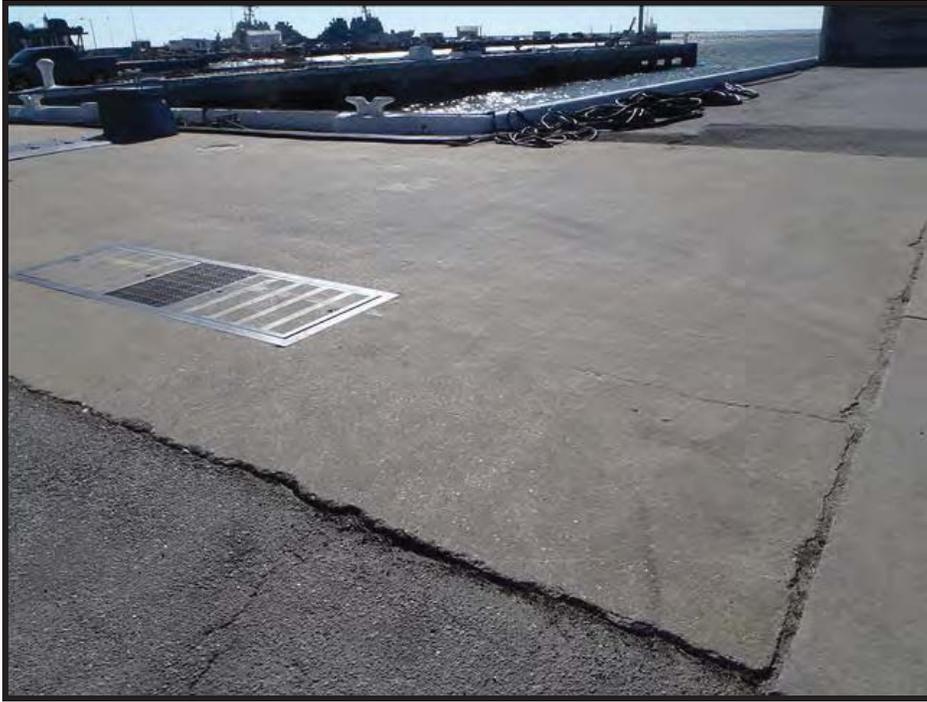
Photo 3.6-18: Typical view of reinforced concrete on-grade deck.

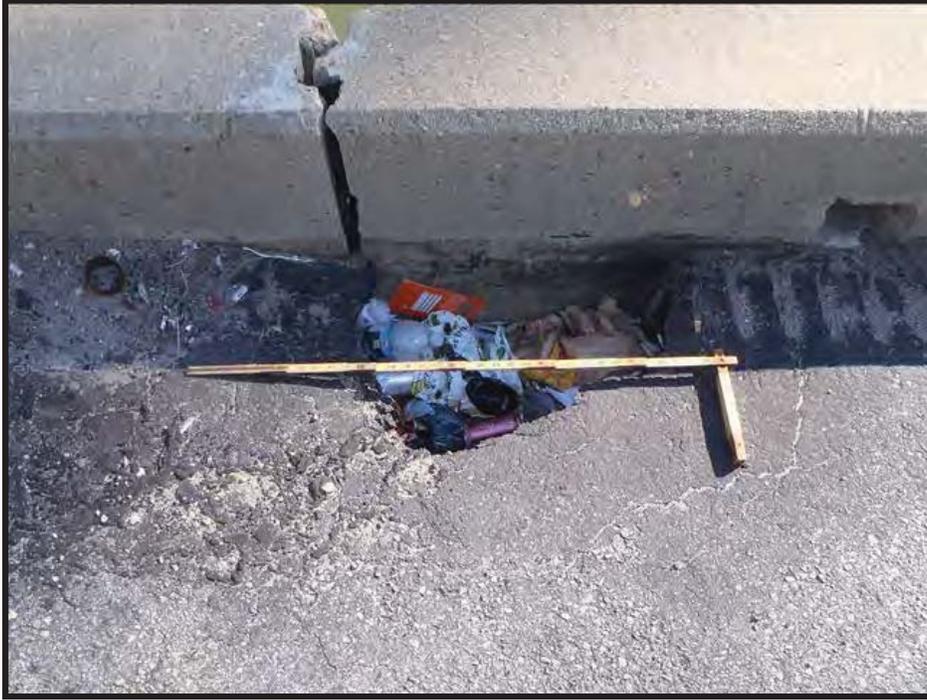
Photo 3.6-22: Typical view of 6 sq ft by 12 in. deep sinkhole, Sta. 7+45.

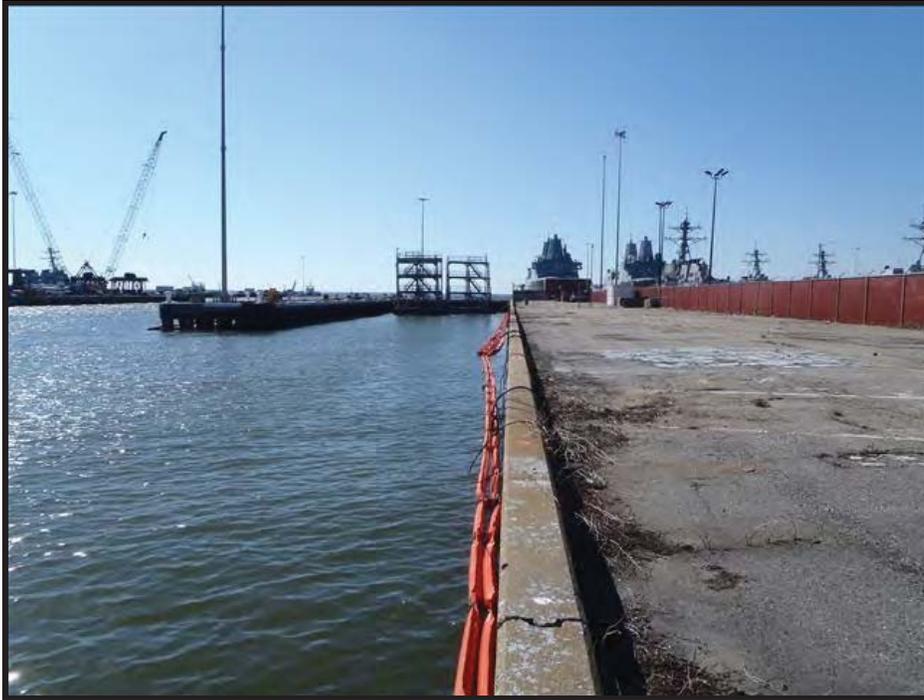
Photo 3.6-23: Typical view of the reinforced concrete curb.

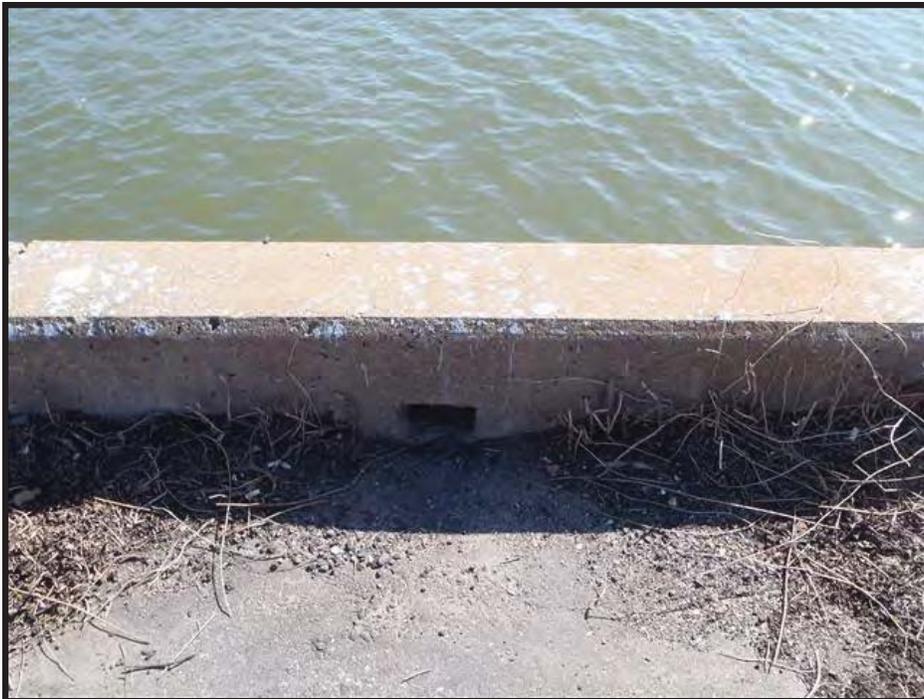
Photo 3.6-24: Typical view of scupper in curb.

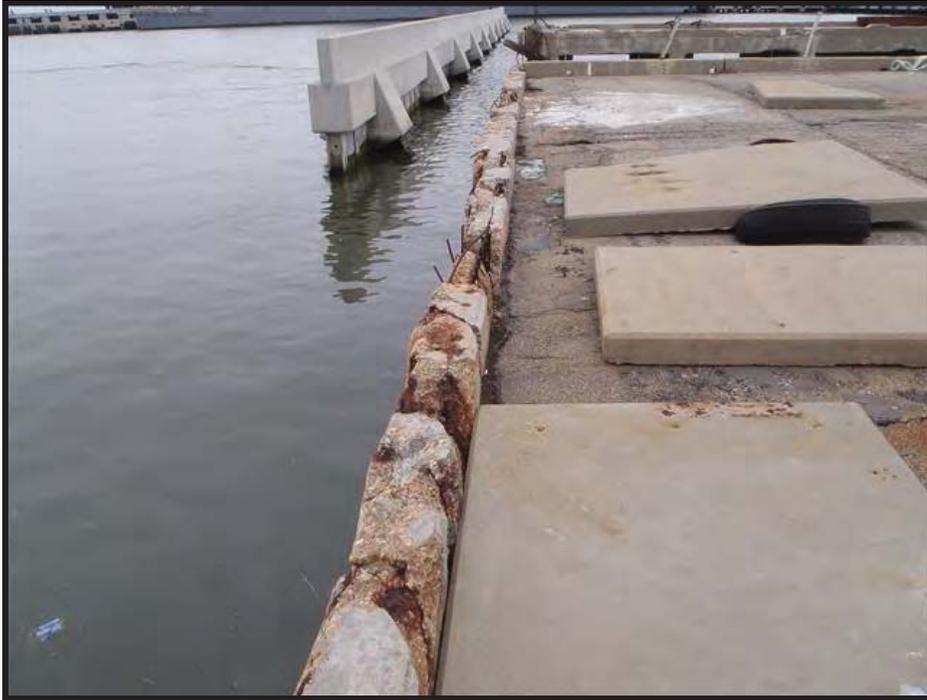
Photo 3.6-25: Overview of damage on the concrete curb, Sta. 16+90 to 17+43.

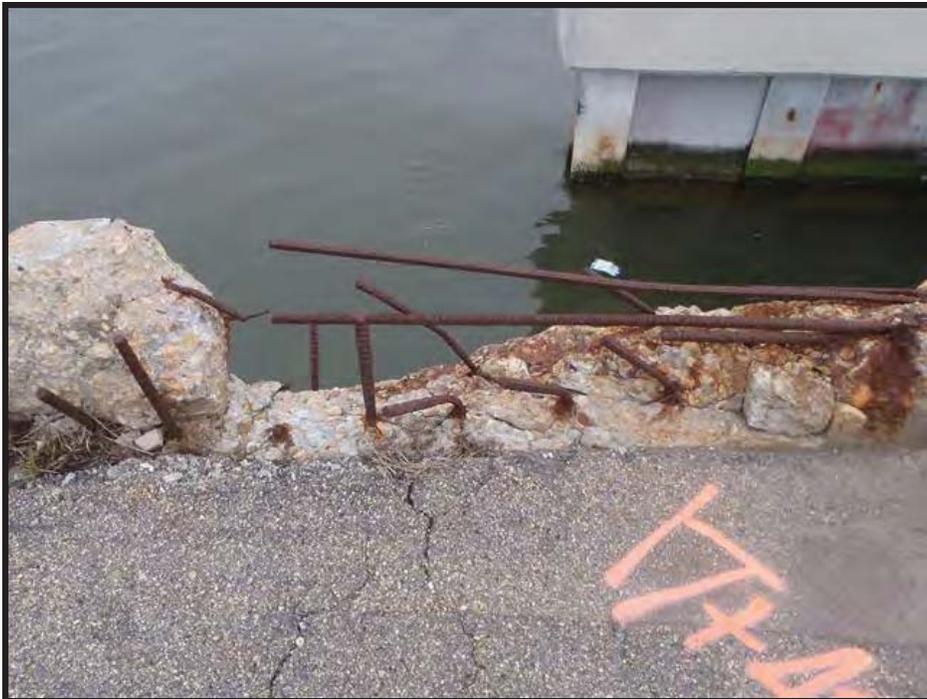
Photo 3.6-26: View of severe damage on the concrete curb, Sta. 17+40.

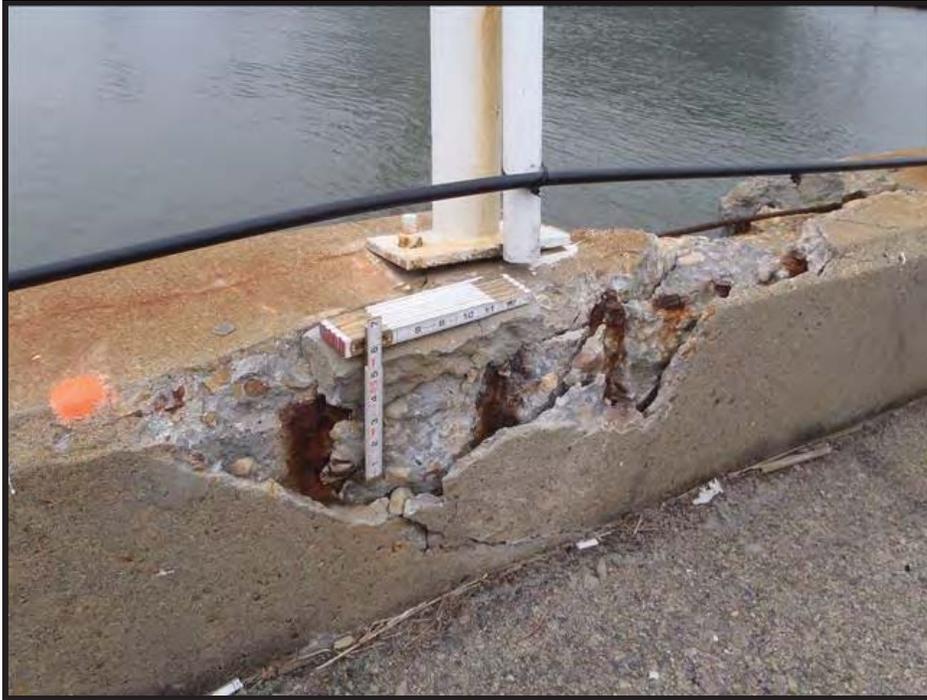
Photo 3.6-27: View of a spall at concrete curb, Sta. 13+27, 6 sq ft by 8 in. deep.

Recommendations	<p>It is recommended that the open corrosion, mechanical and closed corrosion spalls be repaired at 46 locations. It is also recommended that the nine horizontal cracks and four transverse cracks be repaired.</p>

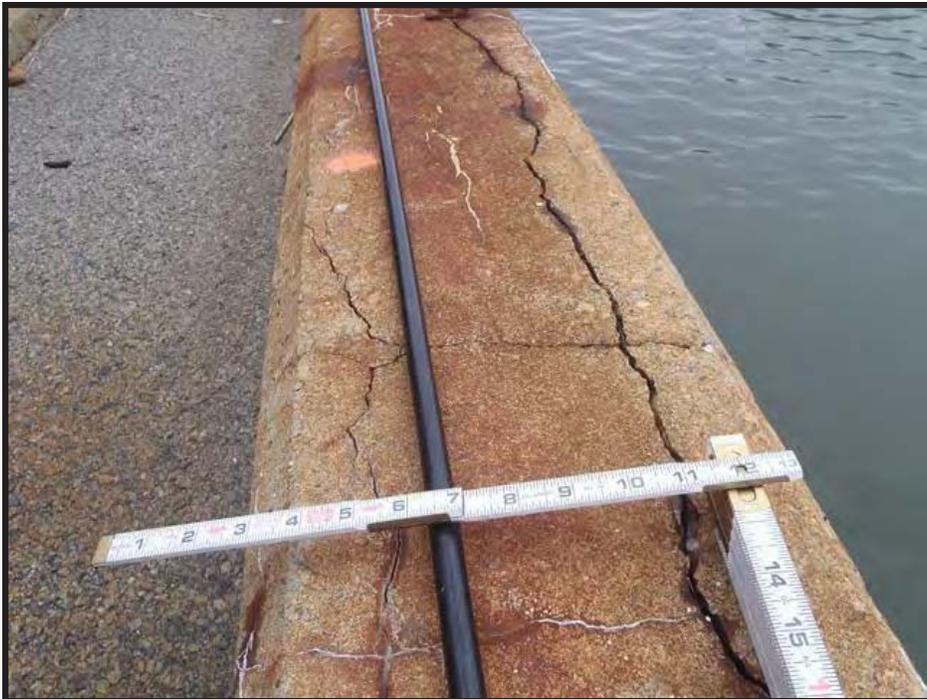
Photo 3.6-28: View of horizontal cracking in top of curb at Sta. 12+80.

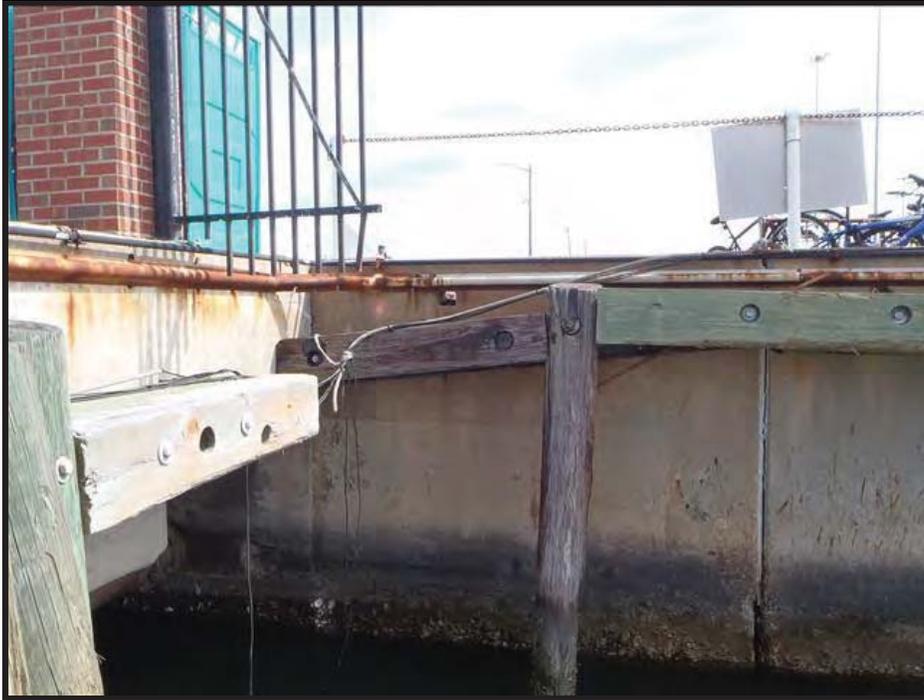
Photo 3.6-39: View of a detached timber fender chock and wale, Sta. 10+50.

Recommendations	It is recommended that the fender system be replaced.

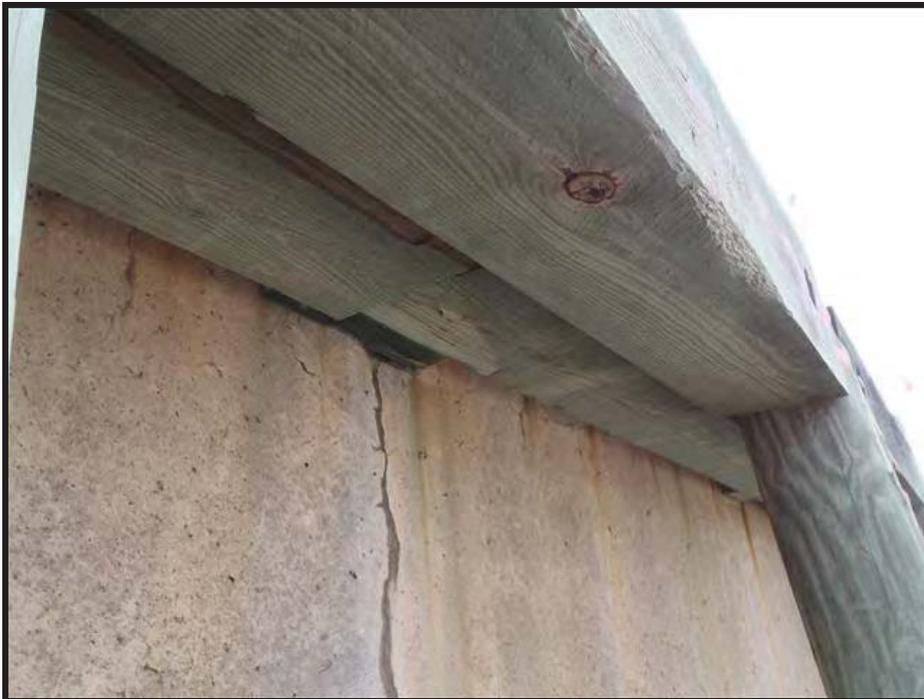
Photo 3.6-40: Typical view of a 12 in. by 12 in. treated timber fender wale.

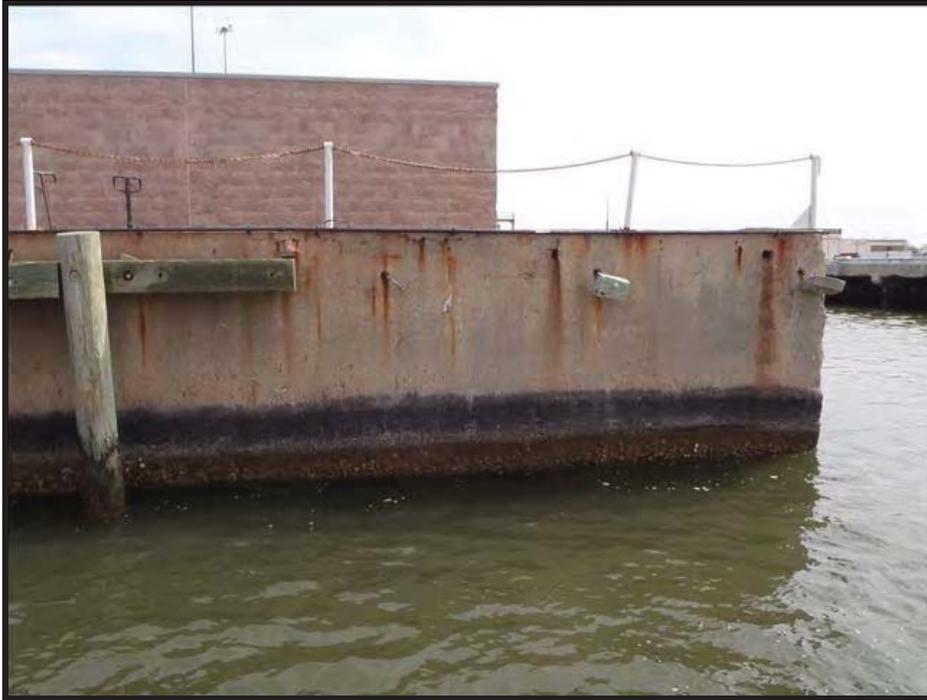
Photo 3.6-41: View of missing timber fender chocks and wales, Sta. 9+15.

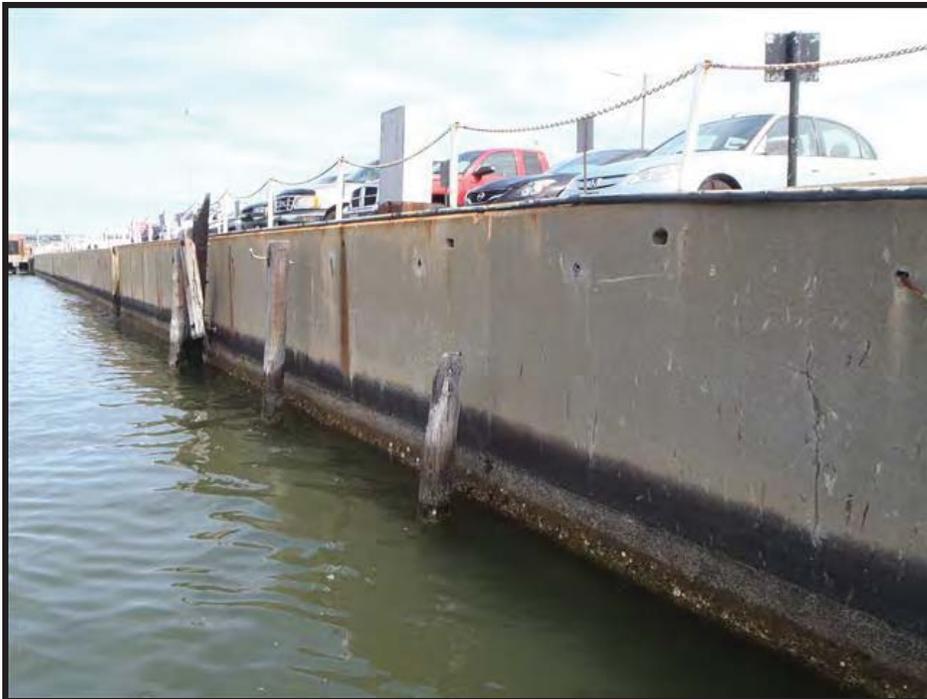
Photo 3.6-42: View of missing timber fender chocks and wales, Sta. 11+25 to Sta. 15+20.

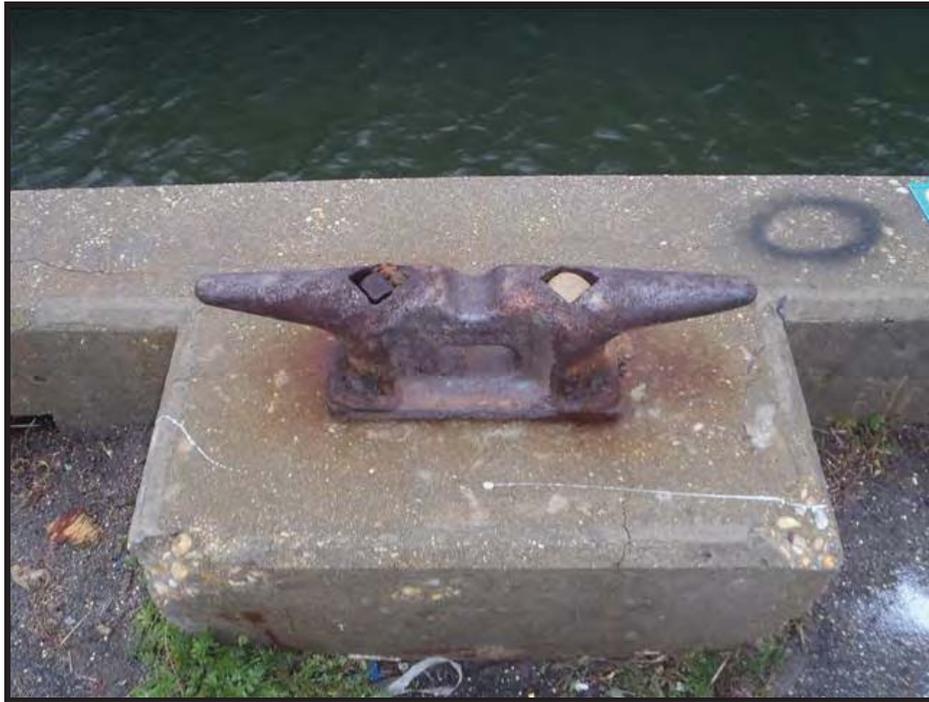
UFII Component	H10400503	Cleats Asset Type(s): MF
Findings	<p>The cleats are in Poor Condition. Berthing at the bulkhead and platform is supported by 11 cleats. The cleats are 24 in. long, painted steel fittings with a design capacity of 7 tons. The cleats are located along the north side of the bulkhead from Sta. 19+65 to Sta. 24+67. The cleats generally have moderate to heavy corrosion and isolated areas of heavy rust scale up to 1/4 in. thick. In the areas of heavier corrosion, minor loss of section of the fitting is evident. Four cleats are loose due to deteriorated or loose hardware.</p> <p>The rated conditions of each mooring fitting in accordance with UFC 4-150-8, Inspection of Mooring Hardware, are also presented within a table at the end of this report section. Please note that "Design Capacity" indicates the estimated original intended nominal allowable capacity of the fitting and the "Rating Capacity" indicates the estimated current nominal allowable capacity of the fitting based only on visual observations.</p>

Photo 3.6-43: View of a 24 in. long painted steel cleat.

Recommendations	<p>It is recommended that the cleats be replaced with new, rated fittings selected and installed to meet operational requirements.</p>
