**CONTRACTOR REPORT
CR-NAVFAC EXWC-CIOFP-DRAFT
Volume II of III - Bulkheads**

**WATERFRONT FACILITIES
INSPECTIONS AND ASSESSMENTS AT
NORFOLK NAVAL STATION
NORFOLK, VIRGINIA**

On Site: Jan-29-2013

Norfolk Naval Station Norfolk, Virginia

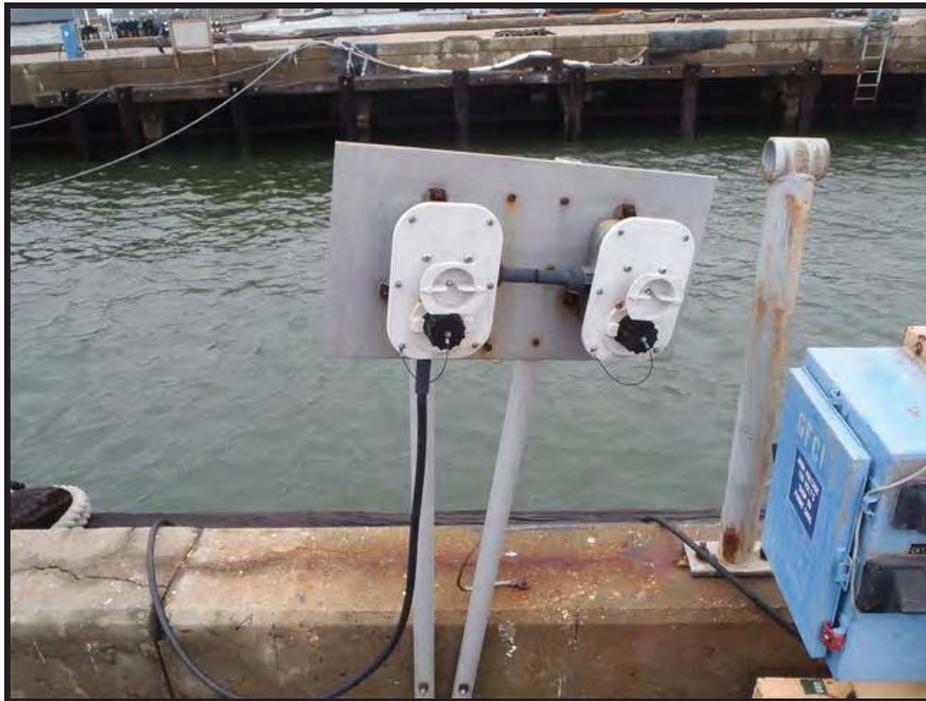
Photo 3.6-44: Typical view of the electrical receptacles at Sta. 21+48.

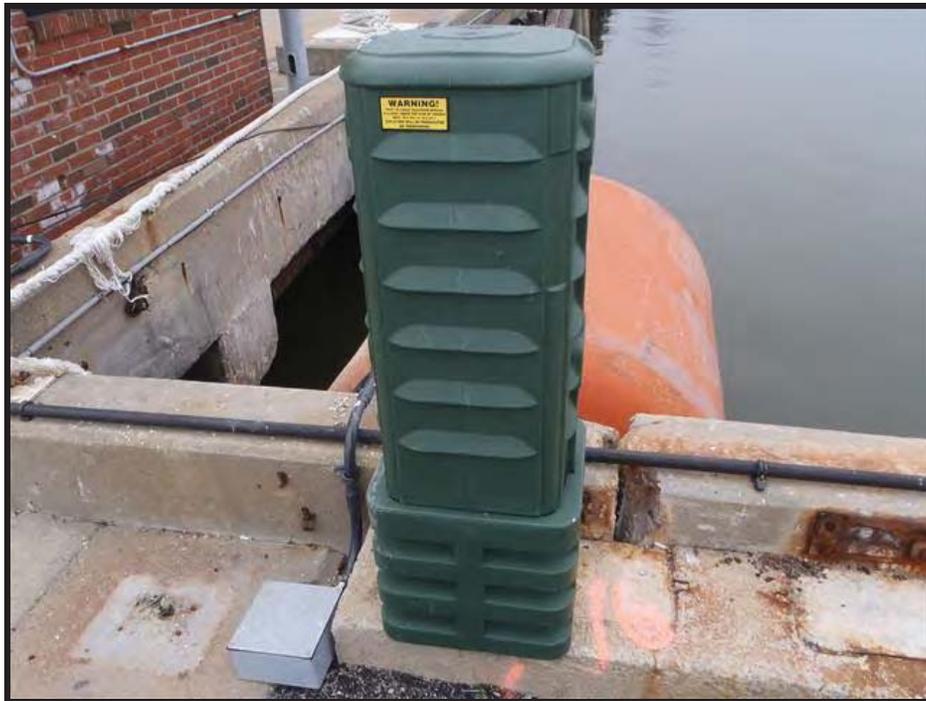
Photo 3.6-45: Typical view of the cable television panel at Sta. 15+99.

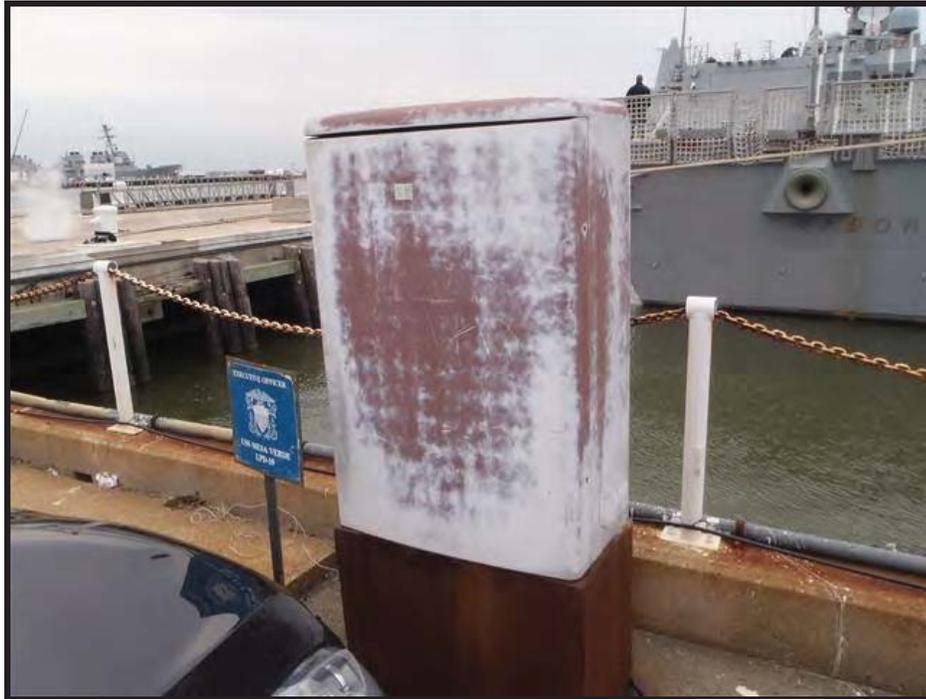
UFII Component	H50200105	Other Electrical Power Distribution Components Asset Type(s): PNL
Findings	The electrical enclosure is in Fair Condition. There is one electrical enclosure at the bulkhead. The electrical enclosure is a painted steel enclosure that is 70 in tall, 32 in. long and 16 in wide located at the edge of the bulkhead at Sta. 11+60. The enclosure has widespread paint loss and moderate surface corrosion at the base of the enclosure.	
Recommendations	It is recommended that the electrical enclosure be cleaned and painted.

Photo 3.6-46: General view of the electrical enclosure at Sta. 11+60 with widespread paint loss and moderate corrosion.

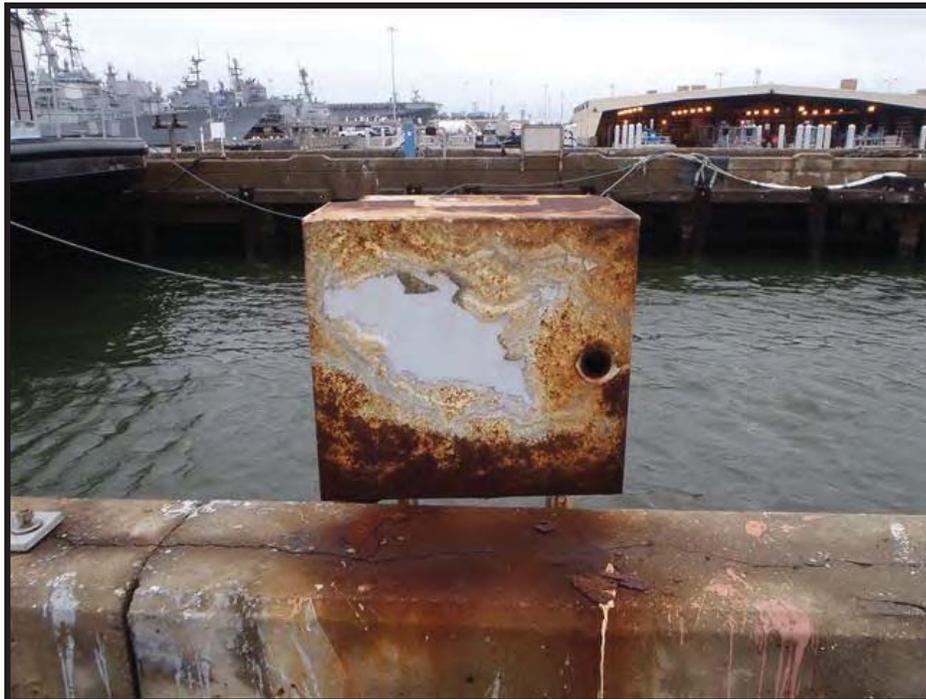
UFII Component	H502002	Telecommunications Asset Type(s): COM
Findings	The communication enclosure is in Poor Condition. There is one communication enclosure at the bulkhead. The communication enclosure is a painted steel enclosure that is 14 in. tall, 16 in. long and 12 in. wide. The enclosure is mounted to the outboard face of the curb at Sta. 21+22 with two steel vertical supports. The enclosure has widespread paint loss and corrosion with visible section loss. At isolated locations the section loss is up to 100 percent.	
Recommendations	It is recommended that the communication enclosure be replaced.

Photo 3.6-47: General view of the communications enclosure at Sta. 21+22 with wide spread paint loss and corrosion.

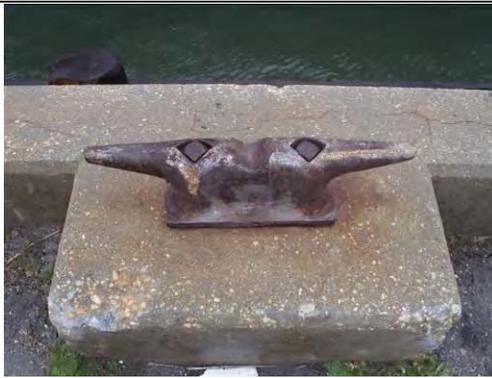
<p>Asset Type: MF</p> <p>Fitting ID: C2</p> <p>Type: 24 in. Cleat</p> <p>Design Capacity: 7 tons</p> <p>Rating Capacity: Reduced tons</p>	<p>Condition:</p> <p>Fitting: 3</p> <p>Base: 2</p> <p>Connection: 3</p>

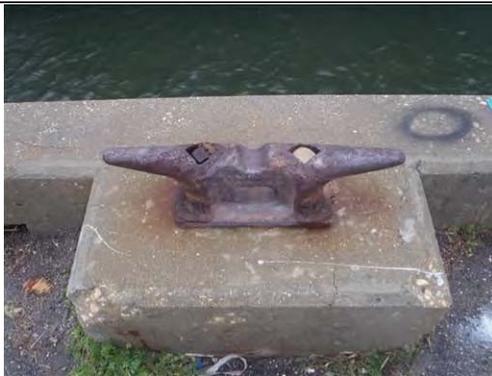
<p>Asset Type: MF</p> <p>Fitting ID: C3</p> <p>Type: 24 in. Cleat</p> <p>Design Capacity: 7 tons</p> <p>Rating Capacity: Reduced tons</p>	<p>Condition:</p> <p>Fitting: 3</p> <p>Base: 2</p> <p>Connection: 3</p>

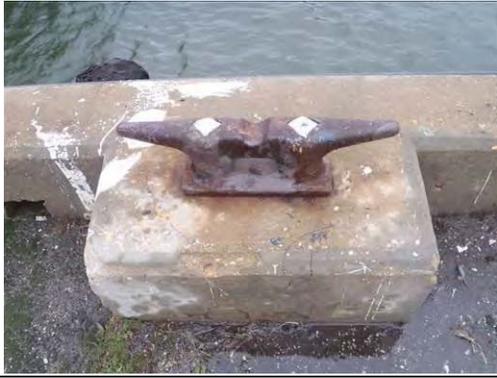
<p>Asset Type: MF</p> <p>Fitting ID: C4</p> <p>Type: 24 in. Cleat</p> <p>Design Capacity: 7 tons</p> <p>Rating Capacity: Reduced tons</p>	<p>Condition:</p> <p>Fitting: 3</p> <p>Base: 2</p> <p>Connection: 3</p>

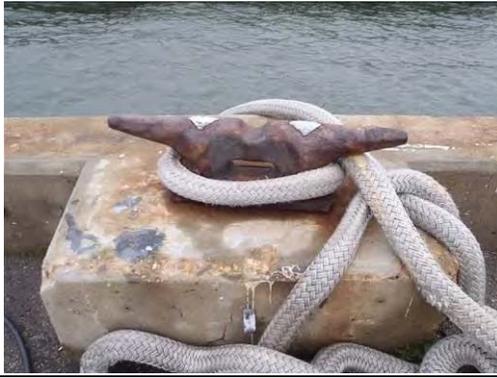
<p>Asset Type: MF</p> <p>Fitting ID: C5</p> <p>Type: 24 in. Cleat</p> <p>Design Capacity: 7 tons</p> <p>Rating Capacity: Reduced tons</p>	<p>Condition:</p> <p>Fitting: 3</p> <p>Base: 2</p> <p>Connection: 2</p>

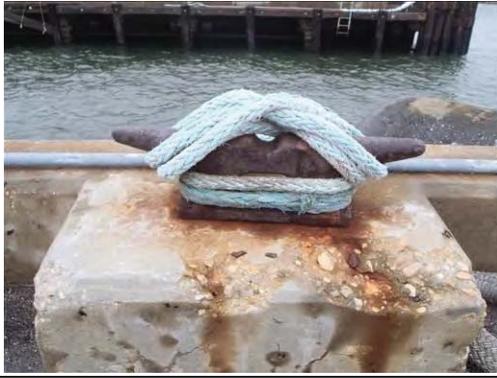
<p>Asset Type: MF</p> <p>Fitting ID: C6</p> <p>Type: 24 in. Cleat</p> <p>Design Capacity: 7 tons</p> <p>Rating Capacity: Reduced tons</p>	<p>Condition:</p> <p>Fitting: 3</p> <p>Base: 2</p> <p>Connection: 3</p>

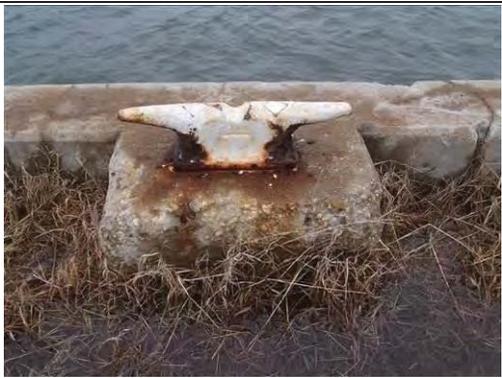
<p>Asset Type: MF</p> <p>Fitting ID: C10</p> <p>Type: 24 in. Cleat</p> <p>Design Capacity: 7 tons</p> <p>Rating Capacity: Reduced tons</p>	<p>Condition:</p> <p>Fitting: 3</p> <p>Base: 2</p> <p>Connection: 2</p>

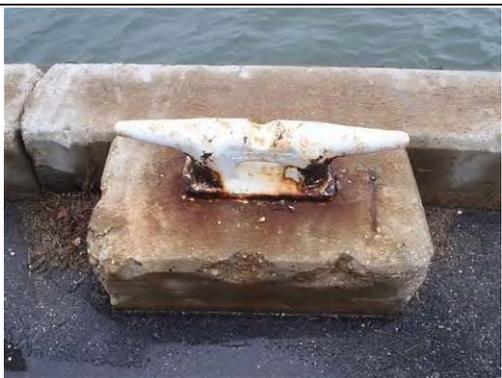
<p>Asset Type: MF</p> <p>Fitting ID: C11</p> <p>Type: 24 in. Cleat</p> <p>Design Capacity: 7 tons</p> <p>Rating Capacity: Reduced tons</p>	<p>Condition:</p> <p>Fitting: 3</p> <p>Base: 2</p> <p>Connection: 2</p>

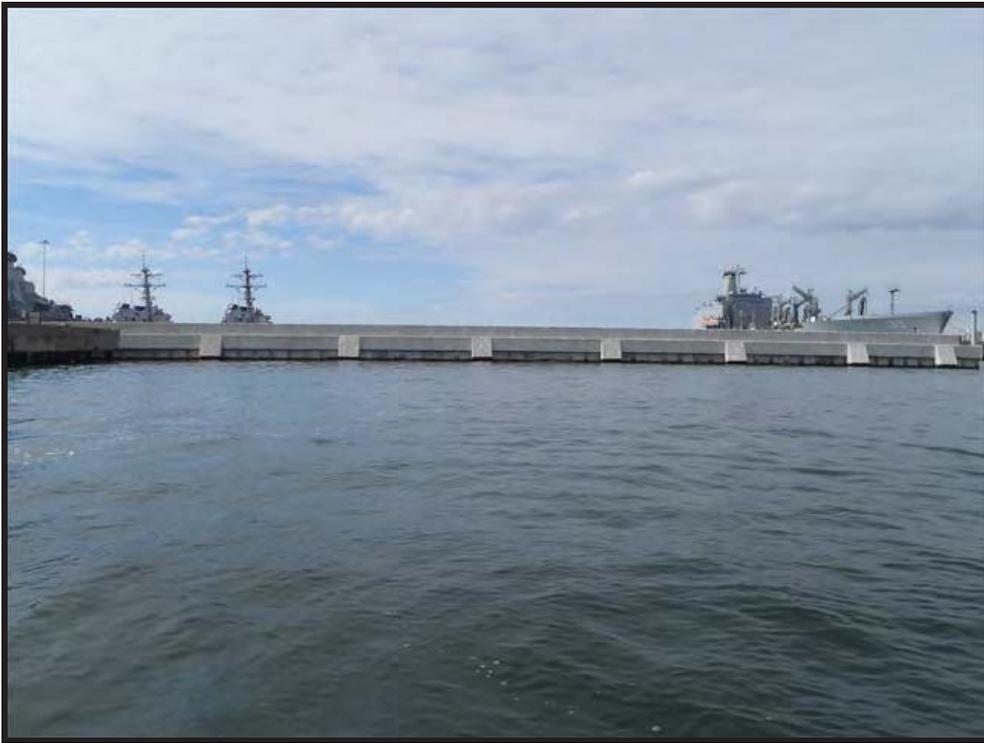
Photo 3.7-2: Overview of CEP169A 5T Breakwater, looking west.

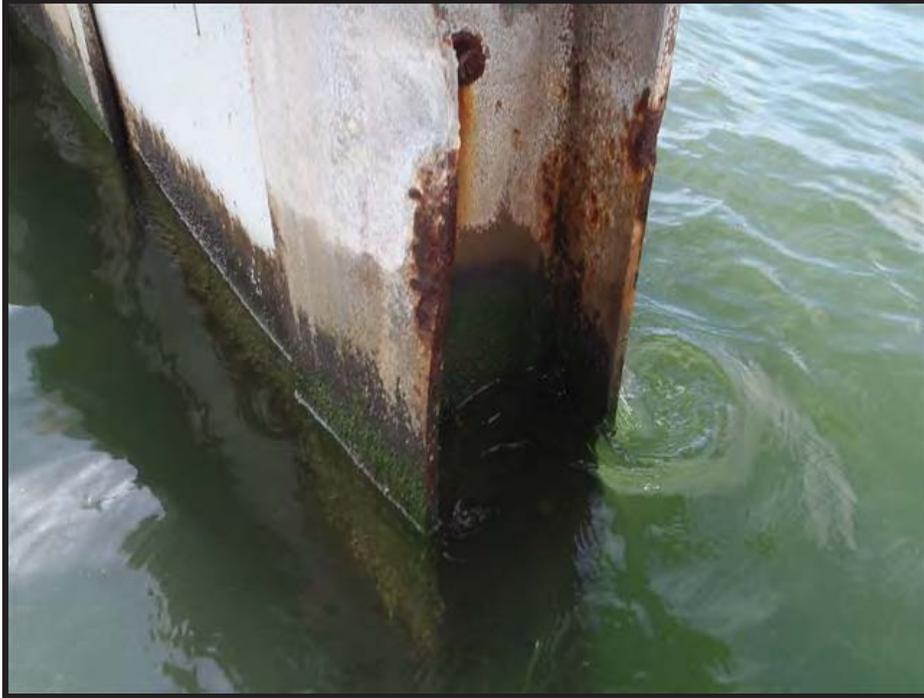
Photo 3.7-5: View of the impacted steel H-pile at the north end of the breakwater.

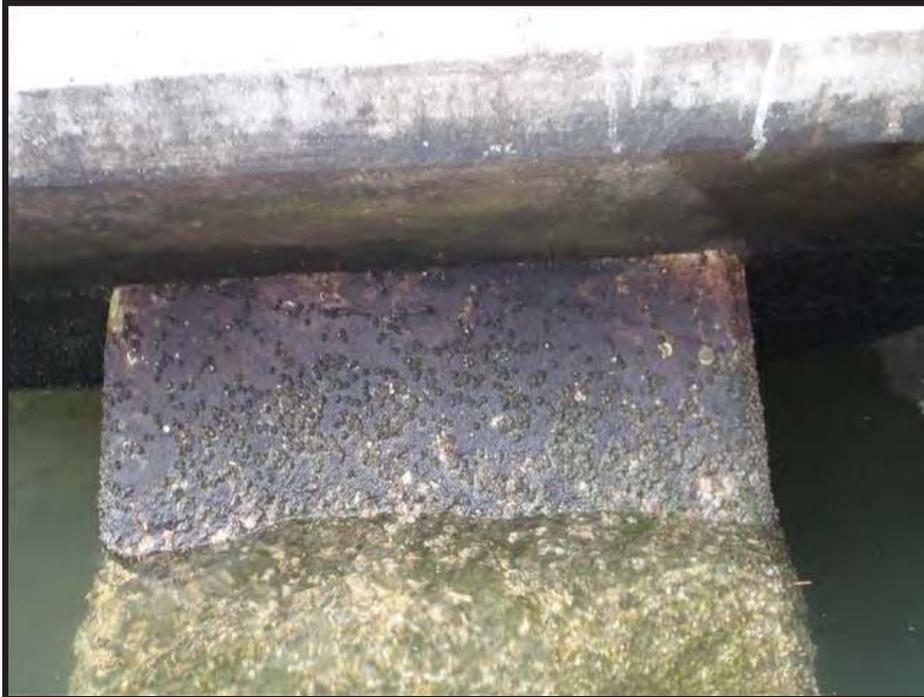
Photo 3.7-6: View of a concrete battered pile.

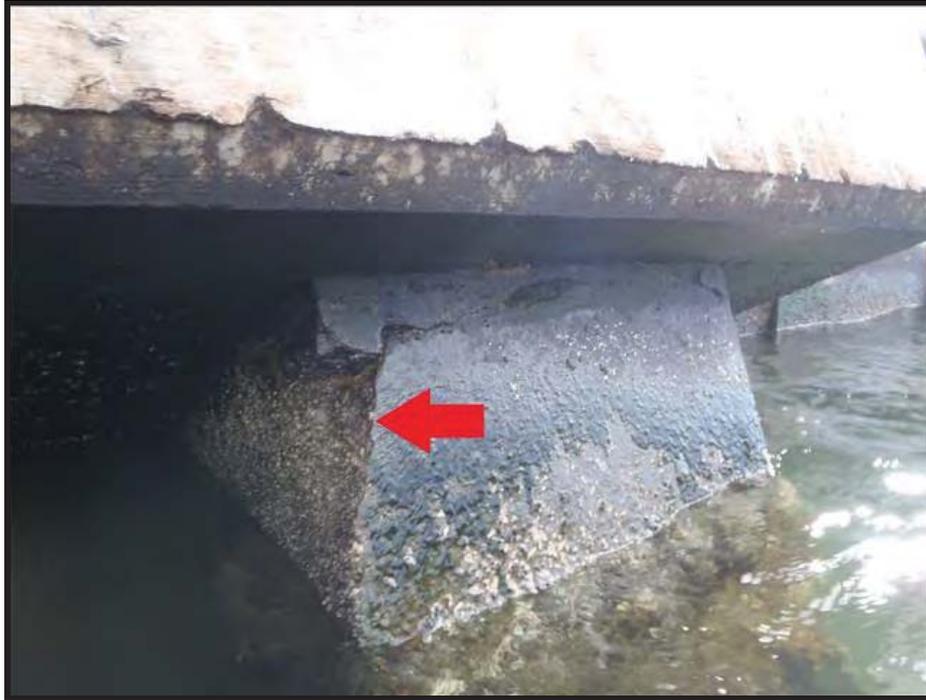
Photo 3.7-7: View of an open mechanical spall at the top of a concrete battered pile.

It is recommended that three open spalls and six cracks on the concrete battered piles be repaired. One open mechanical spall and one diagonal crack on the north end of the longitudinal pile cap should also be repaired.

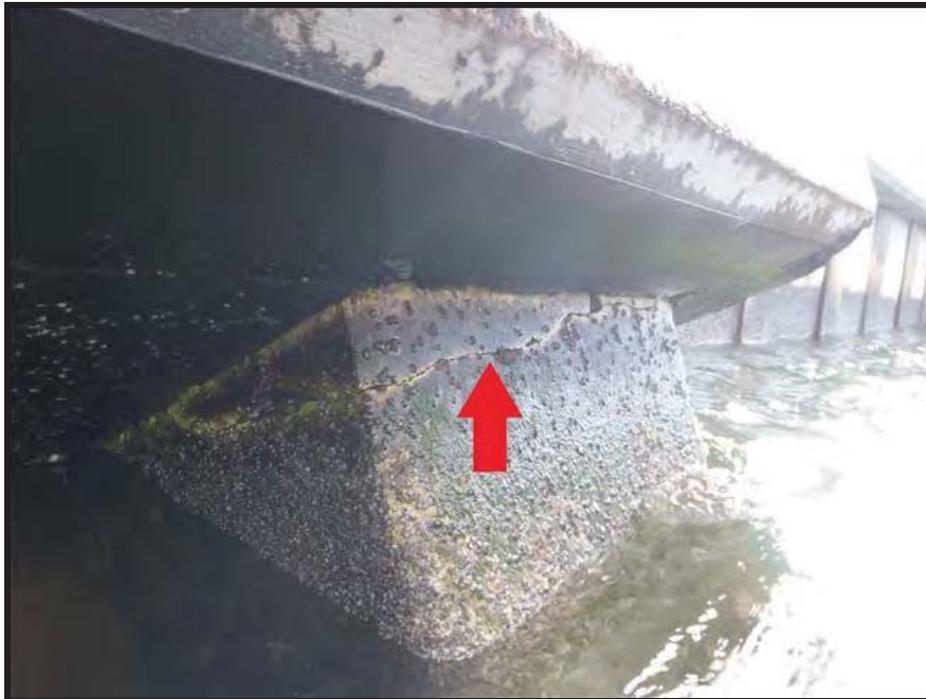
Photo 3.7-8: View of a horizontal crack at the top of a concrete battered pile.

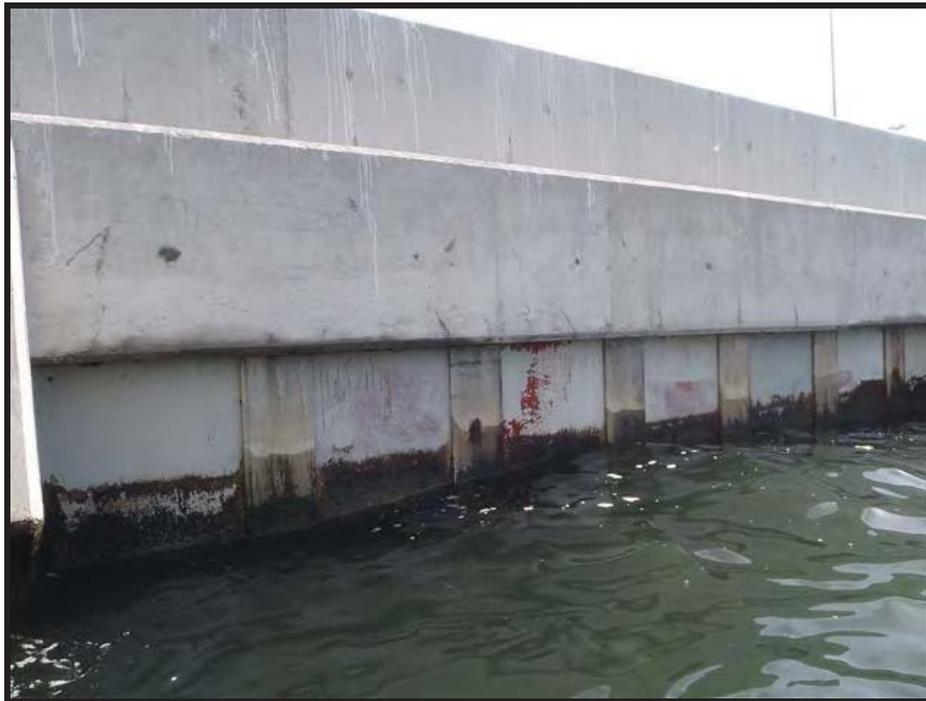
Photo 3.7-9: View of reinforced concrete sheet piles.

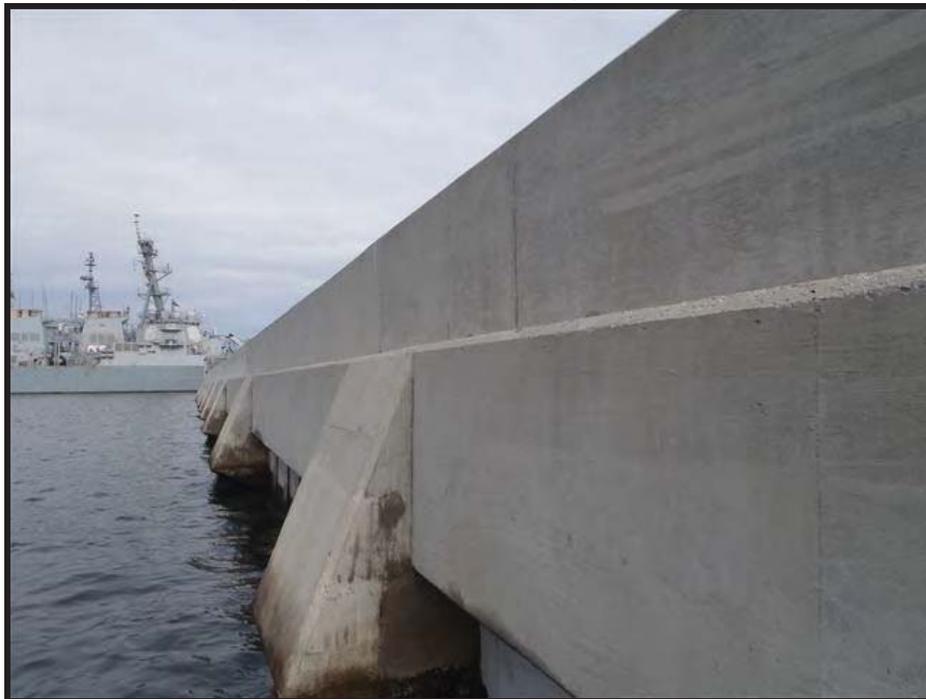
Photo 3.7-12: Overview of the longitudinal concrete pile cap.

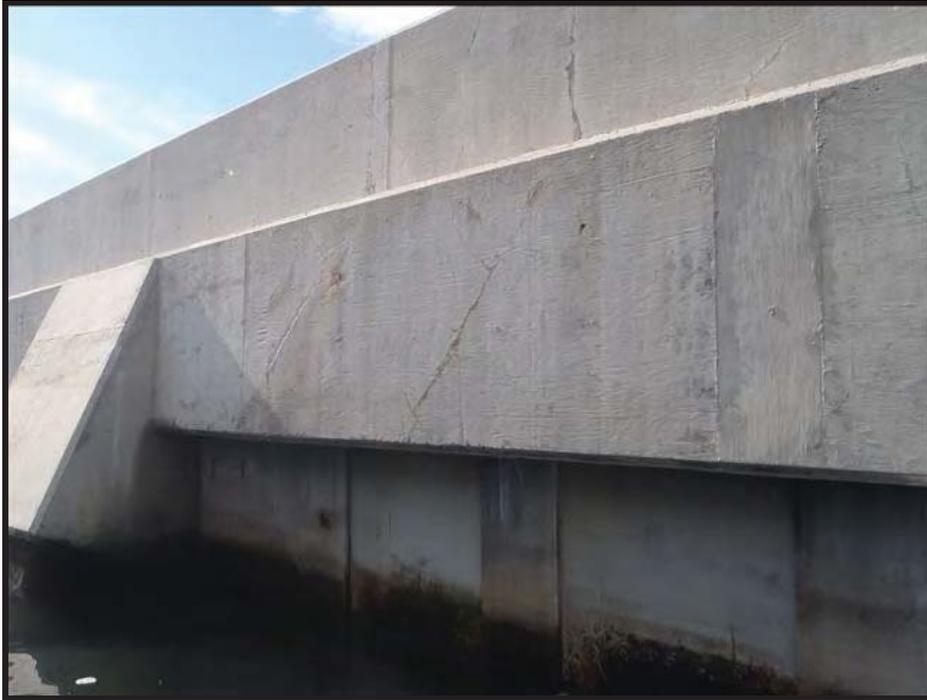
Photo 3.7-13: Typical condition of the longitudinal concrete pile cap.

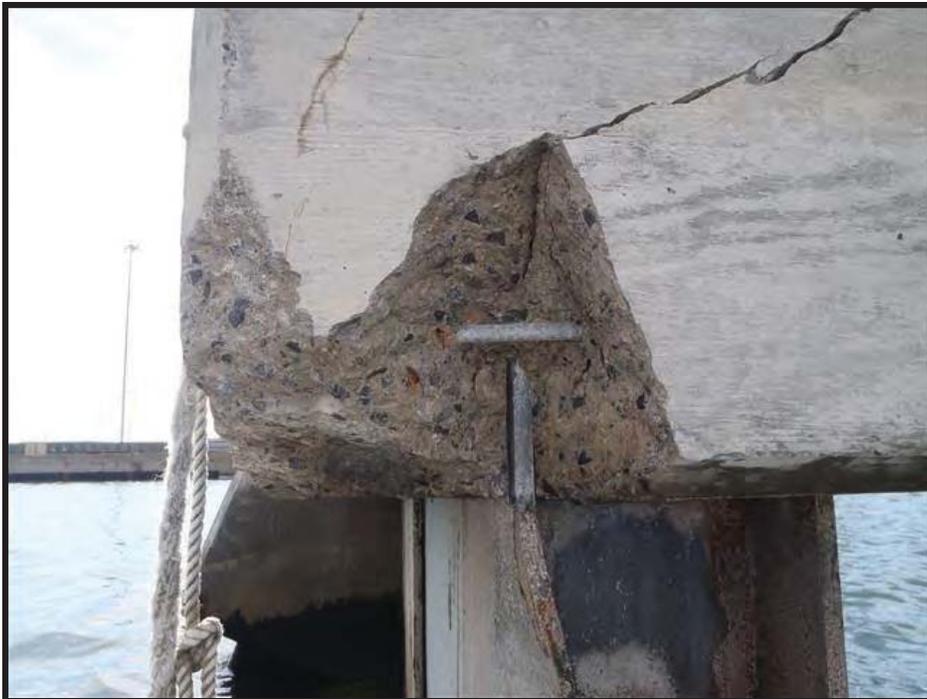
Photo 3.7-14: View of an open mechanical spall on the north end of the longitudinal pile cap.

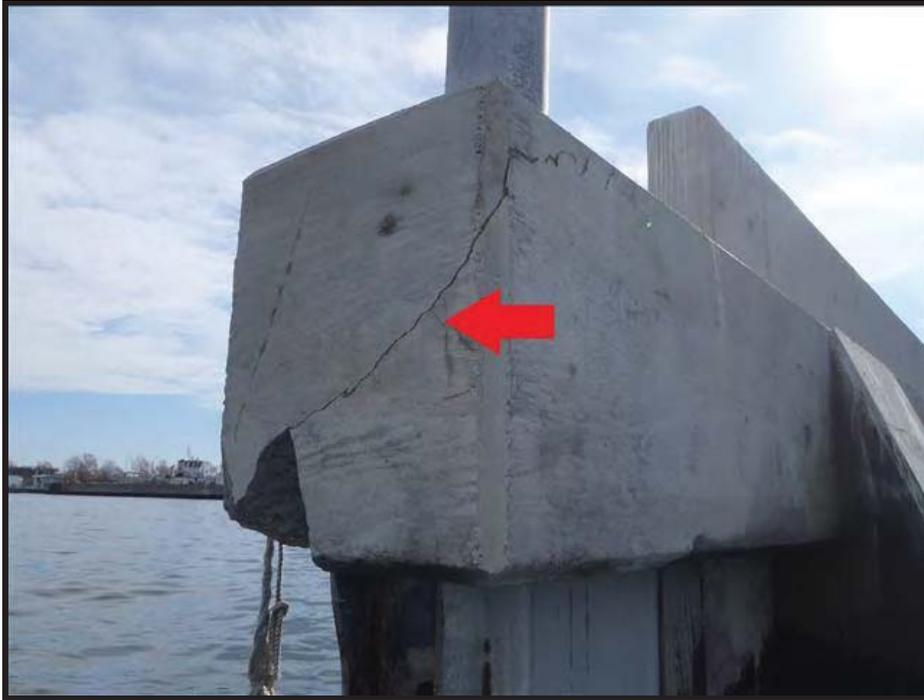
Photo 3.7-15: View of a 3/8 in. wide diagonal crack on the north end of the longitudinal pile cap.

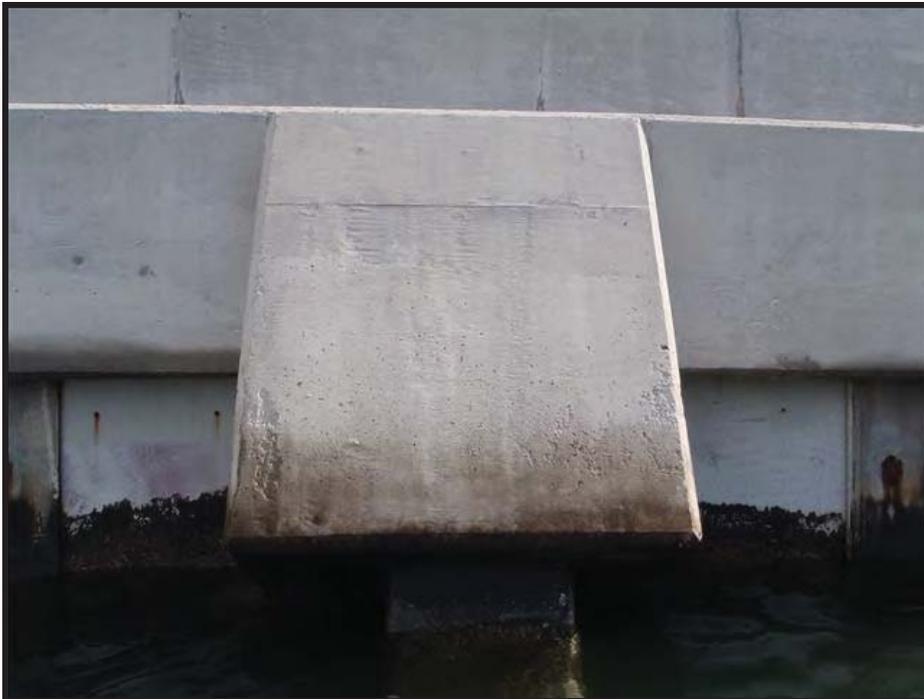
Photo 3.7-16: View of a pile cap located above a battered pile.

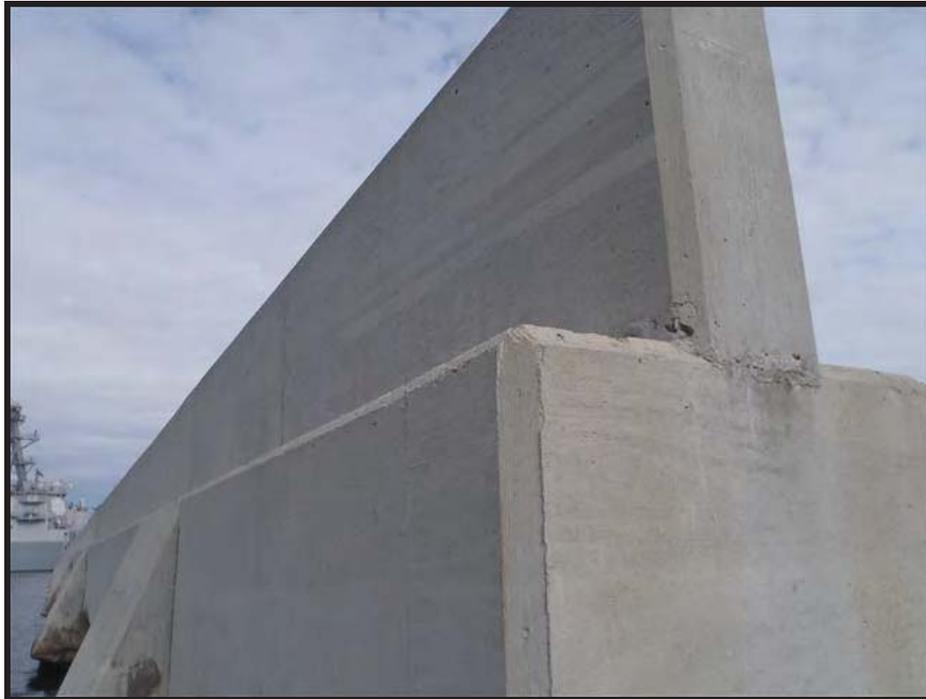
Photo 3.7-17: View of the longitudinal wave screen wall.

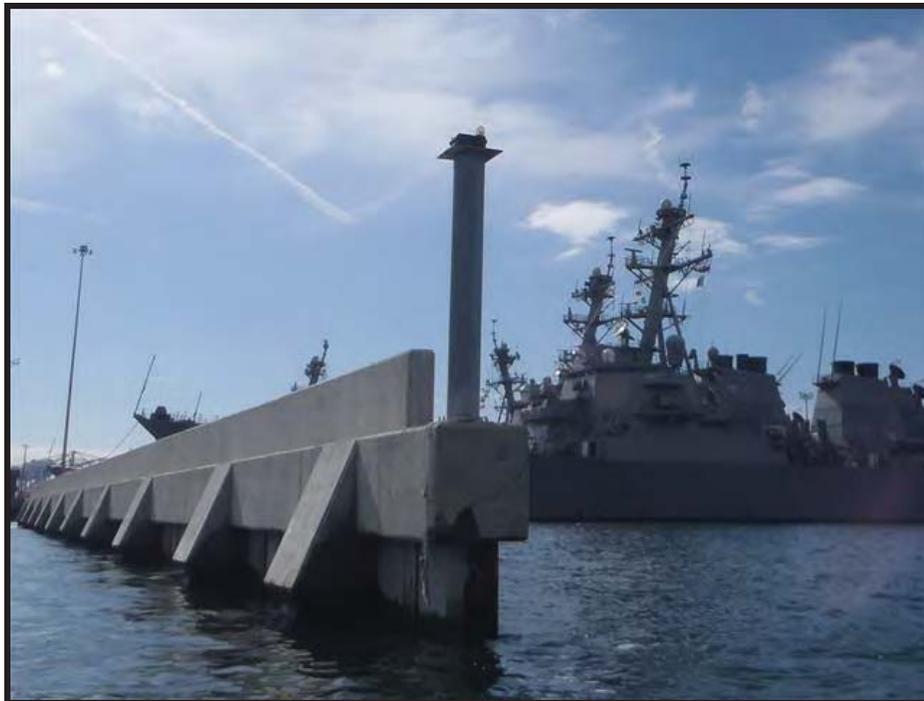
UFII Component	H502003	Lighting Asset Type(s): LGT
Findings	The lighting is in Good Condition. There is one navigation light located on the north end of the breakwater. The galvanized steel light pole is 12 in. diameter and is secured to the topside of the sheet pile cap with 3/4 in. diameter anchor bolts. No defects are noted on the navigation light.	
Recommendations	No repairs are recommended at this time.

Photo 3.7-19: View of the navigation light.

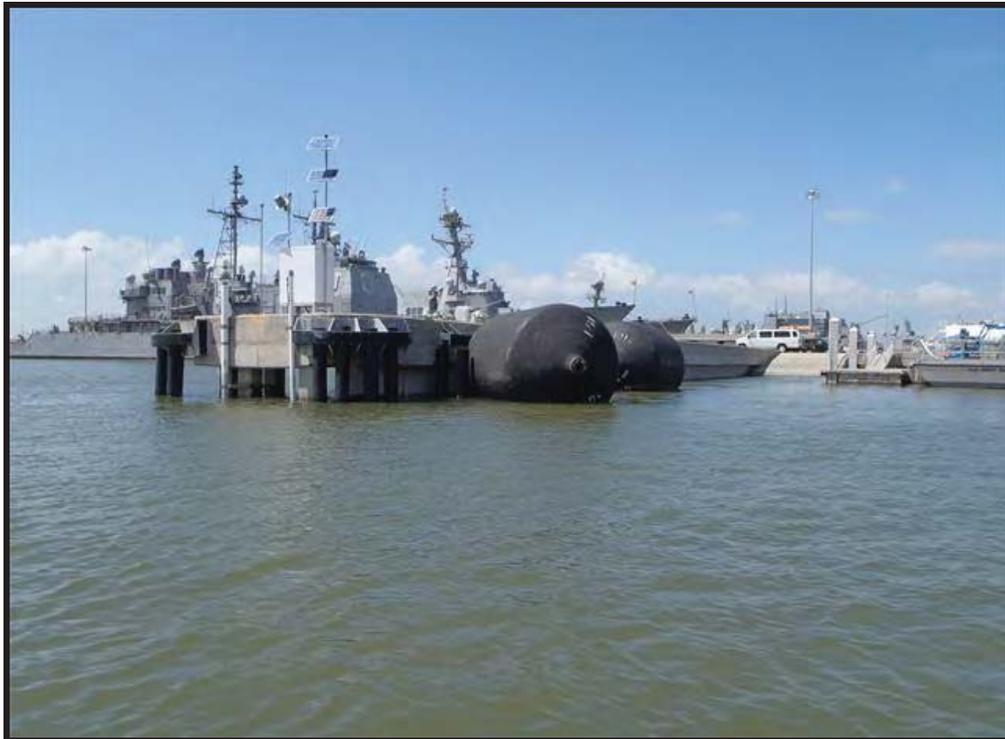
Photo 3.11-2: Overview of CEP169 Breakwater from basin, looking northwest.

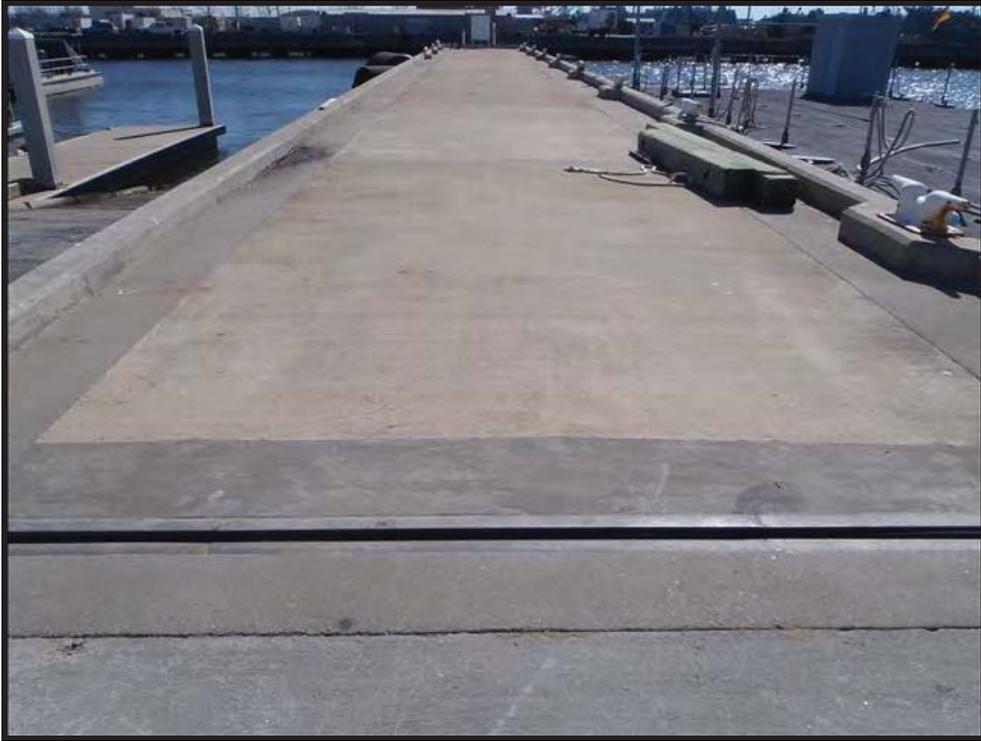
Photo 3.11-3: Overview of CEP169 Breakwater near Sta. 0+00, looking south.

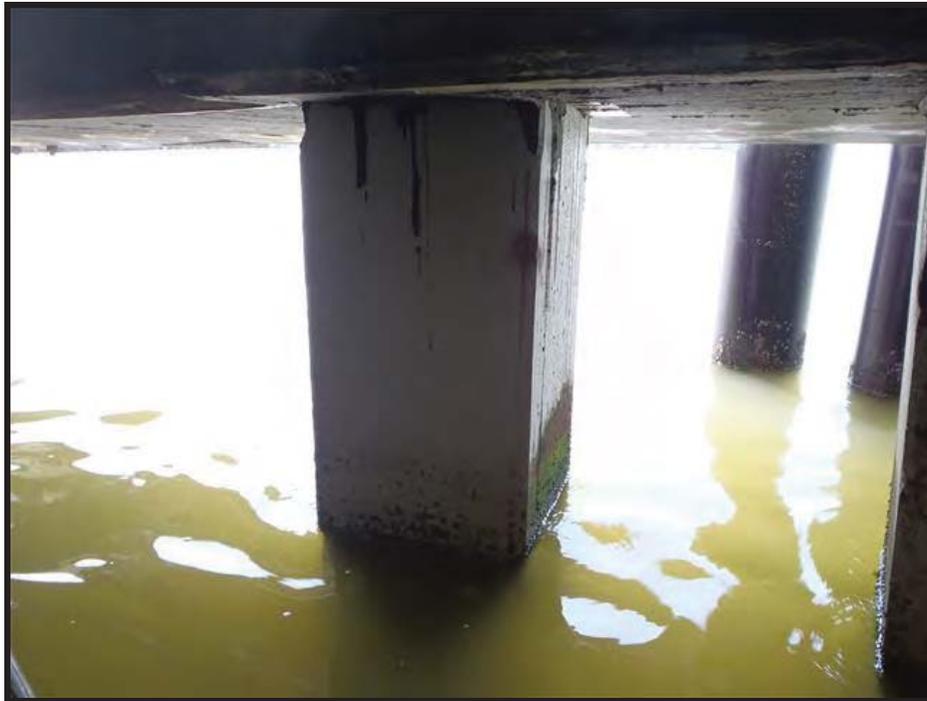
Photo 3.11-5: View of a vertical 18 in. square concrete pile supporting the breakwater.

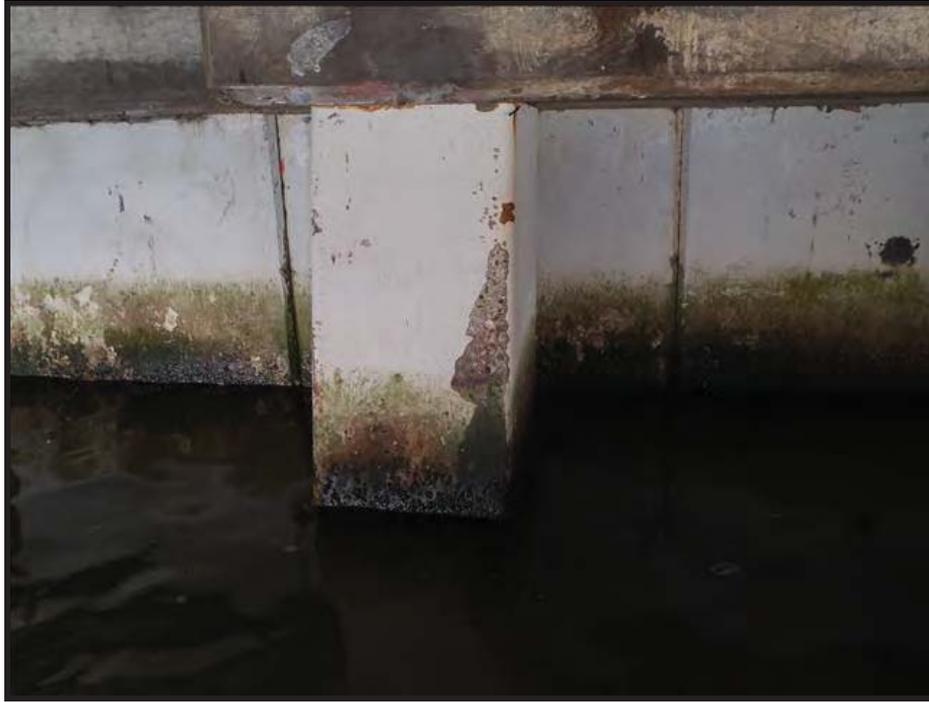
UFII Component	H10100101	Piles Asset Type(s): P & PB
Findings	The piles are in Good Condition. A total of 29 piles support the breakwater. There are 13 vertical and 16 battered, 18 in. square pre-cast reinforced concrete piles. The piles generally have white epoxy coating for their entire exposed length and exhibit only minor scaling, abrasion, and isolated areas of missing coating.	
Recommendations	There are no repairs recommended on the piles at this time. The minor scaling, abrasion, and isolated areas of missing epoxy coating do not warrant repair at this time.

Photo 3.11-8: View of a battered concrete pile with light abrasion and coating loss.

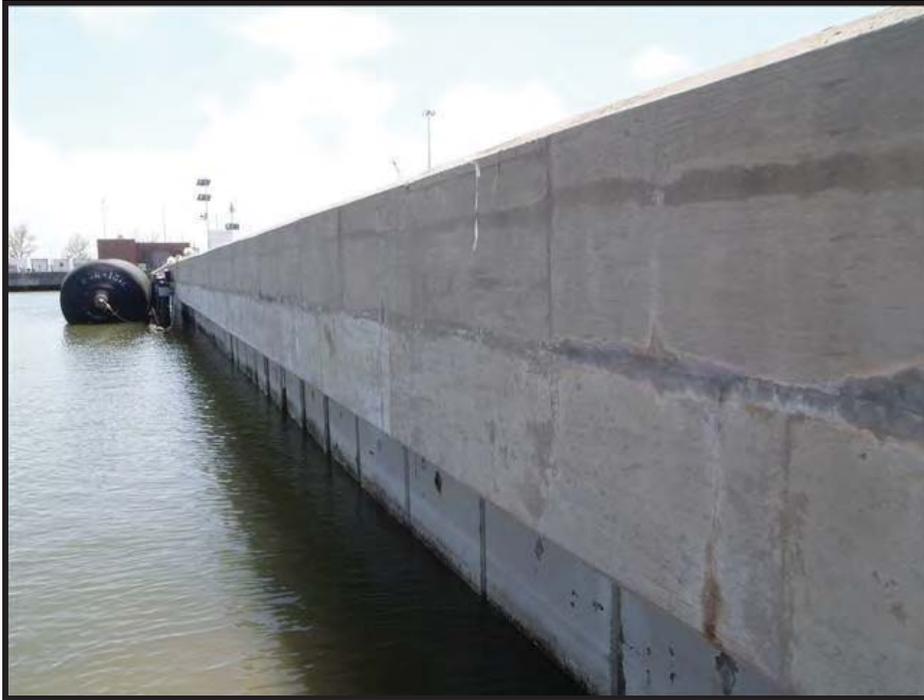
Photo 3.11-11: Overview of the pile cap supported by the inboard row of piles and the concrete sheet piles.

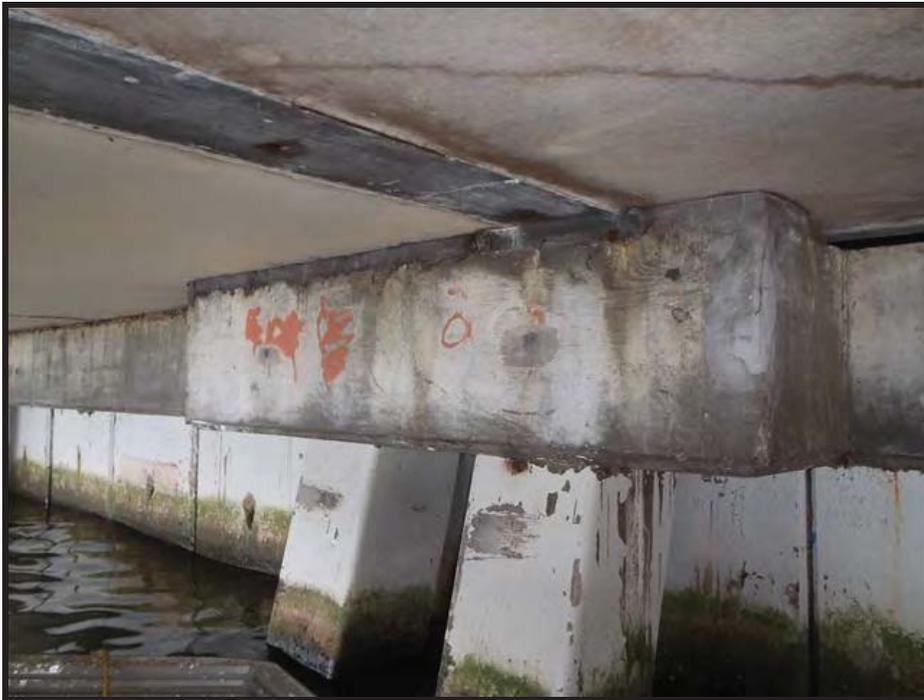
Photo 3.11-12: Typical configuration of the inboard pile cap at battered pile locations.

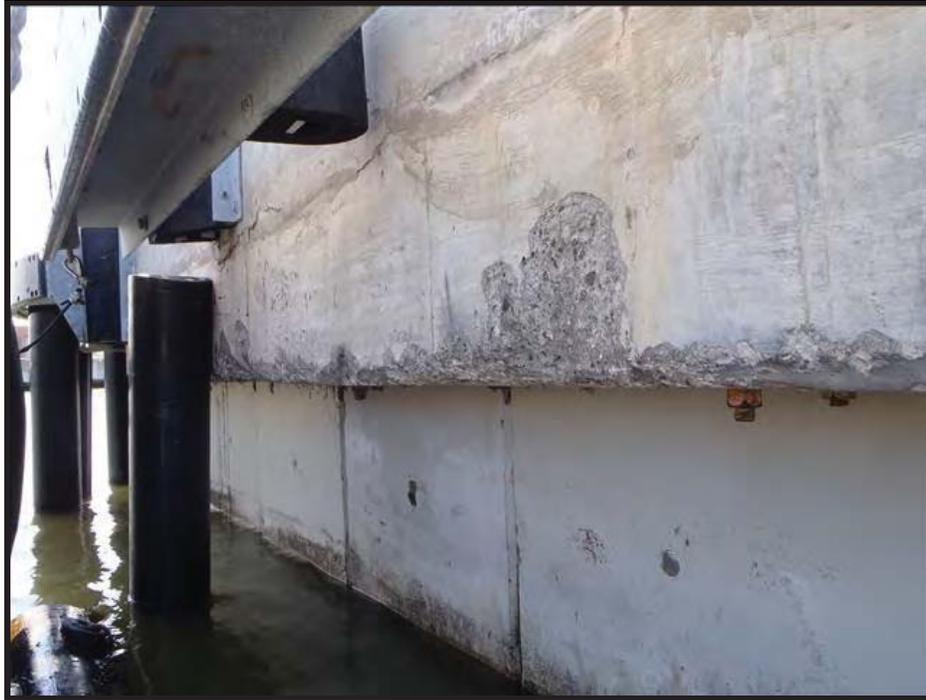
UFII Component	H101002	Pile Caps Asset Type(s): PC1 & PC2
Findings	<p>The pile caps are in Satisfactory Condition overall. The breakwater is constructed of two longitudinal pile caps that span the sheet piles and the bearing piles. The inboard row of battered piles and the concrete sheet piles support a 198 linear ft reinforced concrete pile cap that is 48 in. tall and varies in width from 45 in. to 62 in. The pile cap is in satisfactory condition with isolated areas of mechanical spalling and minor impact damage along the east face of the cap. Defects were noted on the pile cap in two locations, including two mechanical spalls up to 10 ft in length and 2 in. in depth.</p> <p>The outboard row of vertical piles supports a 198 linear ft reinforced concrete pile cap that is 54 in. wide and 24 in. tall. The pile cap is in satisfactory condition with minor impact damage and mechanical spalling near the bottom of the outboard face up to 2 in. in depth. Defects are noted on the pile cap in four locations, including open concrete spalls affecting a total area of 31 sq ft. Reinforcing bars are exposed at one of these locations.</p>

Photo 3.11-13: View of an open mechanical spall located on the east face of the pile cap.

Recommendations	It is recommended that six open concrete spalls on the pile caps be repaired.

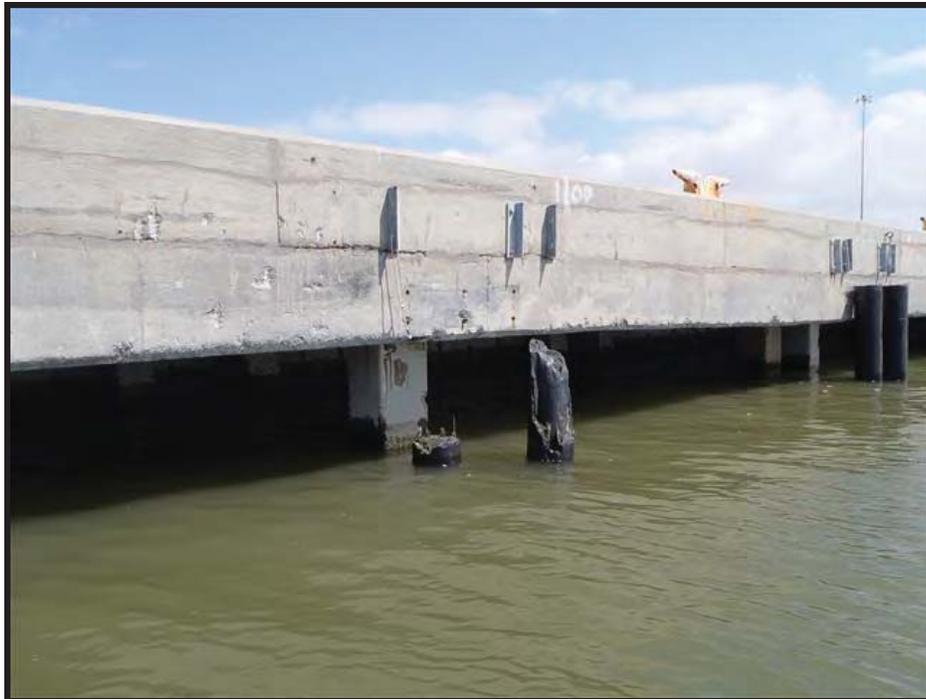
Photo 3.11-14: Overview of the pile cap supported by the outboard row of piles.

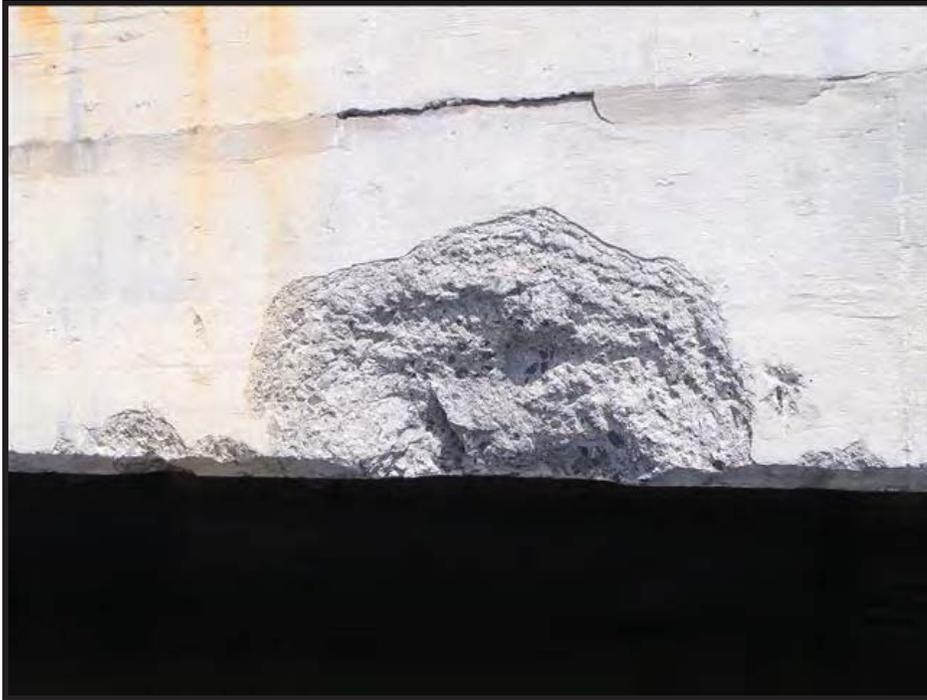
Photo 3.11-15: View of a 4 in. deep open mechanical spall located on the outboard face of the pile cap.

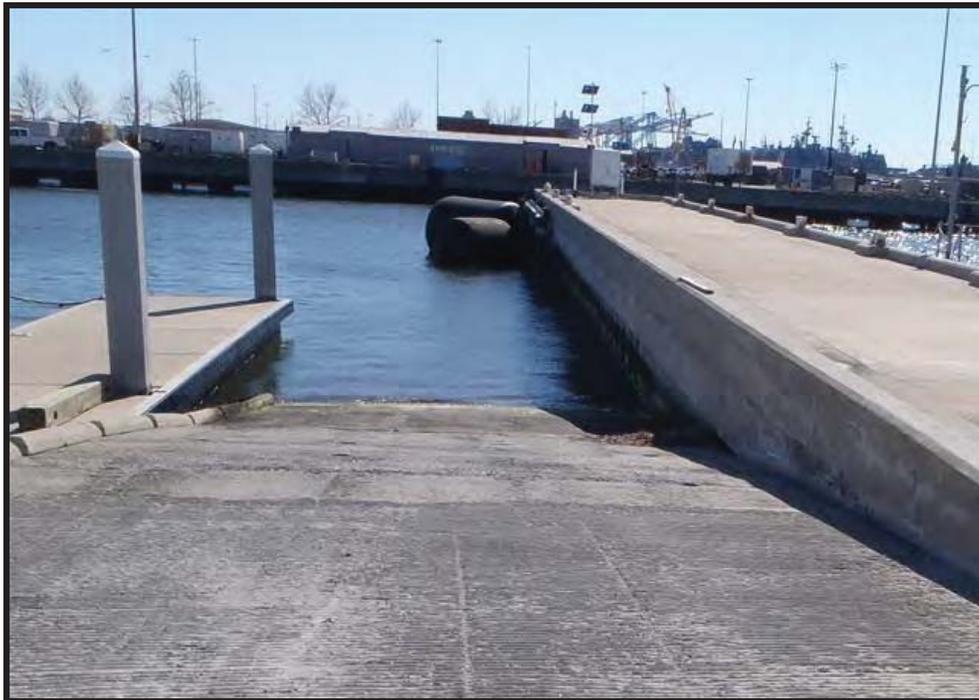
Photo 3.11-18: Overview of the concrete boat ramp adjacent to CEP169 Breakwater.

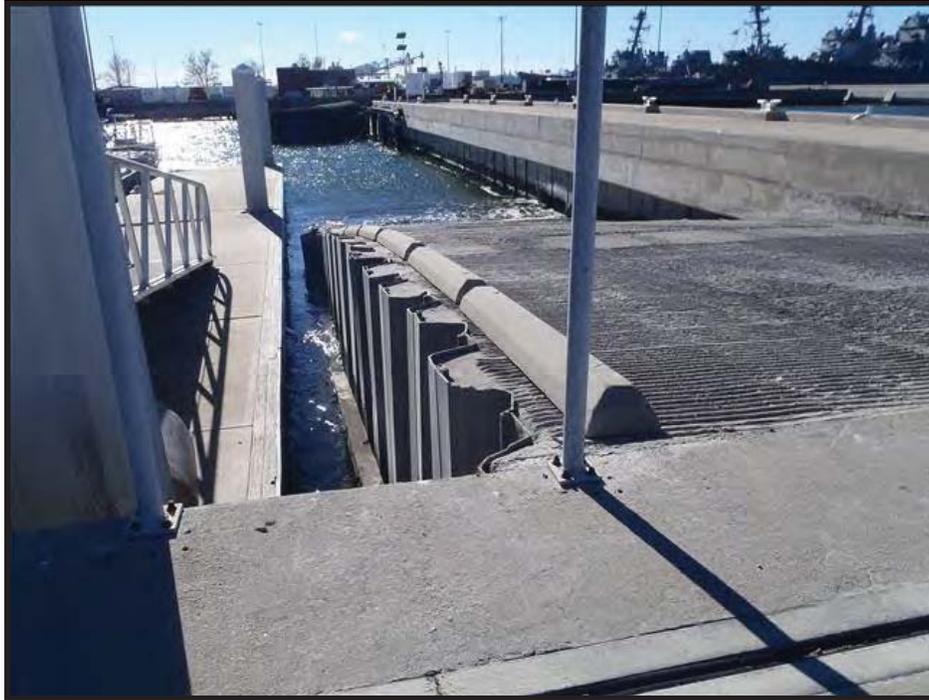
Photo 3.11-19: View of the boat ramp adjacent to the breakwater.

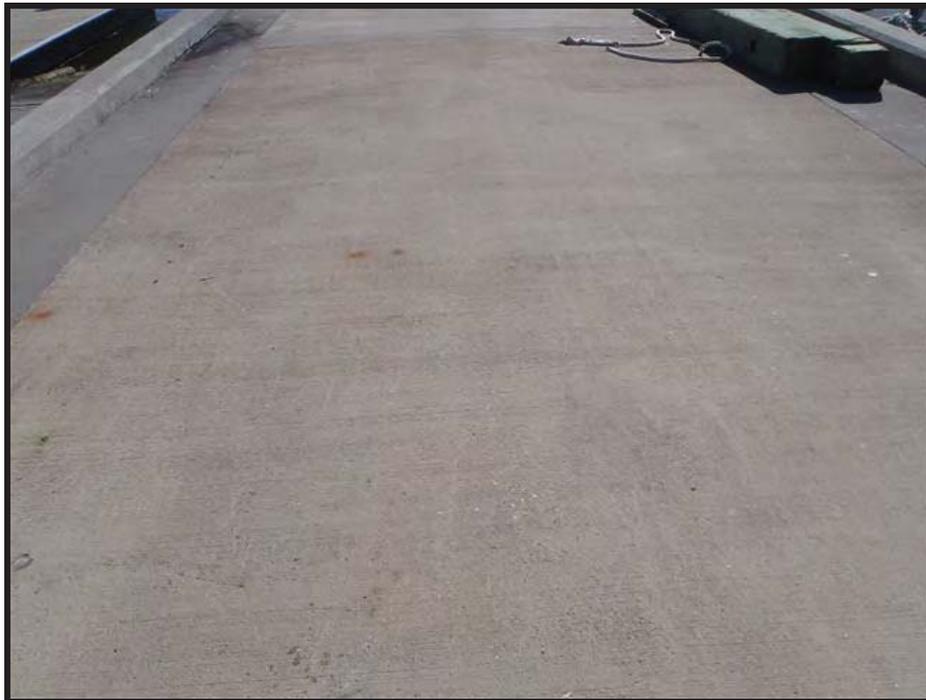
Photo 3.11-20: View of the topside of the deck.

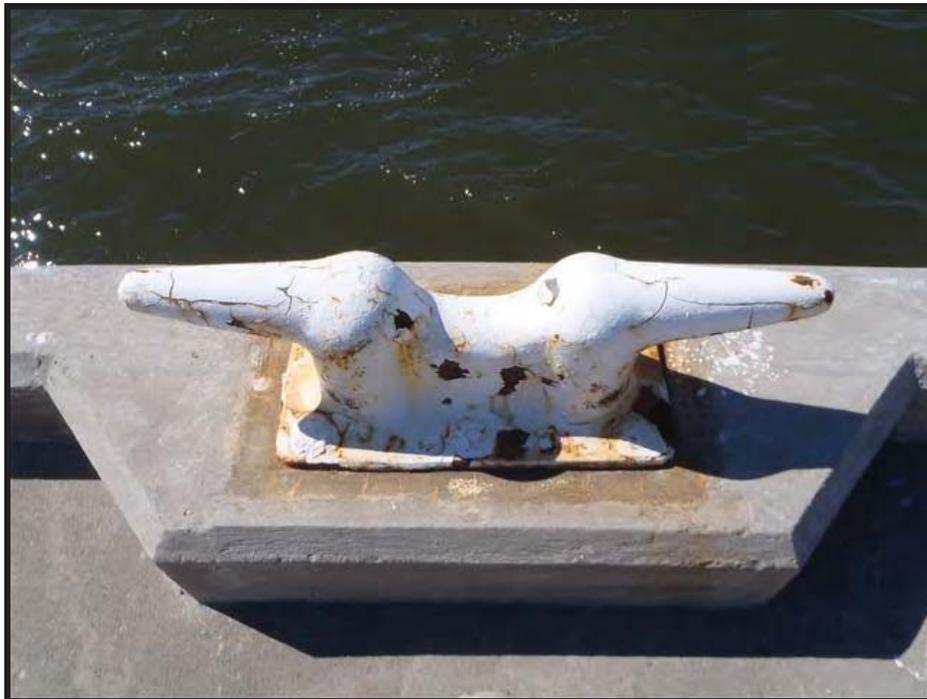
Photo 3.11-23: View of a 42 in. cleat mooring foundation.
