**CONTRACTOR REPORT
CR-NAVFAC EXWC-CIOFP-DRAFT
Volume II of III - Bulkheads**

**WATERFRONT FACILITIES
INSPECTIONS AND ASSESSMENTS AT
NORFOLK NAVAL STATION
NORFOLK, VIRGINIA**

On Site: Jan-29-2013

Norfolk Naval Station Norfolk, Virginia

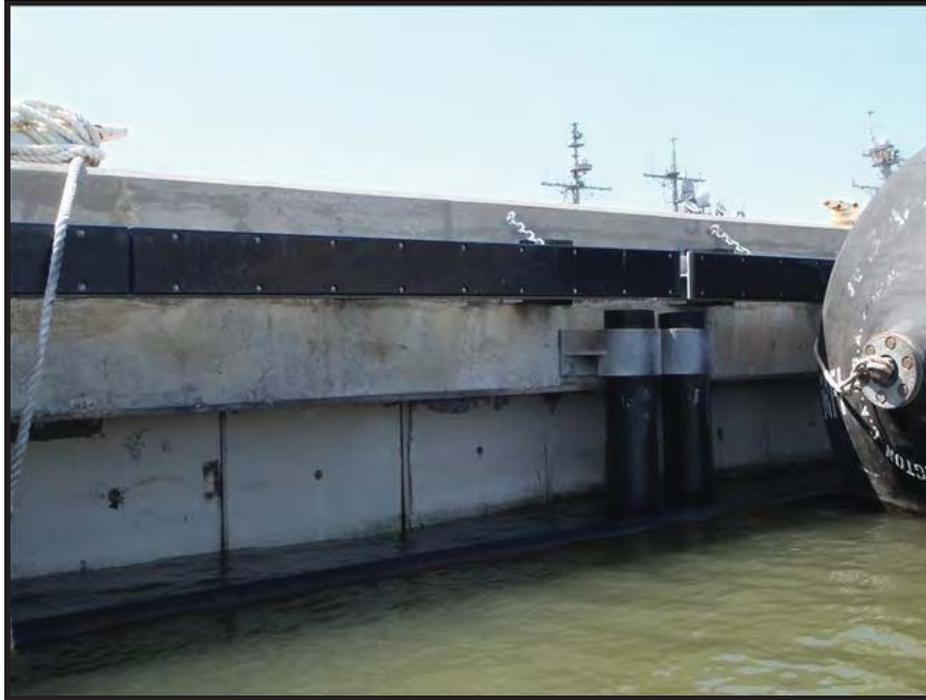
Photo 3.11-28: View of a typical galvanized steel fender wale.

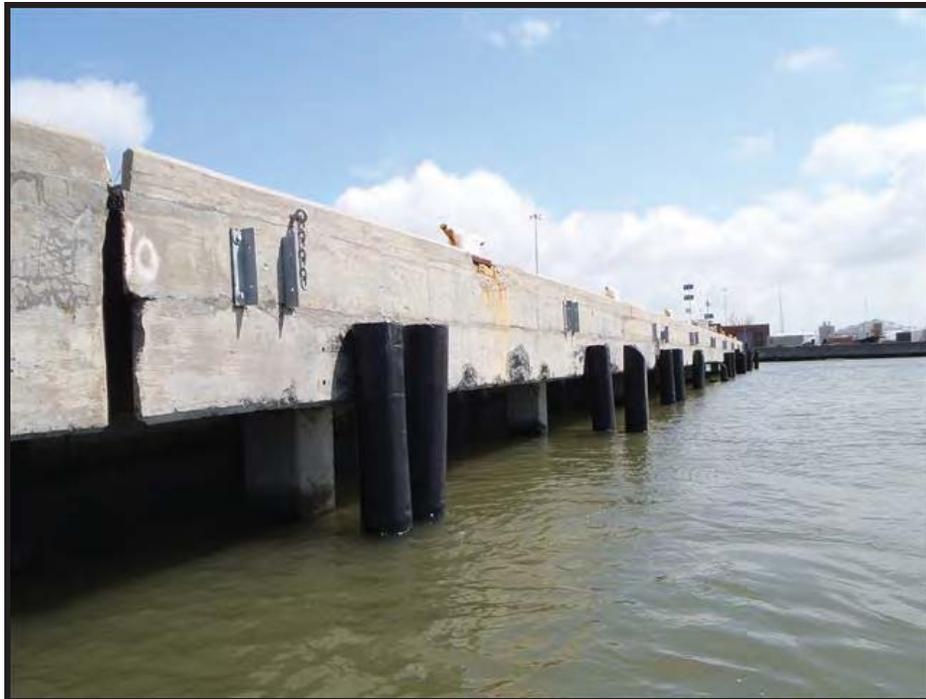
UFII Component	H10400102	Fender Framing Asset Type(s): FWL & FF1
Findings	<p>The fender framing is in Critical Condition overall. The fender framing consists of fender wales and fender pile guide assemblies. There is 228 linear feet of galvanized steel fender wales that are 22 ft 10 in. long, 12 in. tall, and 12 in. deep. A 1-1/2 in. thick HDPE pad is attached to the outboard face of each fender wale and the wales are secured to the breakwater using galvanized steel chains and molded compression members. The galvanized steel fender wale is in critical condition and is missing for 198 linear ft.</p> <p>There are 12 fender pile guide assemblies located on the breakwater. The galvanized steel guide assemblies are 3 ft-7 in. long, 21 in. wide, and 10 in. deep overall and each assembly secures two fender piles to the breakwater. The guide assemblies are in critical condition with 10 missing guide assemblies located on the breakwater, resulting in detached fender piles.</p>

Photo 3.11-29: Overview of missing fender wales on the west side of the breakwater.

Recommendations	<p>It is recommended that the fender system be replaced with components designed to accommodate the conditions and equipment moored at the bulkhead. Reuse of the existing fender piles may be possible.</p>

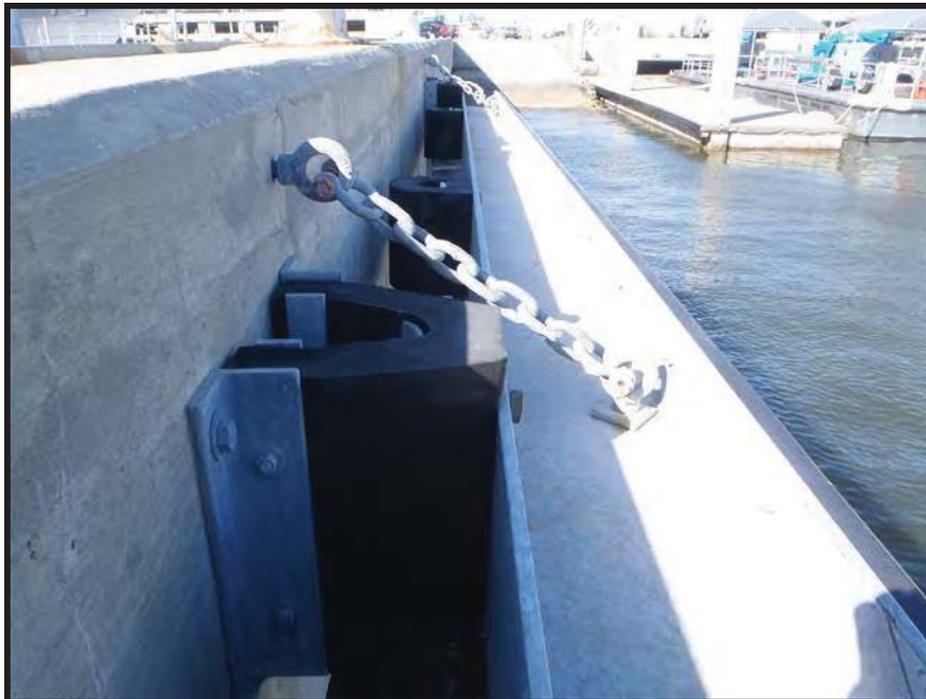
Photo 3.11-32: View of a rubber molded compression fender.

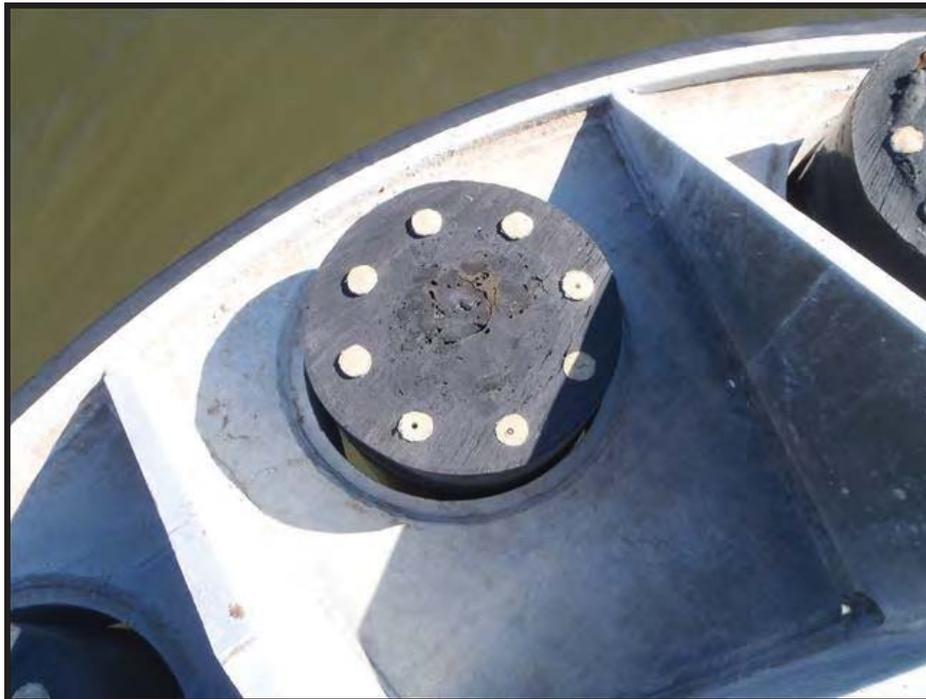
Photo 3.11-34: View of a HDPE corner fender pile showing fiberglass reinforcement.

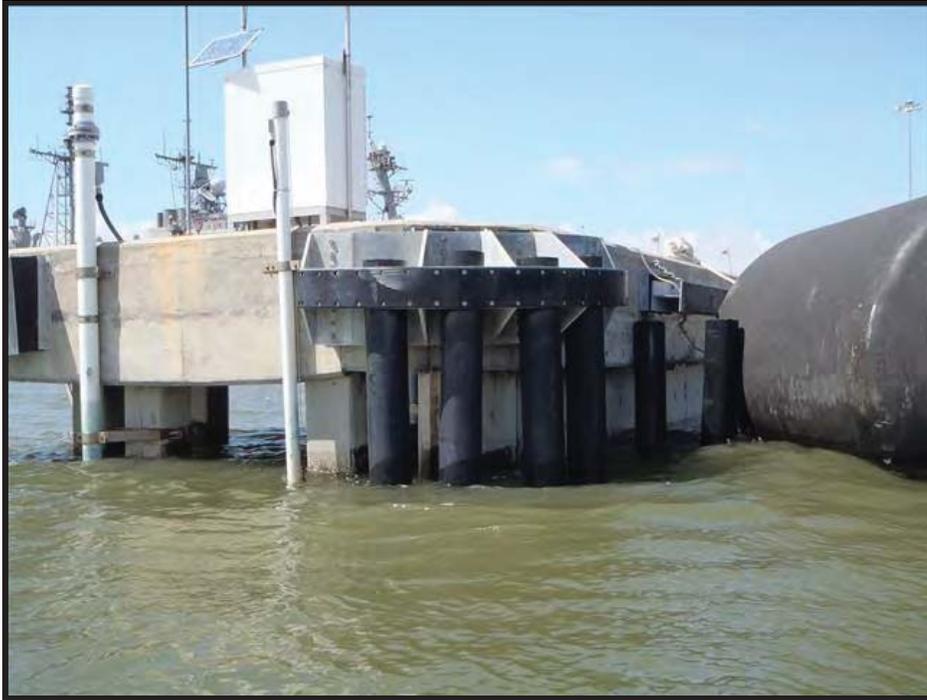
Photo 3.11-35: Overview of the corner fender piles located on the southeast corner of the breakwater.

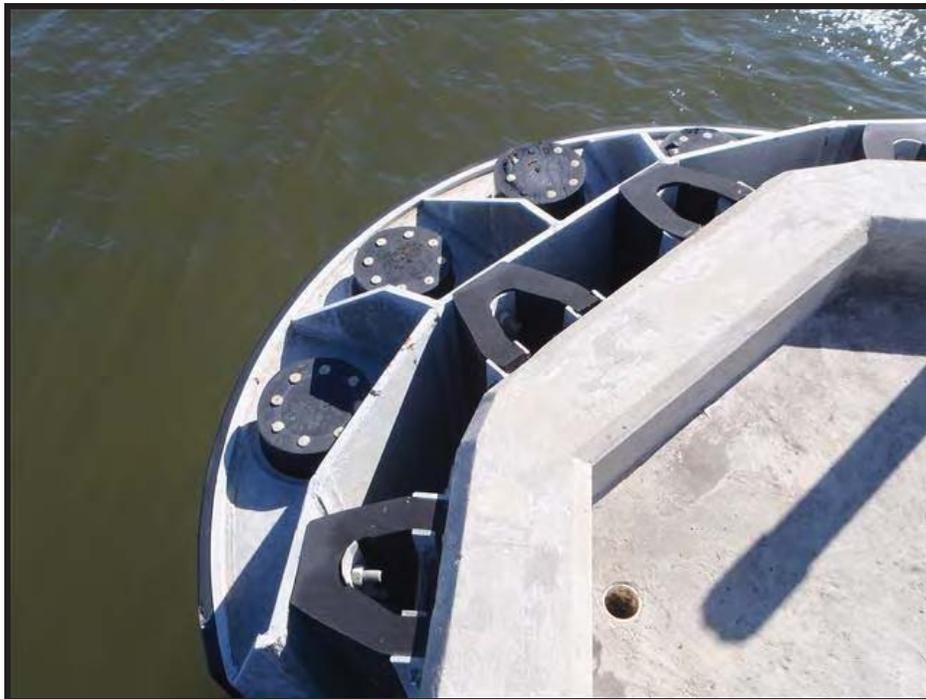
Photo 3.11-36: View of the corner fender framing.

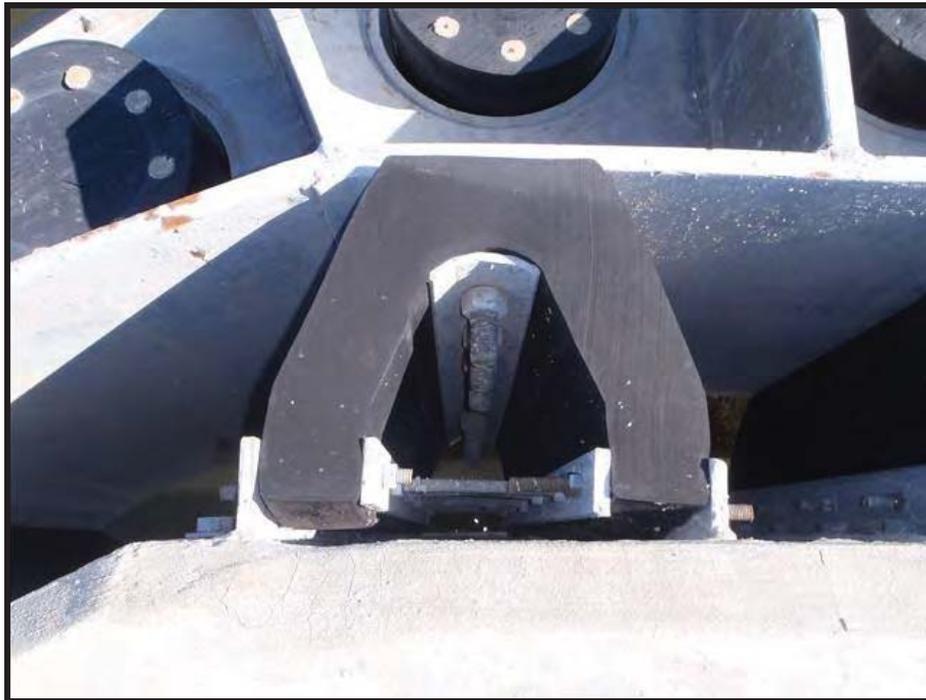
Photo 3.11-37: View of a corner molded compression fender.

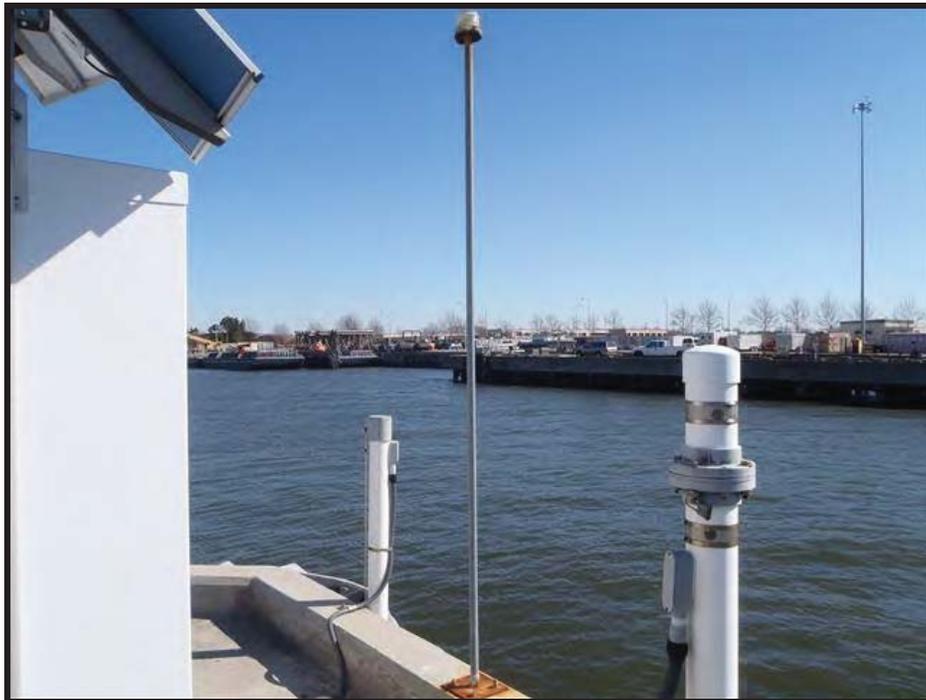
Photo 3.11-41: View of the marking light located at the outboard end of the breakwater.

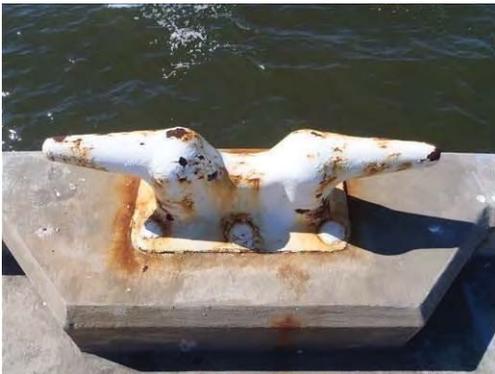
Asset Type: MF	Condition:
	Fitting ID: C6W	Fitting: 2
	Type: 42 in. Cleat	Base: 2
	Design Capacity: 20 tons	Connection: UNK Element Inaccessible
	Rating Capacity: 20 tons

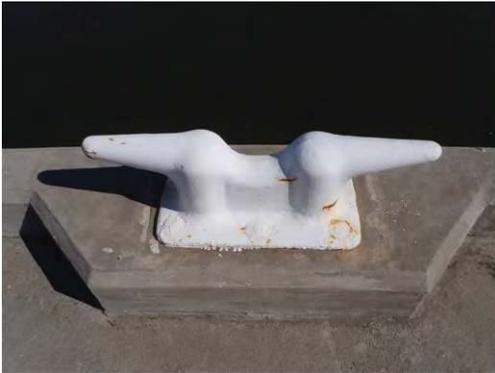
Asset Type: MF	Condition:
	Fitting ID: C6E	Fitting: 2
	Type: 42 in. Cleat	Base: 1
	Design Capacity: 20 tons	Connection: UNK Element Inaccessible
	Rating Capacity: 20 tons

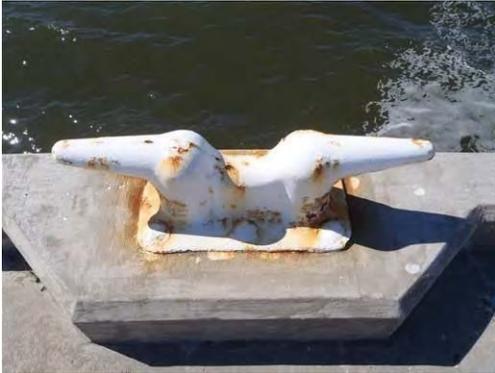
Asset Type: MF	Condition:
	Fitting ID: C7W	Fitting: 2
	Type: 42 in. Cleat	Base: 2
	Design Capacity: 20 tons	Connection: UNK Element Inaccessible
	Rating Capacity: 20 tons

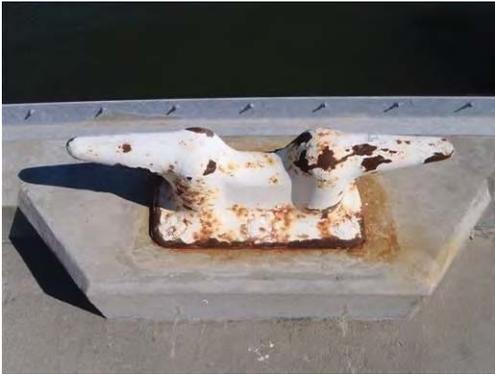
Asset Type: MF	Condition:
	Fitting ID: C7E	Fitting: 2
	Type: 42 in. Cleat	Base: 2
	Design Capacity: 20 tons	Connection: UNK Element Inaccessible
	Rating Capacity: 20 tons

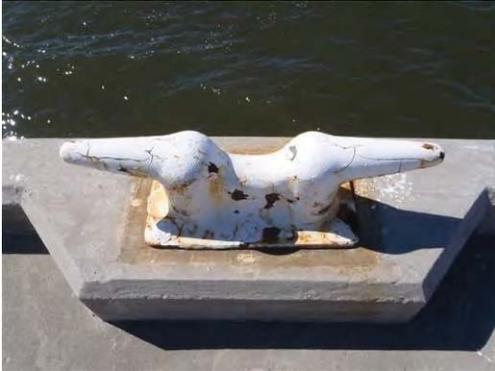
Asset Type: MF	Condition:
	Fitting ID: C8W	Fitting: 2
	Type: 42 in. Cleat	Base: 2
	Design Capacity: 20 tons	Connection: UNK Element Inaccessible
Rating Capacity: 20 tons

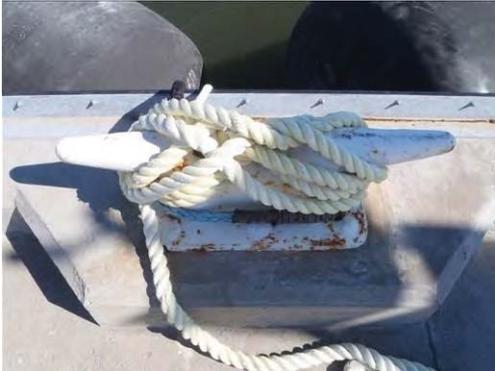
Asset Type: MF	Condition:
	Fitting ID: C8E	Fitting: 2
	Type: 42 in. Cleat	Base: 2
	Design Capacity: 20 tons	Connection: UNK Element Inaccessible
Rating Capacity: 20 tons

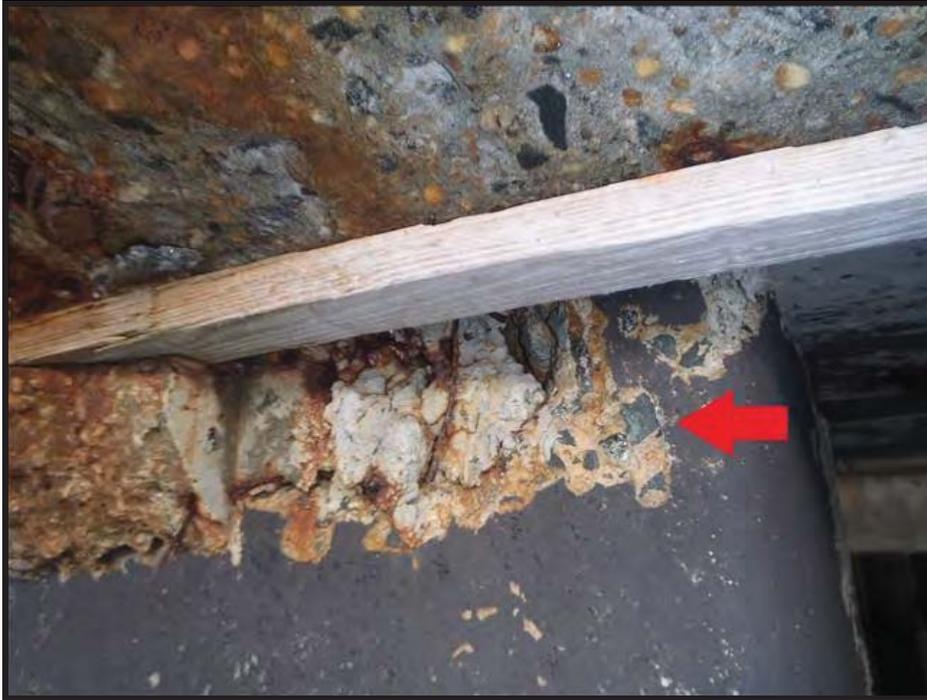
Photo 3.12-10: View of an open mechanical spall at the top of a concrete bearing pile.

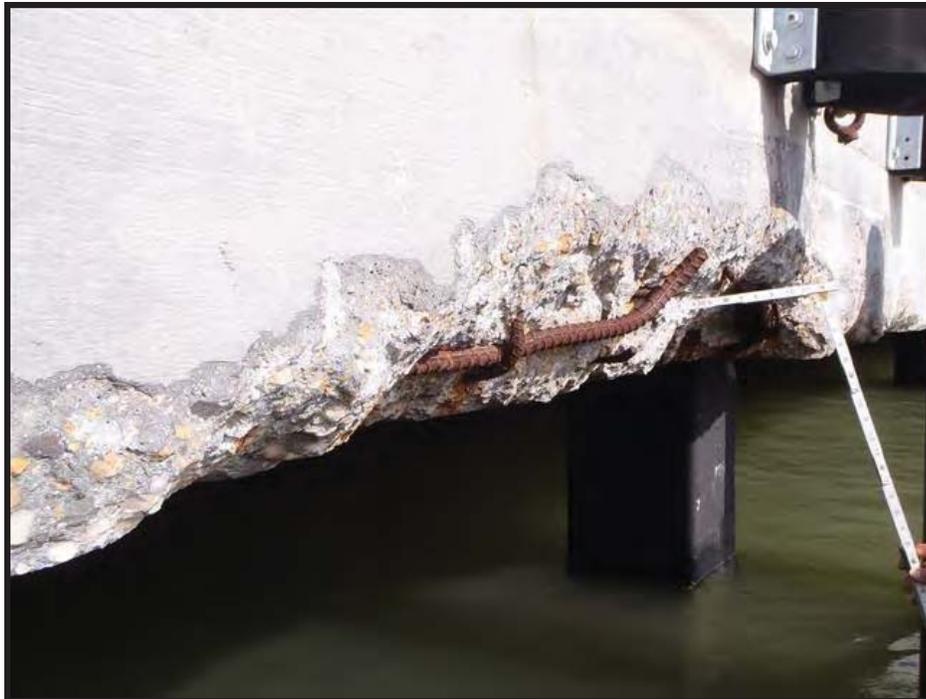
UFII Component	H101002	Pile Caps Asset Type(s): PC1, PC2, PC3, & PC4
Findings	<p>The pile caps are in Satisfactory Condition overall. The bulkhead is constructed of four pile caps that span the sheet piles and the bearing piles supporting the platform. The outboard row of platform piles supports a 1,300 linear ft reinforced concrete pile cap that is 44 in. wide and 24 in. tall. The outboard platform pile cap is in satisfactory condition with isolated hairline vertical cracking and minor impact damage near the bottom of the outboard face. There are a total of nine open concrete spalls on the outboard pile cap of the platform. The total area affected by the open spalls is approximately 93 sq ft.</p> <p>The middle row of platform piles supports an 842 linear ft reinforced concrete pile cap that is 58 in. wide and 24 in. tall. This pile cap extends from Sta. 0+00 to Sta. 8+42. The pile cap is in good condition with no defects noted.</p> <p>There is 1,605 linear ft of a reinforced concrete pile cap is that is 43 in. wide and 24 in. tall, supported by the inboard row of bearing piles for the entire length of the facility. There are three open mechanical spalls located on the pile cap near the north end of the facility where the relieving platform is no longer present. The spalls are up to 10 sq ft in area and 4 in. deep.</p> <p>The sheet piles support a 1,605 linear ft reinforced concrete pile cap that is 30 in. wide and 24 in. tall. The pile cap is in good condition with no defects noted.</p>

Photo 3.12-16: View of a 6 in. deep open spall located on the outboard face of the pile cap.

Recommendations	<p>It is recommended that 12 open concrete spalls on the pile caps be repaired. The hairline cracking and minor impact damage noted on the outboard pile cap do not warrant repair at this time.</p>

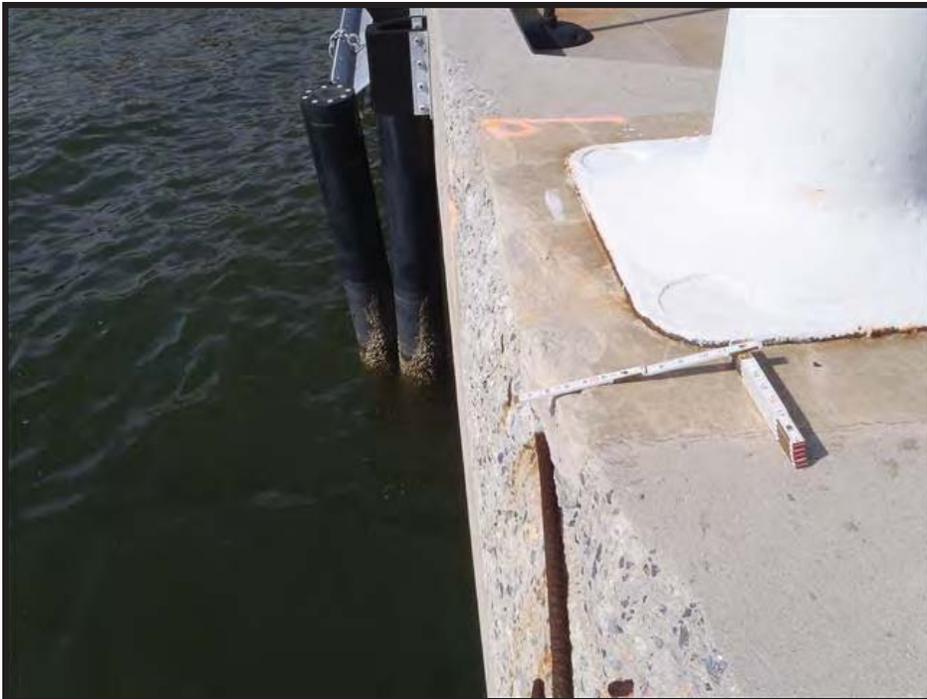
Photo 3.12-30: Impact damage on the outboard side of a mooring foundation.

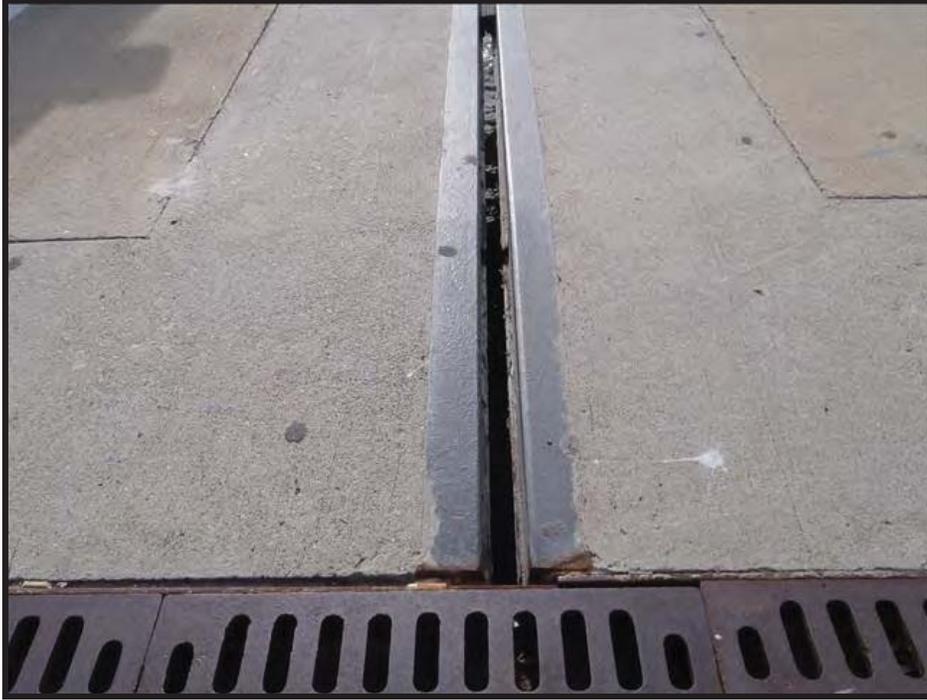
Photo 3.12-33: View of the missing rubber gasket membrane located at Sta. 10+05.

UFII Component	H103008	Expansion Joints Asset Type(s): EJ1 & EJ2
Findings	The expansion joints are in Satisfactory Condition. There are eight expansion joints located on the platform. The joints are oriented perpendicular to the length of the platform and vary in length from 26 ft to 49 ft. The expansion joints are 8 in. wide overall and are constructed of galvanized steel angles and rubber gaskets. The expansion joint located at Sta. 10+05 has 5 ft 6 in. of the rubber gasket membrane missing.	
Recommendations	It is recommended that the missing rubber gasket membrane at one expansion joint be repaired.

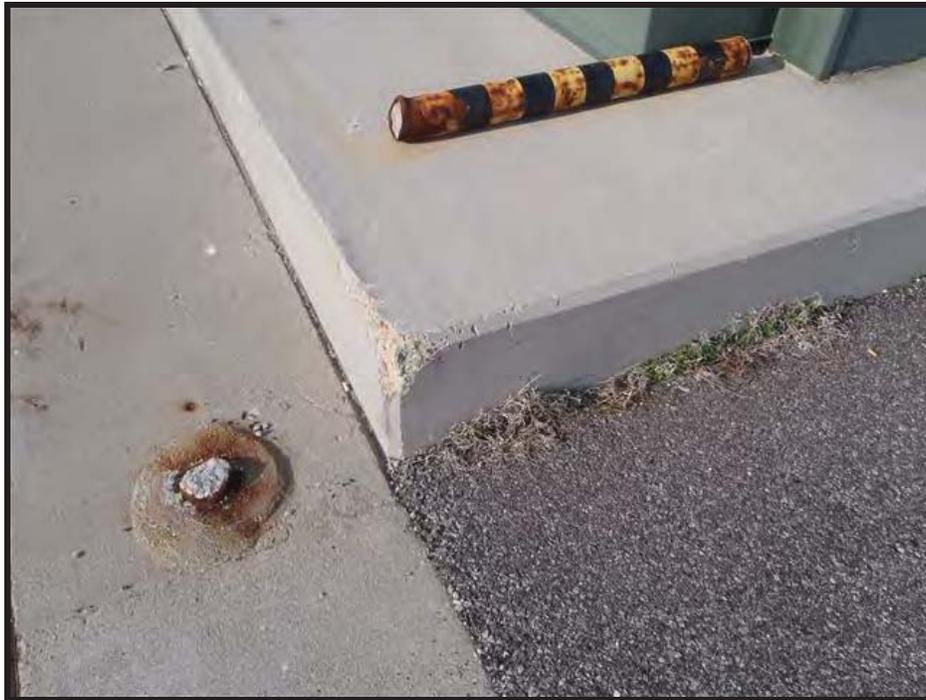
Photo 3.12-36: View of a broken and detached guard post no longer protecting a transformer.

UFII Component	H103009	Guard Posts and Railings Asset Type(s): GPT1 & GPT2
Findings	<p>The guard posts and railings are in Satisfactory Condition overall. There are six painted steel concrete filled 4-1/2 in. OD guard posts located on the bulkhead that are 2 ft 10 in. tall. The guard posts are installed to protect a telecommunications cabinet and two transformers located along the bulkhead. The guard posts are in satisfactory condition with isolated paint loss. One guard post protecting a transformer is broken and detached from its foundation.</p> <p>There are also eight painted steel concrete filled 5 in. OD guard posts located on the bulkhead that are 3 ft 10 in. tall. These guard posts protect a power limit switch and a fire hydrant. The 5 in. OD guard posts are in satisfactory condition with up to 20 percent paint loss and minor corrosion in paint loss areas.</p>	
Recommendations	It is recommended that one broken guard post be replaced.

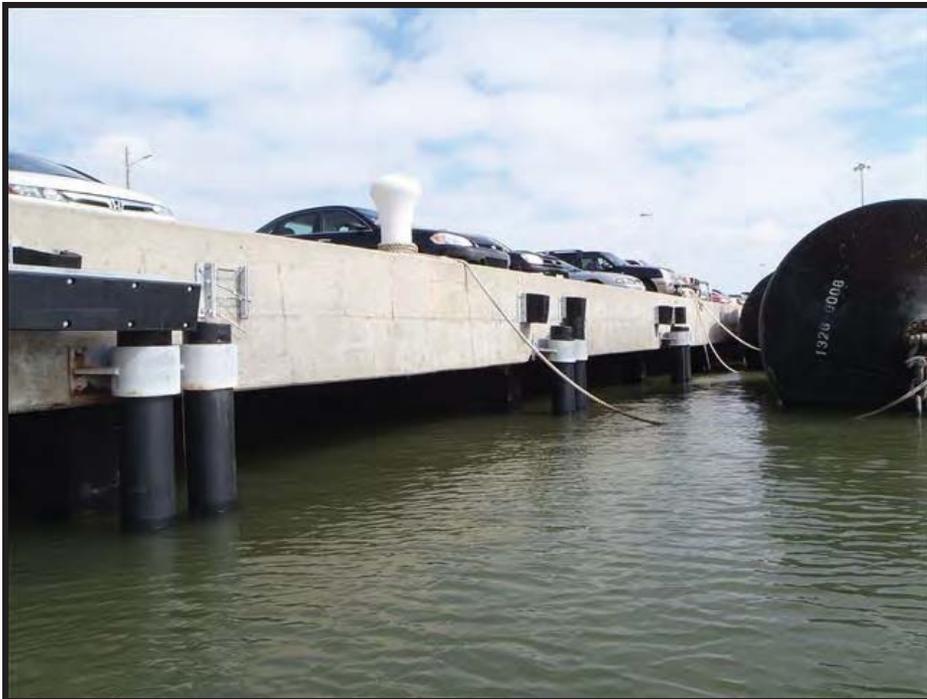
Photo 3.12-43: View of a section of missing fender wales.

Recommendations	<p>It is recommended that 436 linear ft of the fender wale be replaced, that the fender wale be secured to the platform in 23 locations, and that one area of impact damage be repaired. It is also recommended that 20 fender pile guide assemblies be replaced.</p>

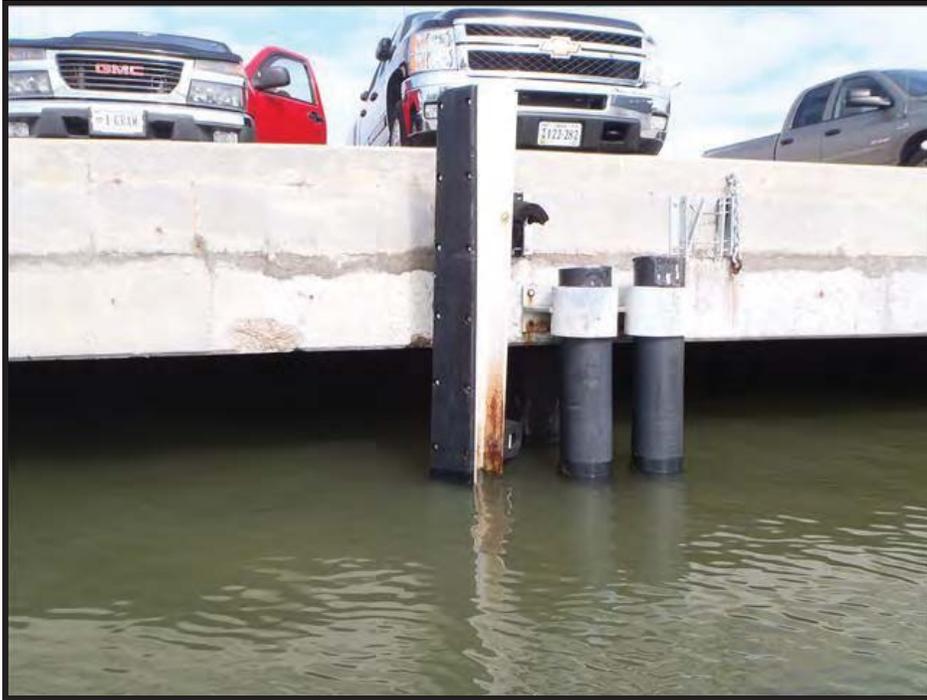
Photo 3.12-44: View of a typical detached fender wale.

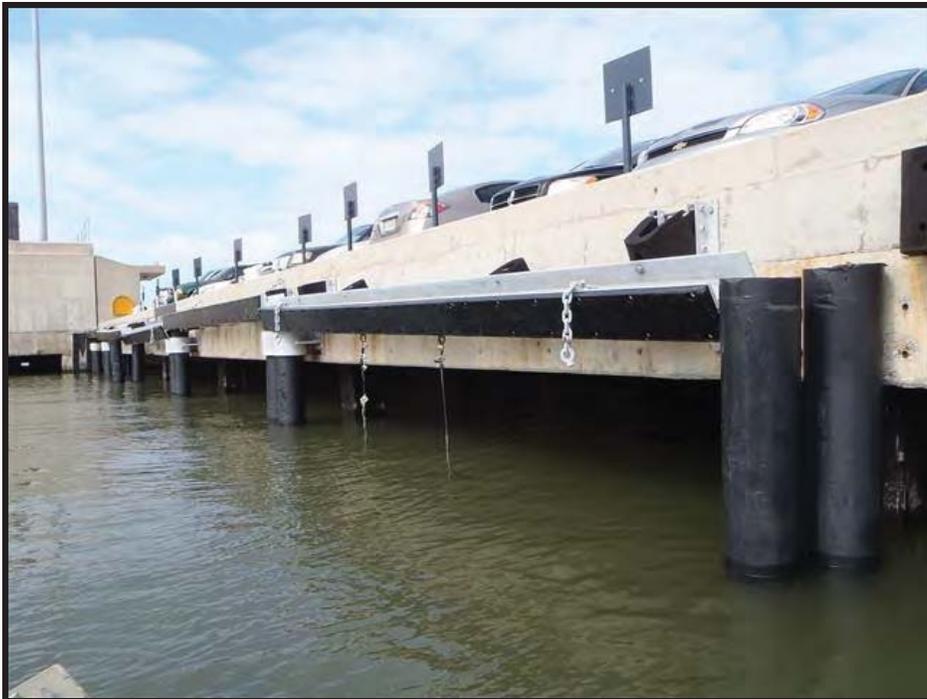
UFII Component	H10400102	Fender Framing Asset Type(s): FWL & FF
Findings	<p>The fender framing is in Poor Condition overall. There is 1,117 linear feet of galvanized steel wide flange beam fender wales. A 1-1/2 in. thick HDPE pad is attached to the outboard face of each fender wale and the wales are secured to the platform using galvanized steel chains and molded rubber compression members. The galvanized steel fender wale is missing for 320 linear ft, detached for 116 linear ft, has loose connections at 23 locations, and exhibits impact damage resulting in a crack between the web and flange in one location.</p> <p>There are 55 fender pile guide assemblies located on the platform. The galvanized steel guide assemblies are 3 ft 7 in. long, 21 in. wide, and 10 in. deep overall and each assembly secures two fender piles to the platform. There are 20 missing guide assemblies located on the platform, resulting in detached fender piles.</p>

Photo 3.12-45: View of a typical loose fender wale.

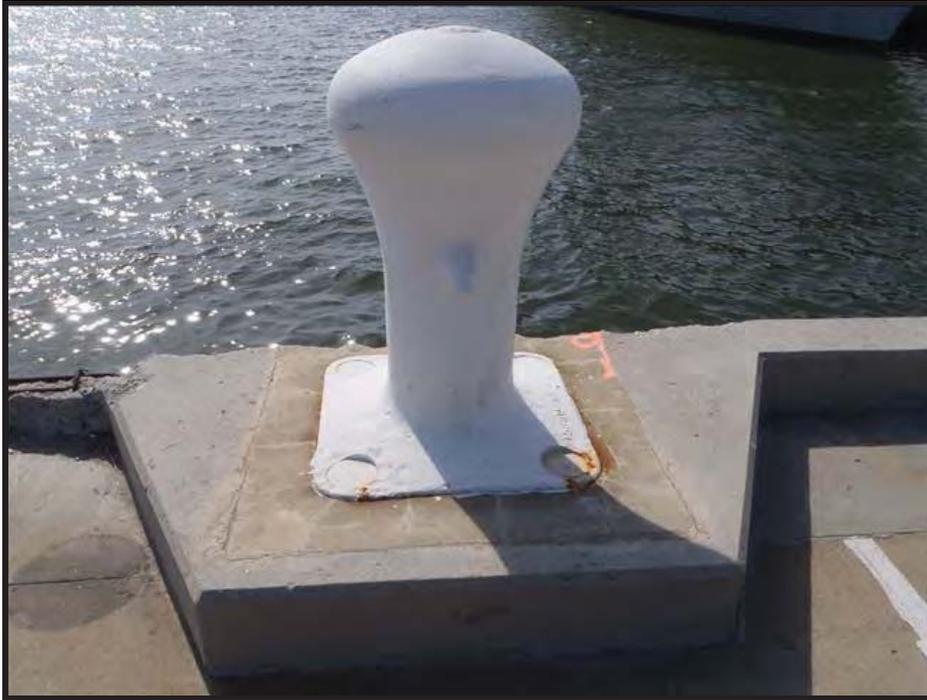
Photo 3.12-52: View of a typical 42 in. tall bollard on the platform.

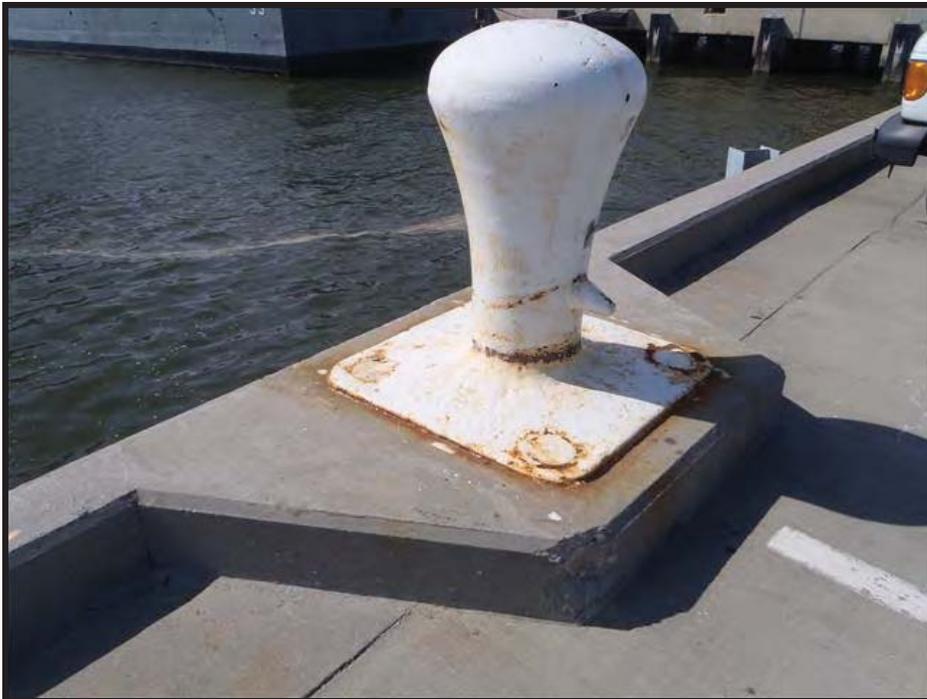
Photo 3.12-53: View of a 42 in. bollard with up to 25 percent coating loss and minor corrosion.

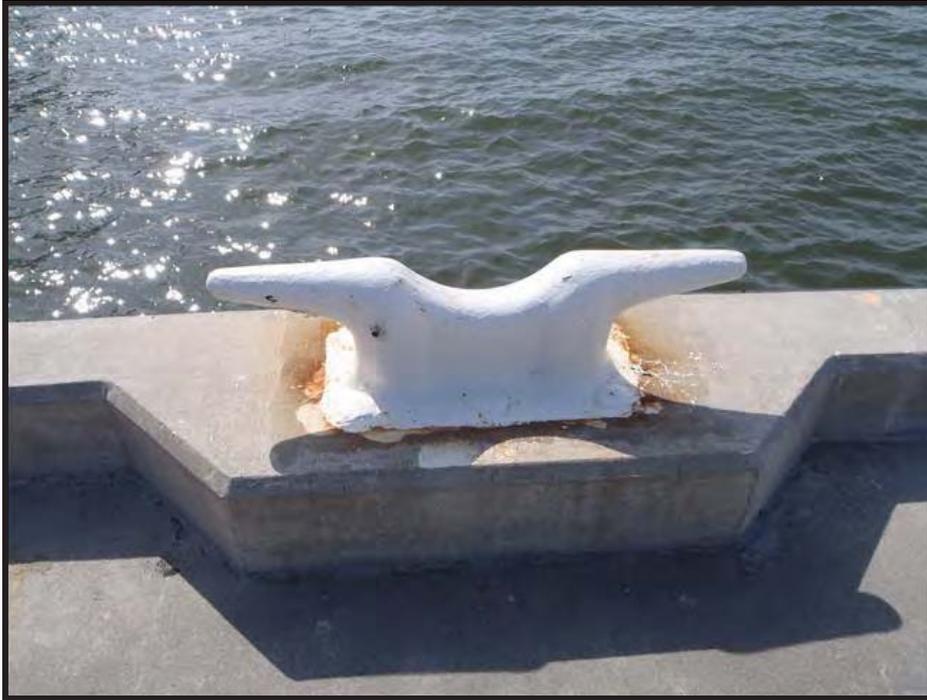
Photo 3.12-54: View of a typical 42 in. cleat.

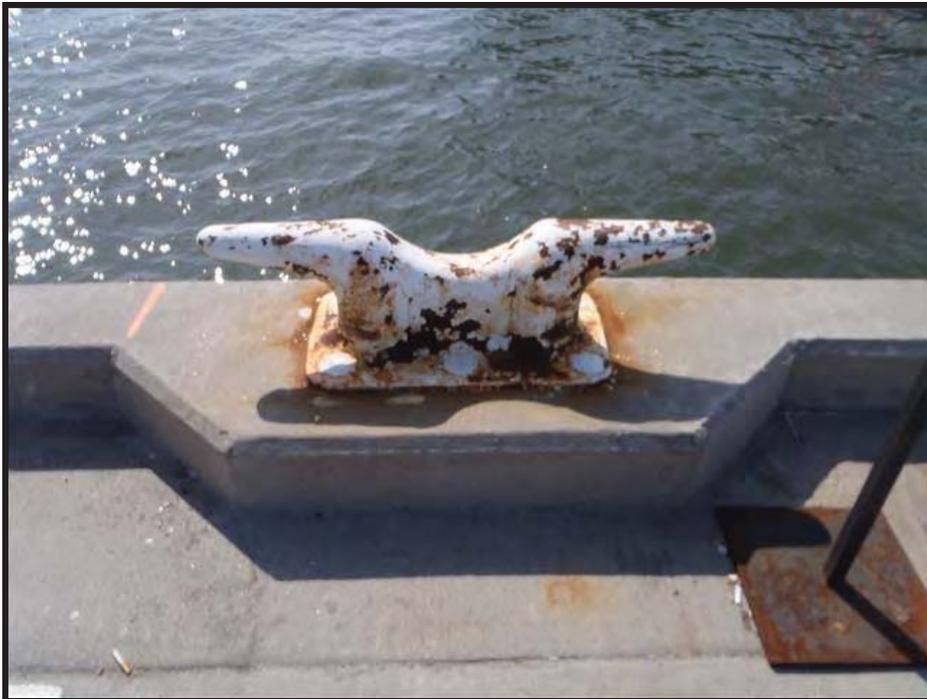
Photo 3.12-55: View of a 42 in. cleat with up to 35 percent coating loss and minor corrosion.

Recommendations	It is recommended that five cleats be cleaned and repainted.

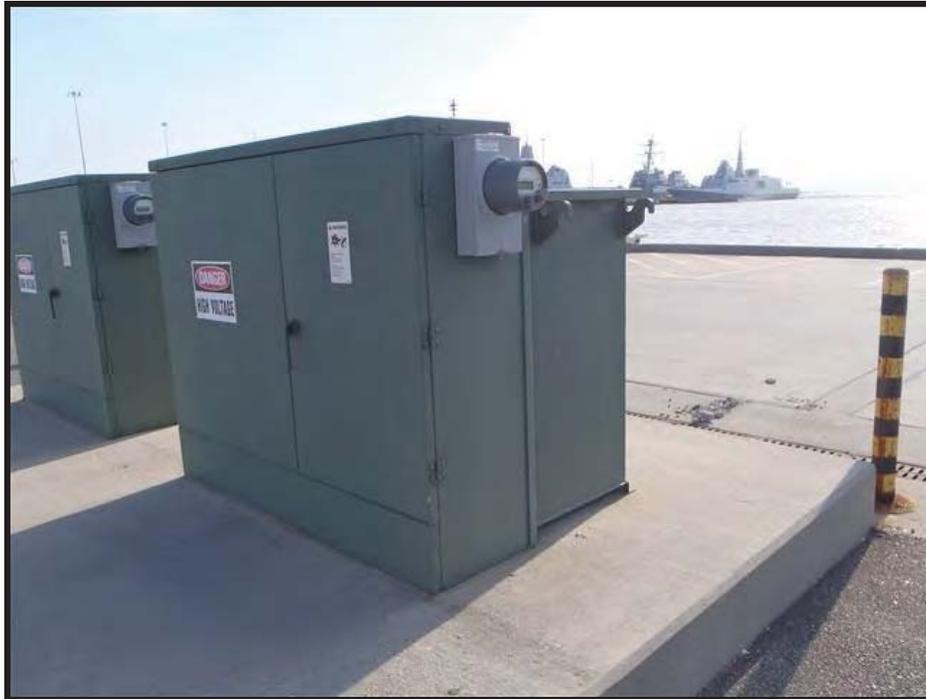
Photo 3.12-56: View of a transformer.

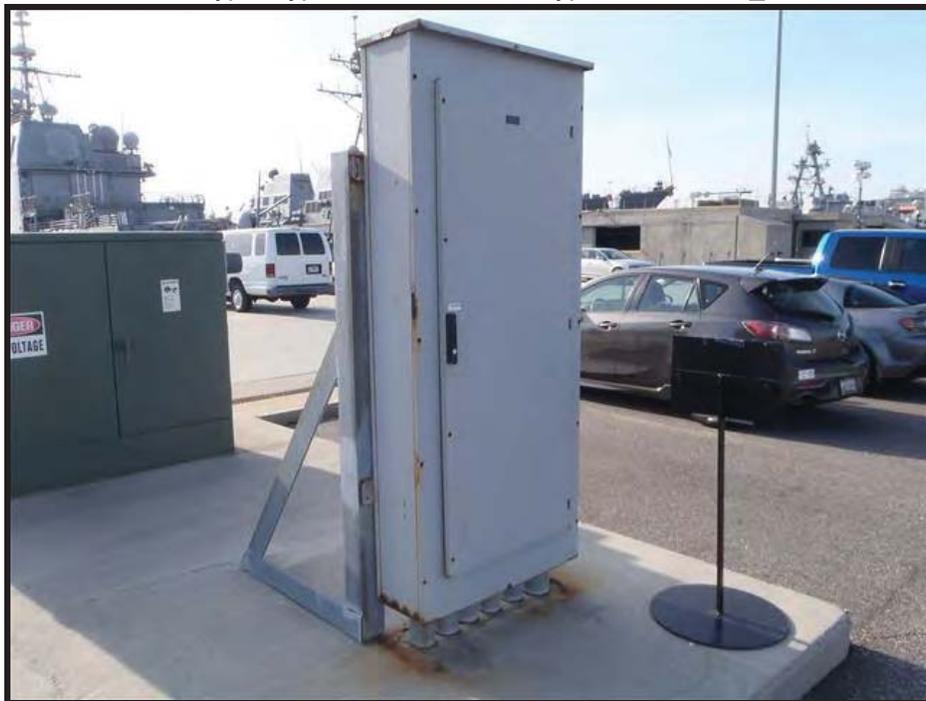
Photo 3.12-57: View of a circuit breaker.

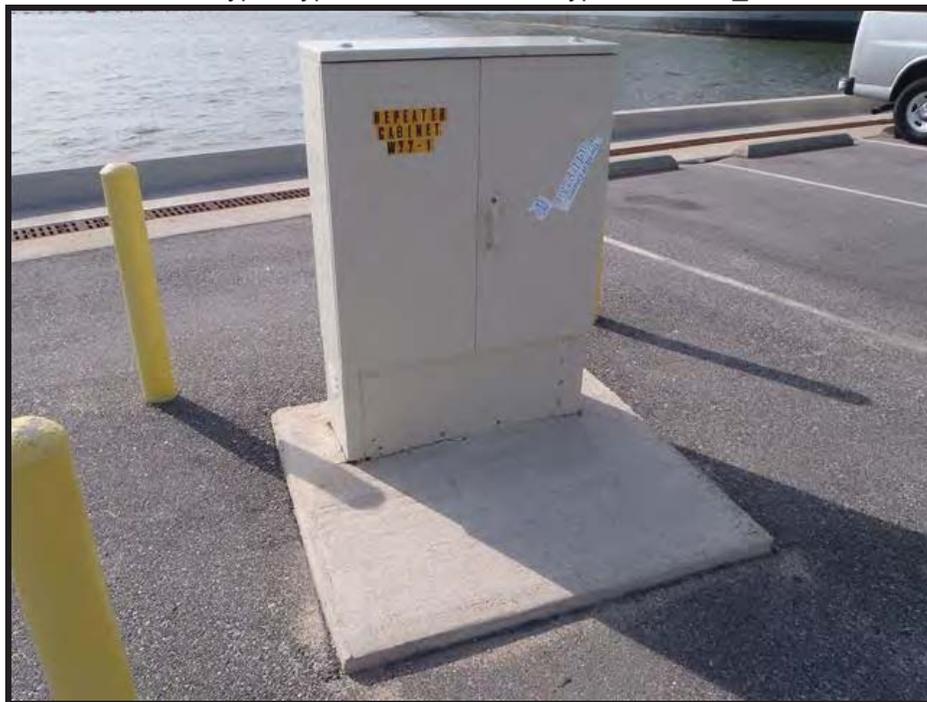
Photo 3.12-59: View of a communications cabinet.

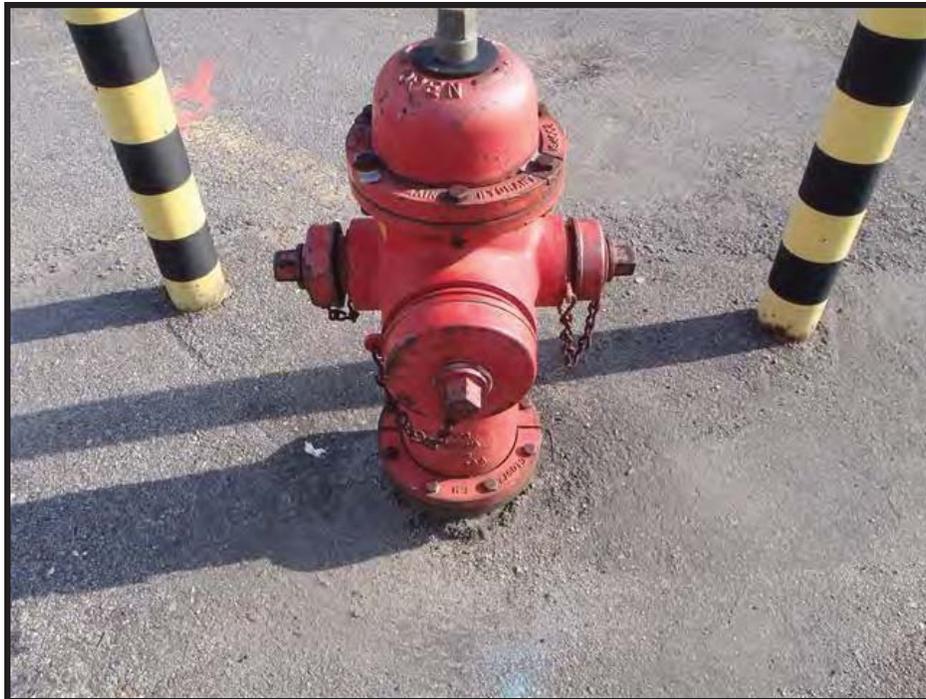
Photo 3.12-60: View of a fire protection hydrant.
